**Restoration Plan
for
Plum Run Watershed
Chester County, Pennsylvania
February 2008**

RETTEW Associates, Inc.
Natural Sciences Group
950 East Main Street, Suite 220
Schuylkill Haven, PA 17972
(570) 385-2270
(570) 385-2217 fax
RETTEW Project No. 07-07568-002

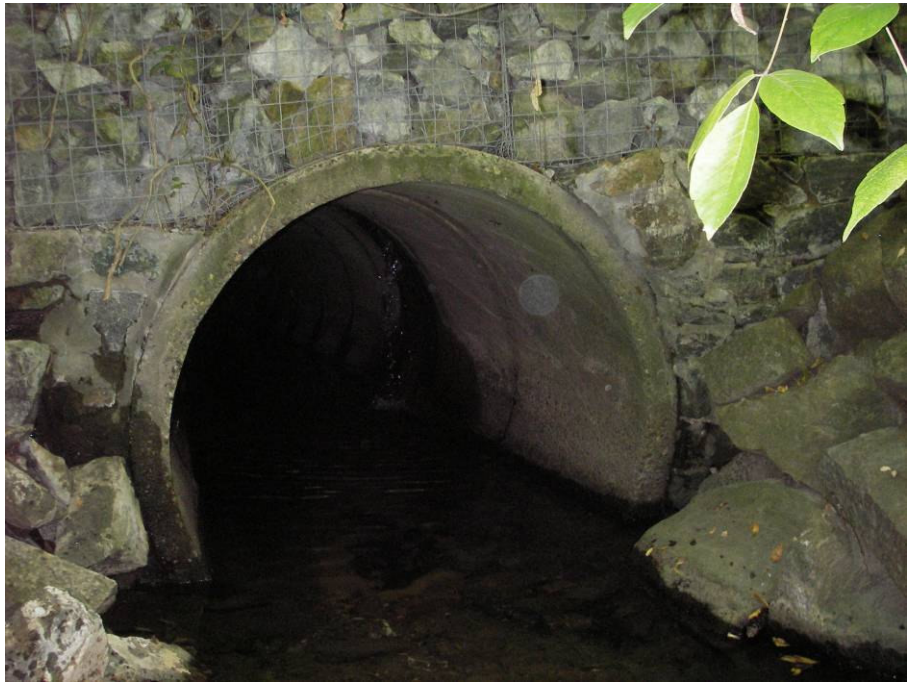
Impacted Stream Segment #53-55:

The West Branch of Plum Run first sees daylight at this outfall below New Street. The water quality is likely impaired as algae scums coat the bottom of the stream. The stream lacks an adequate buffer and has gabion baskets lining the north bank. While the stream is shaded, it is aesthetically impaired by litter that has collected in the channel.

Urban stormwater management retrofits that consider volume, rate, and possibly most importantly water quality should be included with any work that drains into Plum Run (including areas that drain via the storm sewer system). Educational programs in this community should focus on the presence and value of Plum Run. Important first steps are stormdrain stenciling, stream signage and a community litter cleanup.

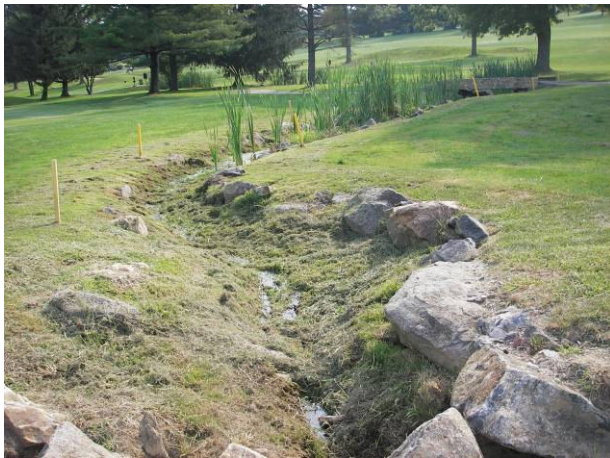
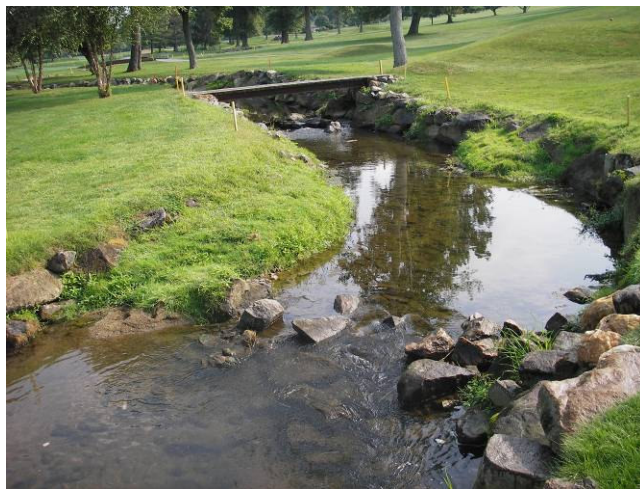
Impacted Stream Segment #8-11:

This section of stream includes a well manicured area with a rip-rap lined streambank. The channel is entrenched, fish habitat is lacking, the bottom is heavily sedimented, no riparian buffer exists to mitigate the effects of any lawn care products that may be applied upslope, and a diversity of riffles and runs is lacking. The streambanks are approx. 5' high, but are stabilized with rip-rap. An exposed pipe in the area of a gas-line crossing should be investigated by the appropriate utility representatives.

The effective restoration of this stream segment will largely depend on the willingness of the landowner in altering the riparian area of the property. Reshaping the stream channel to a natural stream geometry would be ideal. This area would also benefit from a fish habitat enhancement project. Placing structures in the stream would aid in transporting sediment through this area and may enhance the aesthetics as the water gently splashes over and through the various structures. The bottom photo (above) shows an example of functioning in-stream structure that is improving habitat in that immediate area. Of great importance is the installation of bioretention areas that will function as small wetlands to mitigate pollutants that are added to the lawn areas adjacent to the stream. Installation of the bioretention areas at the historic floodplain elevation would be ideal.

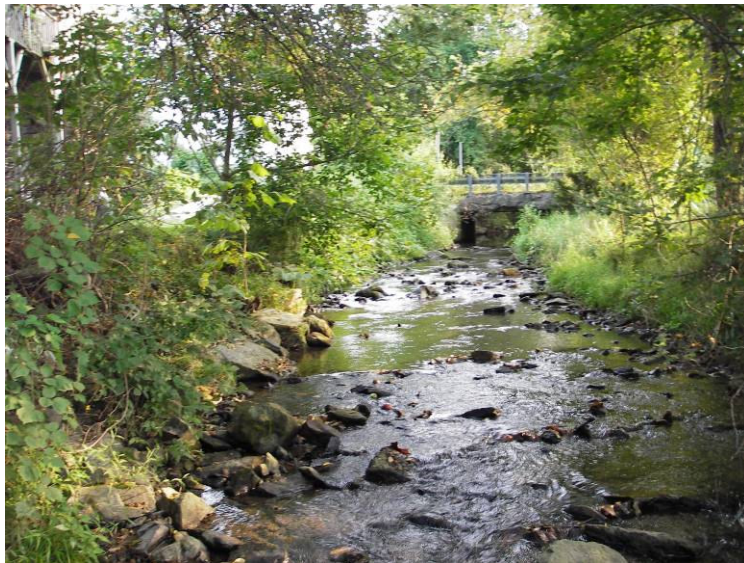
Impacted Stream Segment #17:

This impacted stream section begins at the Birmingham Rd. bridge and extends downstream for approximately 500 feet. Downstream of the bridge is the Strodes Mill structure. Strodes Mill is considered historically significant and its preservation is an asset to the community. This structure has experienced flooding issues in the past. The streambanks in this area are vegetated and approximately 3-4' high. The impacted area includes a straight section of stream that is likely not the historic location of the stream channel. Downstream of the straight reach, some riffle, run, pool and glide habitat types are present, but the stream bottom is sediment laden.

While a large floodplain restoration project that restores the stream to its pre-European settlement location would be ideal, the constraint of an existing PennDOT bridge should not be underestimated. A suitable alternative approach would minimize project costs, but still minimize

flooding risk to the structure and promote biodiversity. An option of installing traditional in-stream deflectors to encourage the channel to move away from the structure during bankfull and lower flows events should be coupled with floodplain restoration on the east side of the stream. The improved floodplain on the east side of the stream would ideally allow flows higher than bankfull to spread out away from the structure. As the east side of the stream is currently in riparian buffer and agriculture, expanding the floodplain in that area may be

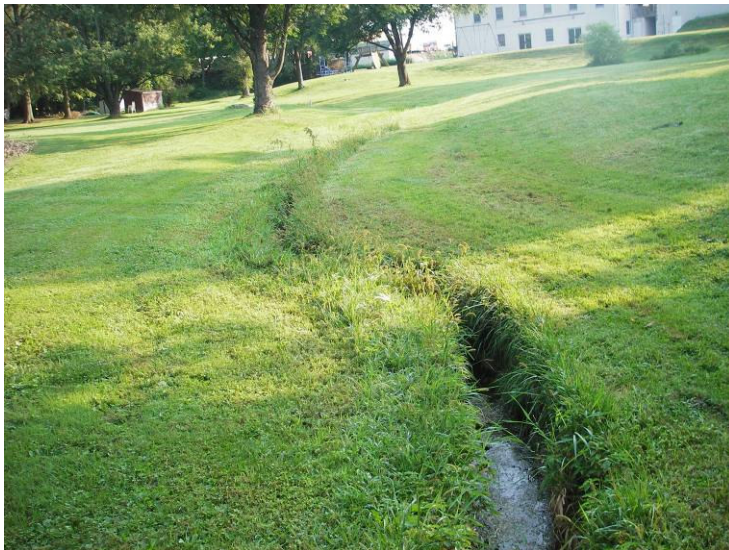
Impacted Stream Segment #97:

A 24" outfall pipe from a stormwater basin behind Swopes Music Building begins the East Branch of Plum Run. Stormwater management from the campus and surrounding areas is lacking due to the lack of stormwater regulation during the urbanization of this area. When present, stormwater management in this area typically focuses on volume control and not water quality. While this stream segment is noted as #97 it includes the urbanized area of the headwaters of the East Branch of Plum Run. A separate unnamed tributary begins at the outfall from the Sikes parking lot and should be included with any stream improvement initiatives in this immediate area.

Urban stormwater management retrofits that consider volume, rate, and water quality should be included with any work that drains into the East Branch of Plum Run (including areas that drain via the stormsewer system). Educational programs in this community should focus on the presence and value of Plum Run and things that the homeowner may do to reduce stormwater volume. Particular attention should be given to providing information on construction of small raingardens and use of rainbarrels and stormwater cisterns. Stormdrain

stenciling, stream signage and a community litter cleanup would be ideal educational activities. An important first step is involving the community in the Plum Run workshop to be held at West Chester University. Immediately downstream of point #97, a church property may be the best location for a community showcase raingarden project. One opportunity would be to plant the raingarden with biblical plants to demonstrate the bridge between faith and environmental stewardship.

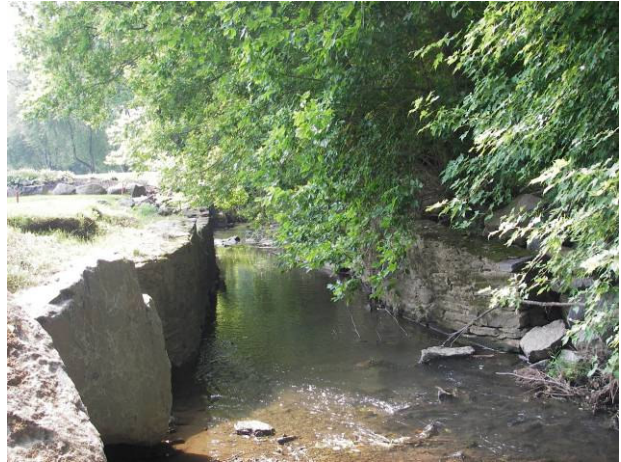
Impacted Stream Segment #4-6:

In this location, remnants of an abandoned bridge are channelizing flow and causing downstream scour. Lawn extends to the top of the streambank on the east side. Invasive bamboo is growing on the west bank.

Remove stream encroachments and restore the natural stream geometry. Invasive species removal with riparian buffer enhancement.

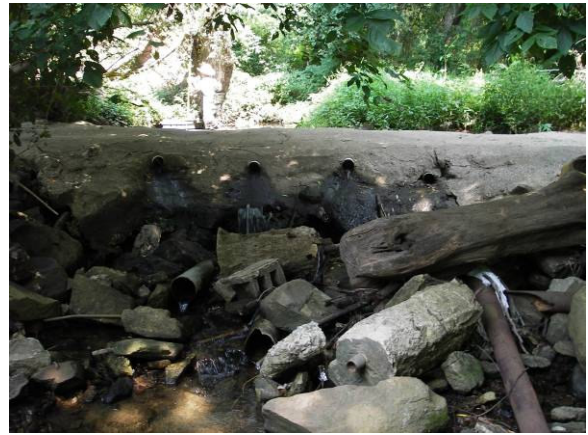
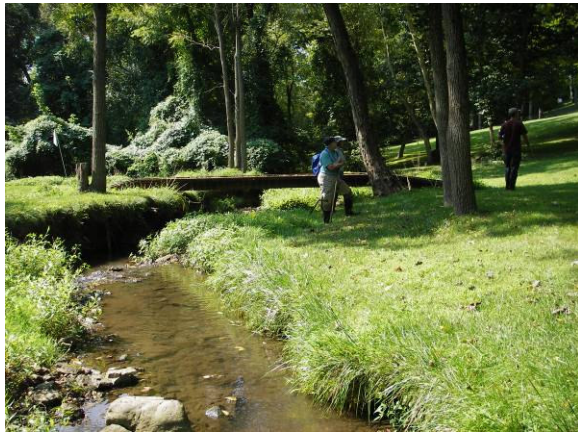
Impacted Stream Segment #32:

A small on-line dam that contains sediment and includes an intake structure for a larger off-line pond is located at this point. The on-line dam is a likely barrier to fish passage. The stream buffer in this area is impacted by some mowing.

A dam removal for the on-line dam with installation of an intake structure that is designed to stay free of debris would be appropriate. Riparian buffer enhancements for this area would include native shrub plantings.

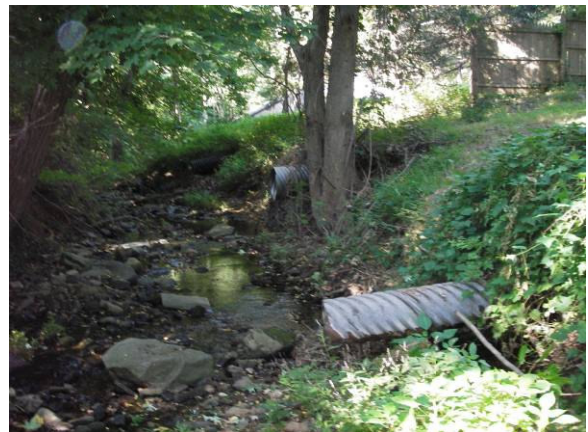
Impacted Stream Segment #46-47:

Heavy stream encroachment exists from this point to the head of the main stem. The streambuffer on the west side of the stream is approximately 10' wide. A garage sits at the top of an eroding streambank in this segment. The restoration options in this heavily impacted area are limited due to the constraints of existing floodway encroachments.

A combination of urban stormwater retrofits and low cost BMPs such as rainbarrels and cisterns may cut down on some of the stormwater volume in this area. Bank stabilization projects in this area should be constructed to use as much natural material as possible to achieve long-term stabilization.

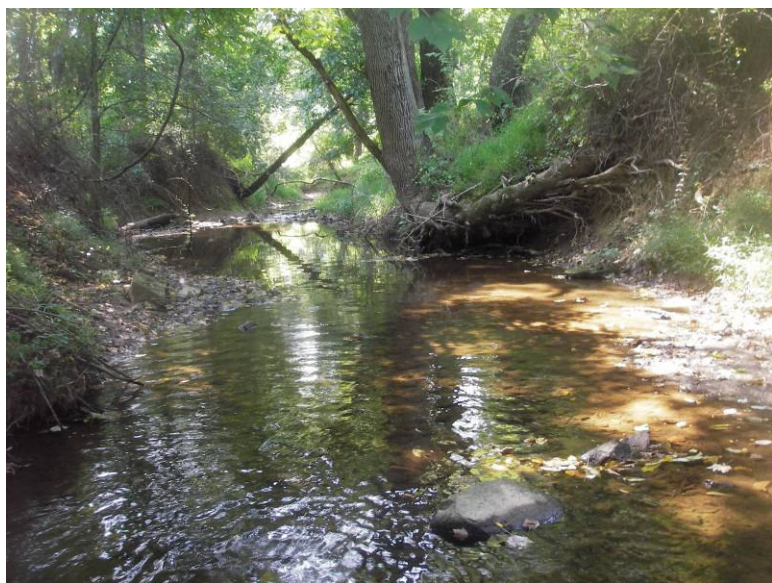
Impacted Stream Segment #19-65:

This area includes legacy sediment from the Strode's Mill Dam. While the streambanks are 4-5' high with approximately 10' of buffer on each side of the stream, they are not as heavily eroded as the streambanks on the mainstem in this area. The stream appears overwidened.

Restoring the natural stream geometry with a floodplain restoration would be very appropriate. Riparian buffer enhancements in this area would include increasing the width of the existing buffer.

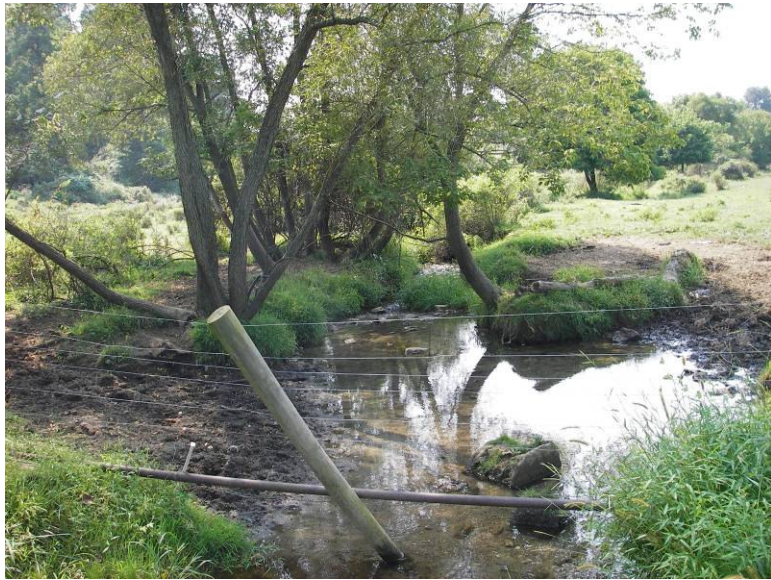
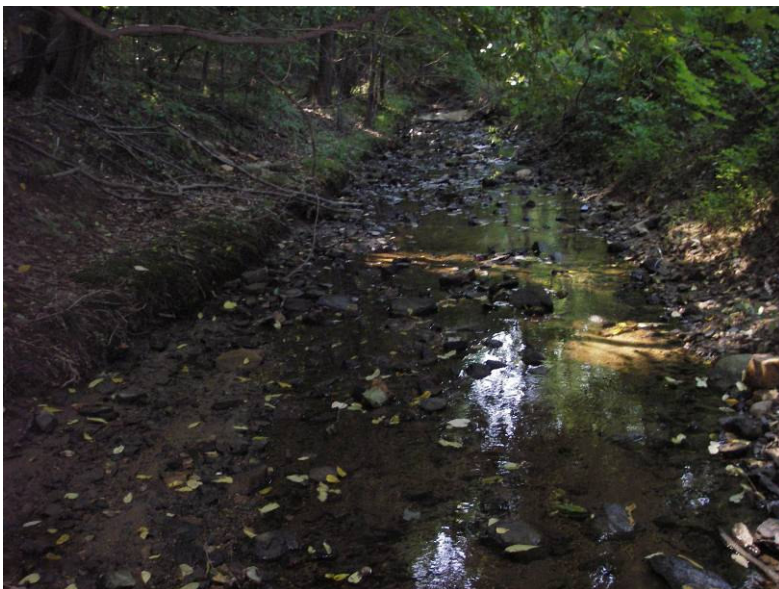
Impacted Stream Segment #65-66:

A cattle pasture exists in this location. The cattle have access to the entire stream corridor and have grazed much of the desirable vegetation. Multiflora rose is growing throughout the pasture.

The first priority for this area is to install streambank fencing with stable stream crossings. This would promote herd health and minimize impacts to the stream. The stream buffer should be planted with native vegetation. One complimenting benefit of the streambank fencing project would be to break the pasture into separate paddocks thus allowing the farmer to rotationally graze livestock. This would allow grazed paddocks to recover before livestock are rotated back into that section.
