**Restoration Plan  
for  
Plum Run Watershed  
Chester County, Pennsylvania  
February 2008**

RETTEW Associates, Inc.  
Natural Sciences Group  
950 East Main Street, Suite 220  
Schuylkill Haven, PA 17972  
(570) 385-2270  
(570) 385-2217 fax  
RETTEW Project No. 07-07568-002

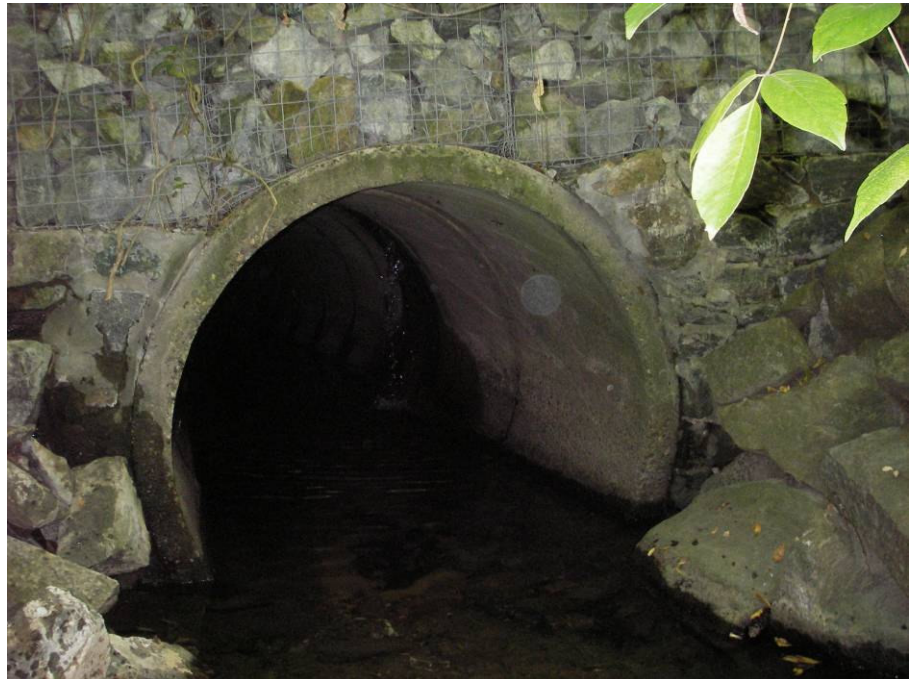
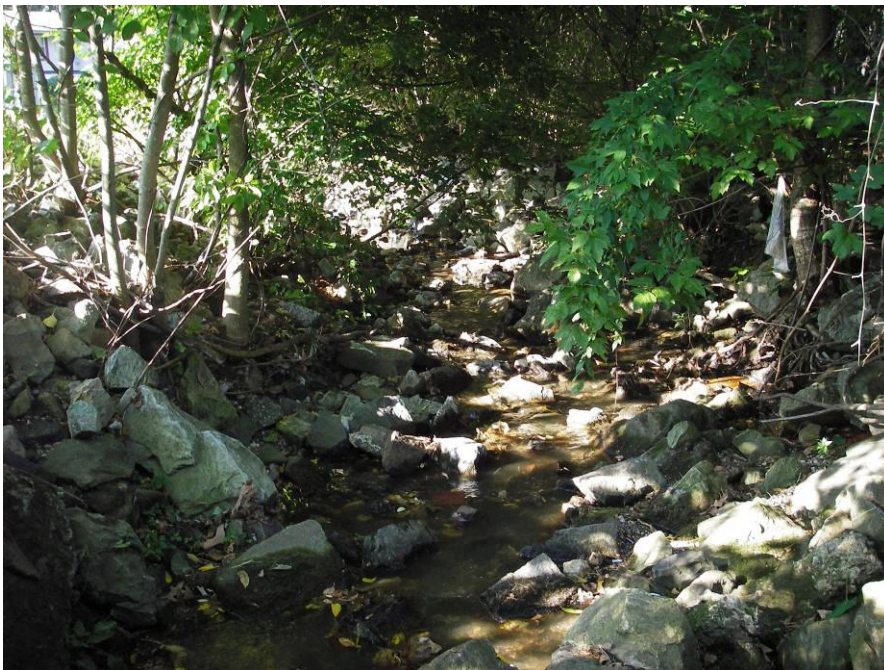
#### **Impacted Stream Segment #53-55:**

The West Branch of Plum Run first sees daylight at this outfall below New Street. The water quality is likely impaired as algae scums coat the bottom of the stream. The stream lacks an adequate buffer and has gabion baskets lining the north bank. While the stream is shaded, it is aesthetically impaired by litter that has collected in the channel.

Urban stormwater management retrofits that consider volume, rate, and possibly most importantly water quality should be included with any work that drains into Plum Run (including areas that drain via the storm sewer system). Educational programs in this community should focus on the presence and value of Plum Run. Important first steps are stormdrain stenciling, stream signage and a community litter cleanup.

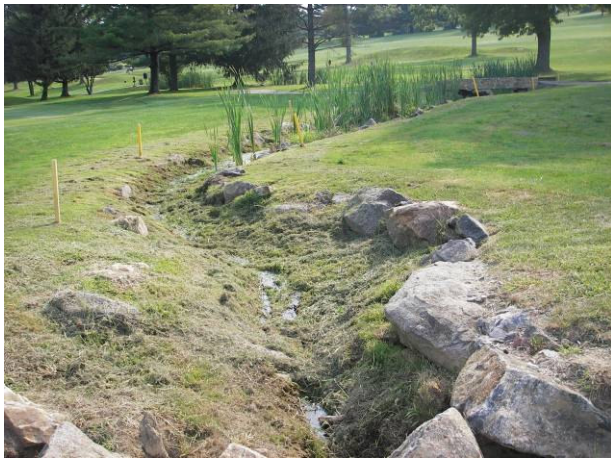
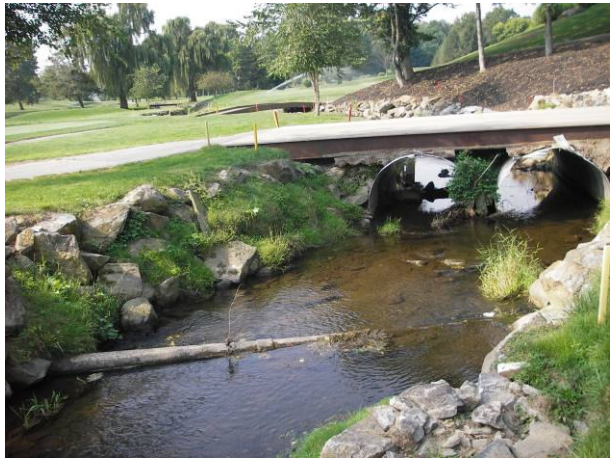
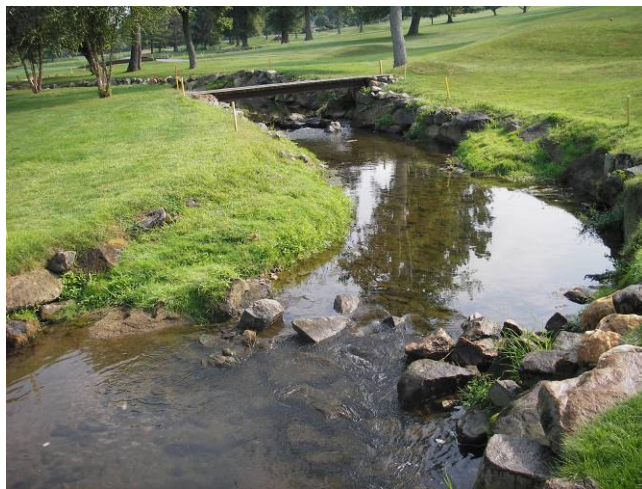
### **Impacted Stream Segment #8-11:**

This section of stream includes a well manicured area with a rip-rap lined streambank. The channel is entrenched, fish habitat is lacking, the bottom is heavily sedimented, no riparian buffer exists to mitigate the effects of any lawn care products that may be applied upslope, and a diversity of riffles and runs is lacking. The streambanks are approx. 5' high, but are stabilized with rip-rap. An exposed pipe in the area of a gas-line crossing should be investigated by the appropriate utility representatives.

The effective restoration of this stream segment will largely depend on the willingness of the landowner in altering the riparian area of the property. Reshaping the stream channel to a natural stream geometry would be ideal. This area would also benefit from a fish habitat enhancement project. Placing structures in the stream would aid in transporting sediment through this area and may enhance the aesthetics as the water gently splashes over and through the various structures. The bottom photo (above) shows an example of functioning in-stream structure that is improving habitat in that immediate area. Of great importance is the installation of bioretention areas that will function as small wetlands to mitigate pollutants that are added to the lawn areas adjacent to the stream. Installation of the bioretention areas at the historic floodplain elevation would be ideal.

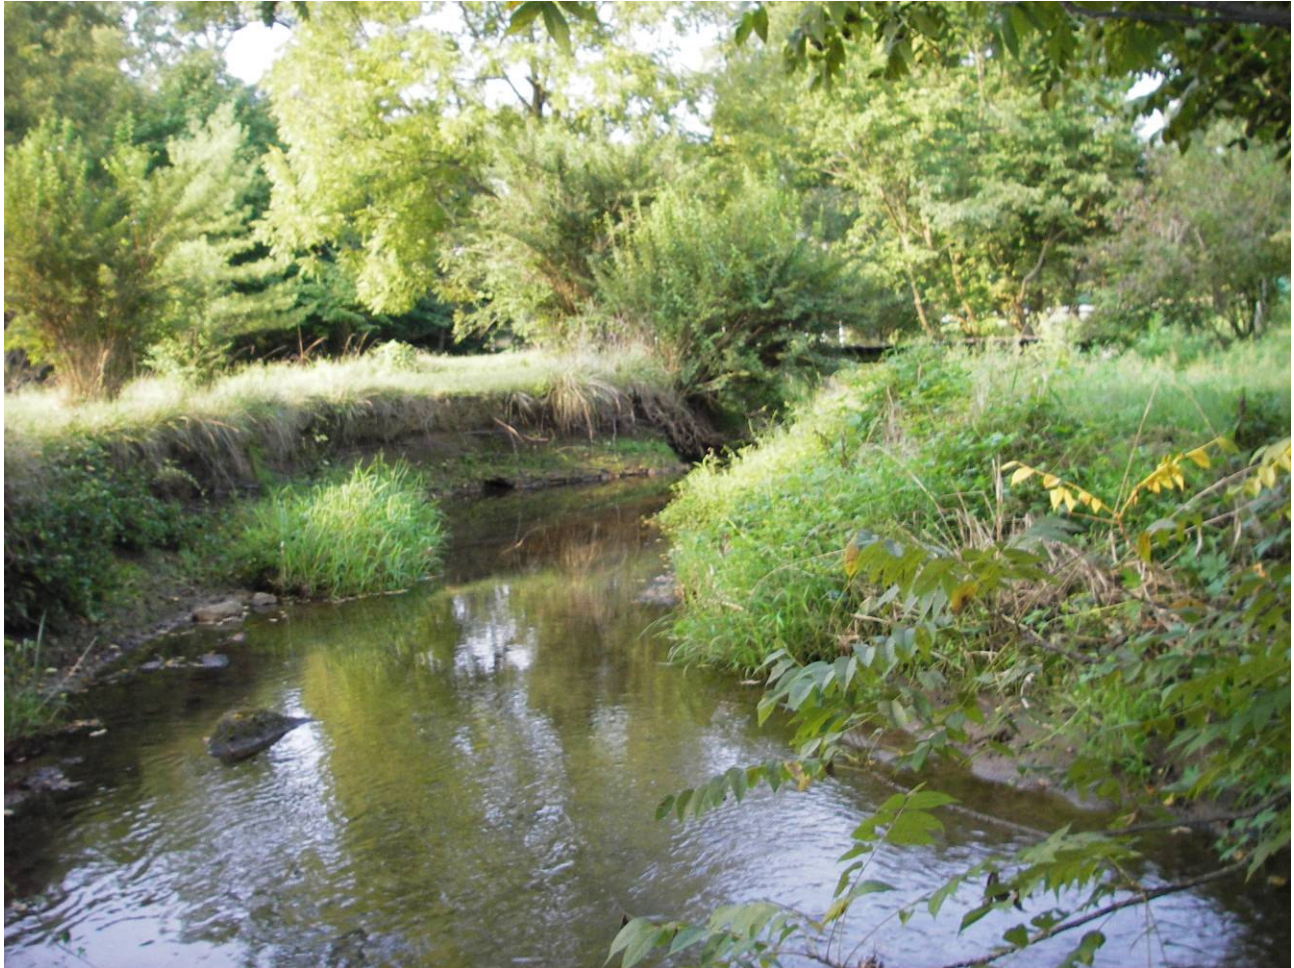
### **Impacted Stream Segment #14-15:**

The streambanks in this area are approx. 4' high and are eroding. The west bank of Plum Run is mowed right up to the edge of the channel. The east bank is periodically mowed and contains various woodland species including invasive species such as mile-a-minute and Japanese hops. A small tributary, with mowed banks, enters from the west. This tributary is entrenched 3-4'.

Streambank stabilization that restores a natural stream channel geometry is necessary. Floodplain restoration should also be considered. During the implementation phase of this site, invasive species should be removed and the riparian buffer should be planted with native species to promote biodiversity. Riparian buffer enhancement and stream channel geometry restoration should be considered for the section of the small tributary immediately upstream of its confluence with Plum Run as a portion of this project. The lack of wetlands at the top of the bank, potential for definite water quality benefits, and potentially easy access to this site make it a good candidate for restoration.

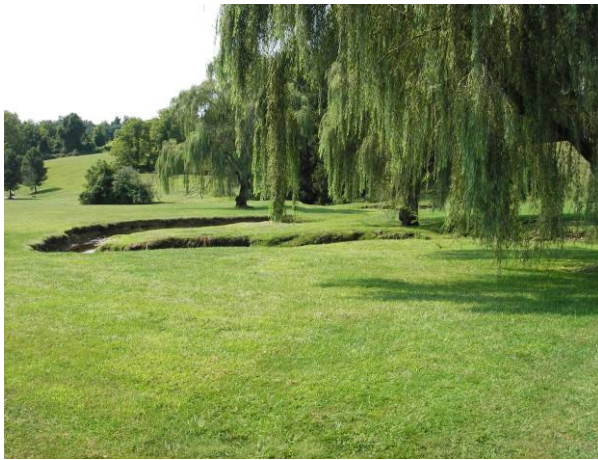
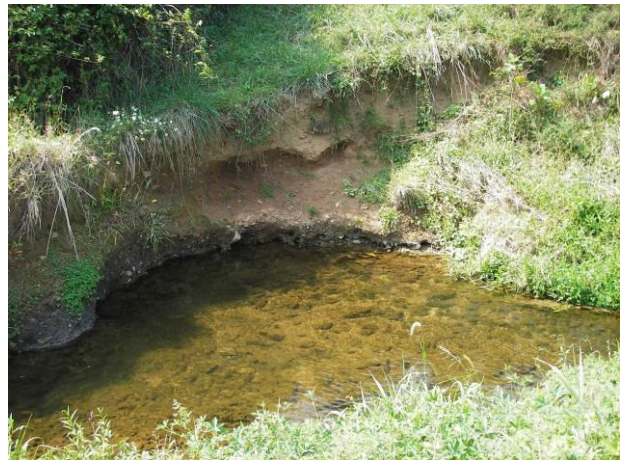
### **Impacted Stream Segment #19-26:**

Remnant of a breached dam breast for the Strode's Mill Dam and confluence with the East Branch of Plum Run. Mowed lawn in a large section of the reach is magnifying the erosion issue. This stream reach has severe legacy sediment impacts that include actively eroding streambanks of the incised channel. The stream segment identified as high priority includes the section with the most severe active erosion. Additional legacy sediment impacts from the mill exist in the area that was likely slackwater upstream of this section as well as on the East Branch. Small tributaries and seeps enter the stream in this section. The three bridges within this section cross overwidened channels and appear to have maintenance issues as sediment is depositing downstream of the structures.

Restore the natural stream geometry and restore the floodplain by removing legacy sediment. Temporary stabilization of the streambank should only occur with stream channel geometry restoration as the channel is likely to continue lateral erosion unless the stream's hydrology is considered in the restoration effort. After restoration of the channel, a riparian buffer enhancement project would be appropriate to increase the likelihood of a positive outcome for the project and work to naturally reinforce the streambanks. While this project covers a large area and is potentially the most expensive in the restoration plan, it will also likely have the greatest positive effect as sediment from this area likely impacts the stream all the way to the confluence with the Brandywine. Also important are the minimal number of wetlands that are located on the streambanks which should aid in permitting of the project and not obstruct access to the site. The lack of forest in a large section of this reach should be looked at as an opportunity to begin the project without having to clear and grub or be as concerned with removing invasive rootstock.

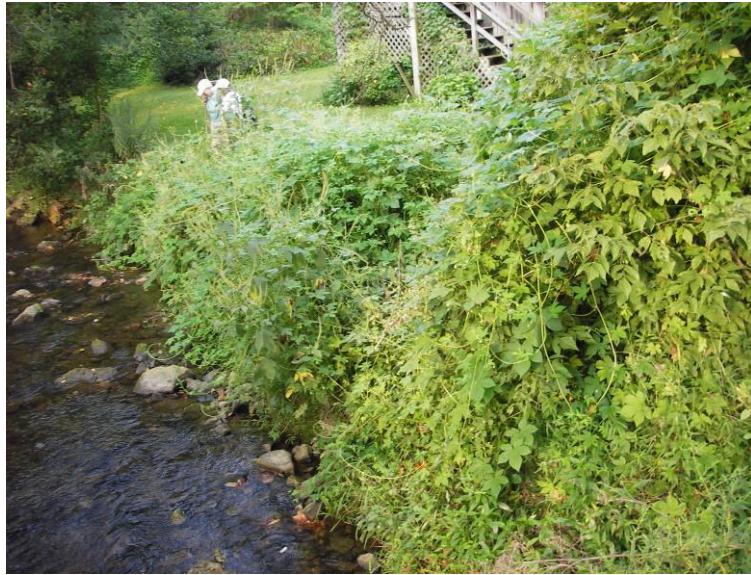
### **Impacted Stream Segment #17:**

This impacted stream section begins at the Birmingham Rd. bridge and extends downstream for approximately 500 feet. Downstream of the bridge is the Strodes Mill structure. Strodes Mill is considered historically significant and its preservation is an asset to the community. This structure has experienced flooding issues in the past. The streambanks in this area are vegetated and approximately 3-4' high. The impacted area includes a straight section of stream that is likely not the historic location of the stream channel. Downstream of the straight reach, some riffle, run, pool and glide habitat types are present, but the stream bottom is sediment laden.

While a large floodplain restoration project that restores the stream to its pre-European settlement location would be ideal, the constraint of an existing PennDOT bridge should not be underestimated. A suitable alternative approach would minimize project costs, but still minimize

flooding risk to the structure and promote biodiversity. An option of installing traditional in-stream deflectors to encourage the channel to move away from the structure during bankfull and lower flows events should be coupled with floodplain restoration on the east side of the stream. The improved floodplain on the east side of the stream would ideally allow flows higher than bankfull to spread out away from the structure. As the east side of the stream is currently in riparian buffer and agriculture, expanding the floodplain in that area may be

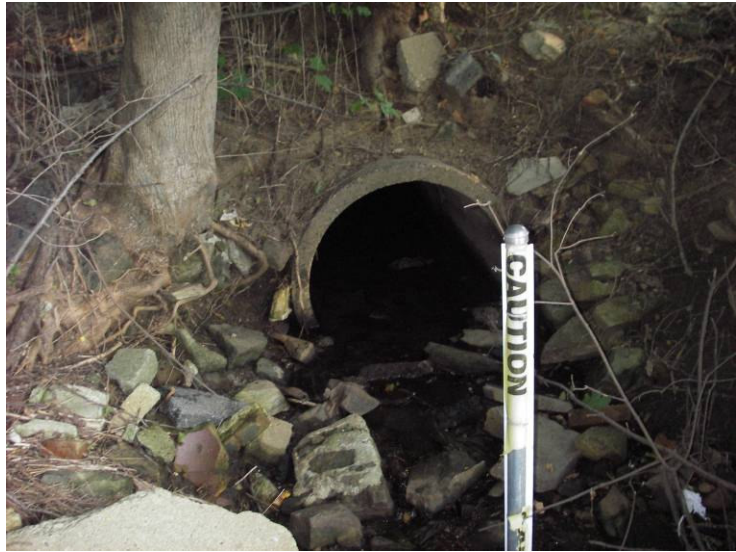
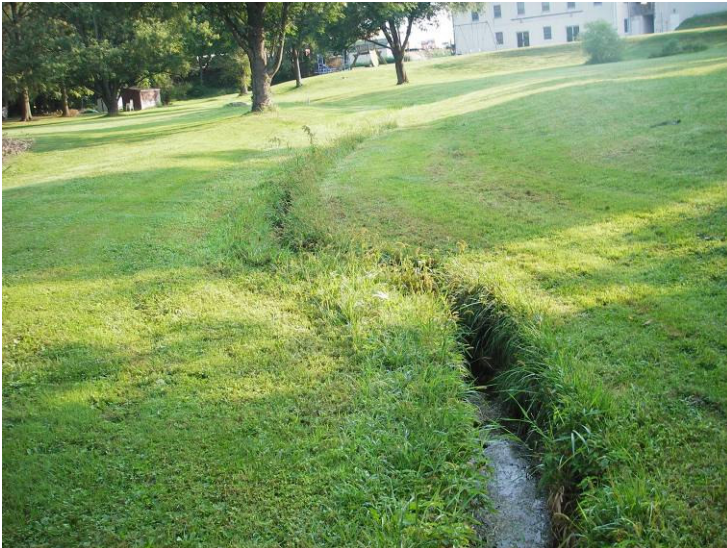
### **Impacted Stream Segment #97:**

A 24" outfall pipe from a stormwater basin behind Swopes Music Building begins the East Branch of Plum Run. Stormwater management from the campus and surrounding areas is lacking due to the lack of stormwater regulation during the urbanization of this area. When present, stormwater management in this area typically focuses on volume control and not water quality. While this stream segment is noted as #97 it includes the urbanized area of the headwaters of the East Branch of Plum Run. A separate unnamed tributary begins at the outfall from the Sikes parking lot and should be included with any stream improvement initiatives in this immediate area.

Urban stormwater management retrofits that consider volume, rate, and water quality should be included with any work that drains into the East Branch of Plum Run (including areas that drain via the stormsewer system). Educational programs in this community should focus on the presence and value of Plum Run and things that the homeowner may do to reduce stormwater volume. Particular attention should be given to providing information on construction of small raingardens and use of rainbarrels and stormwater cisterns. Stormdrain

stenciling, stream signage and a community litter cleanup would be ideal educational activities. An important first step is involving the community in the Plum Run workshop to be held at West Chester University. Immediately downstream of point #97, a church property may be the best location for a community showcase raingarden project. One opportunity would be to plant the raingarden with biblical plants to demonstrate the bridge between faith and environmental stewardship.

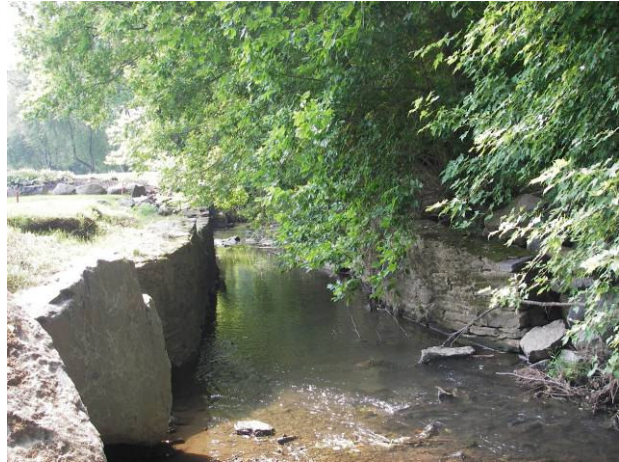
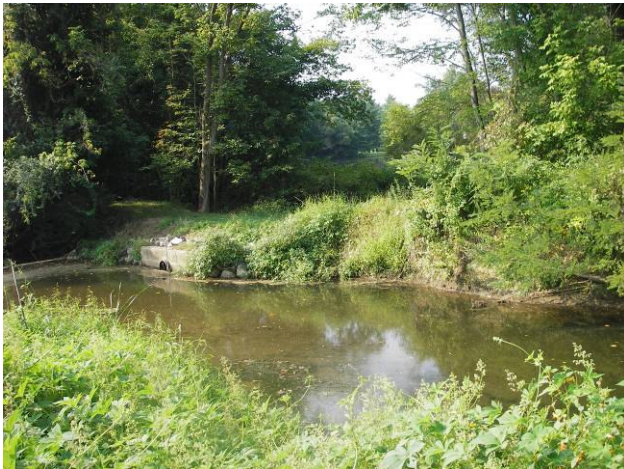
#### **Impacted Stream Segment #4-6:**

In this location, remnants of an abandoned bridge are channelizing flow and causing downstream scour. Lawn extends to the top of the streambank on the east side. Invasive bamboo is growing on the west bank.

Remove stream encroachments and restore the natural stream geometry. Invasive species removal with riparian buffer enhancement.

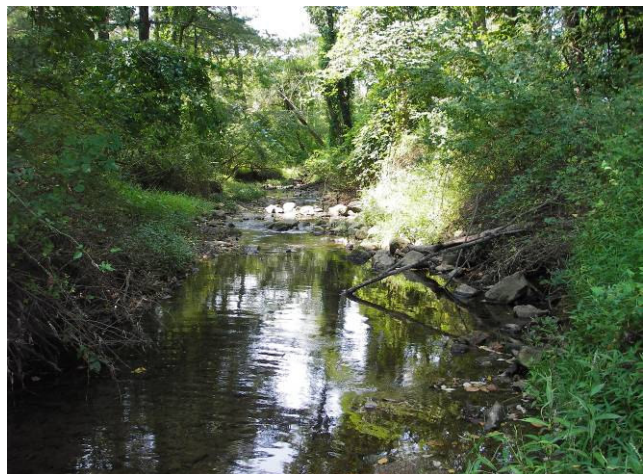
#### **Impacted Stream Segment #26-28:**

This stream section has stable banks, but is entrenched with an approx. 7' high east bank. In the lower 350 ft. of this section, the stream is entrenched 3-4 feet but has stable banks.

The entrenched geometry of this section would benefit from a floodplain restoration project. As the banks appear more stable than several other sections of the stream, this segment should be completed only after the more unstable reaches are restored.

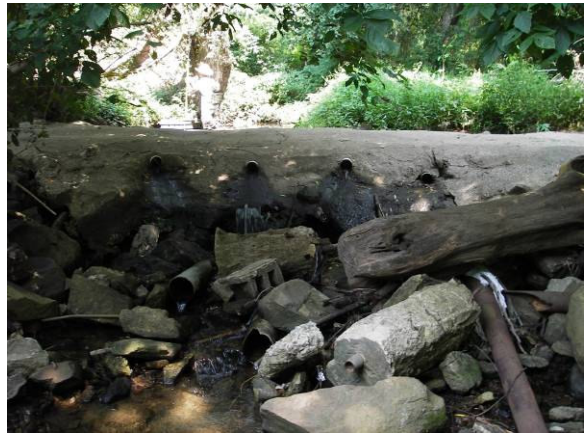
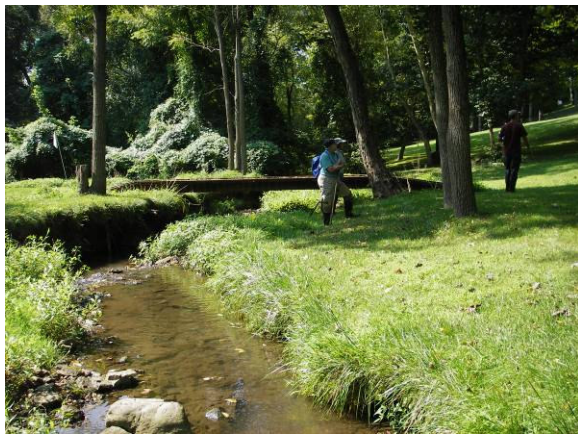
**Impacted Stream Segment #32:**

A small on-line dam that contains sediment and includes an intake structure for a larger off-line pond is located at this point. The on-line dam is a likely barrier to fish passage. The stream buffer in this area is impacted by some mowing.

A dam removal for the on-line dam with installation of an intake structure that is designed to stay free of debris would be appropriate. Riparian buffer enhancements for this area would include native shrub plantings.

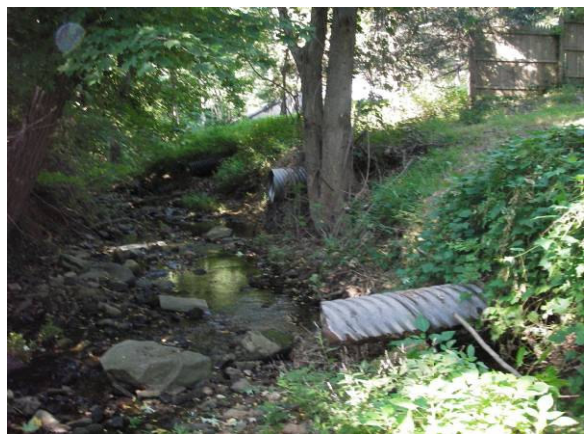
**Impacted Stream Segment #46-47:**

Heavy stream encroachment exists from this point to the head of the main stem. The streambuffer on the west side of the stream is approximately 10' wide. A garage sits at the top of an eroding streambank in this segment. The restoration options in this heavily impacted area are limited due to the constraints of existing floodway encroachments.

A combination of urban stormwater retrofits and low cost BMPs such as rainbarrels and cisterns may cut down on some of the stormwater volume in this area. Bank stabilization projects in this area should be constructed to use as much natural material as possible to achieve long-term stabilization.

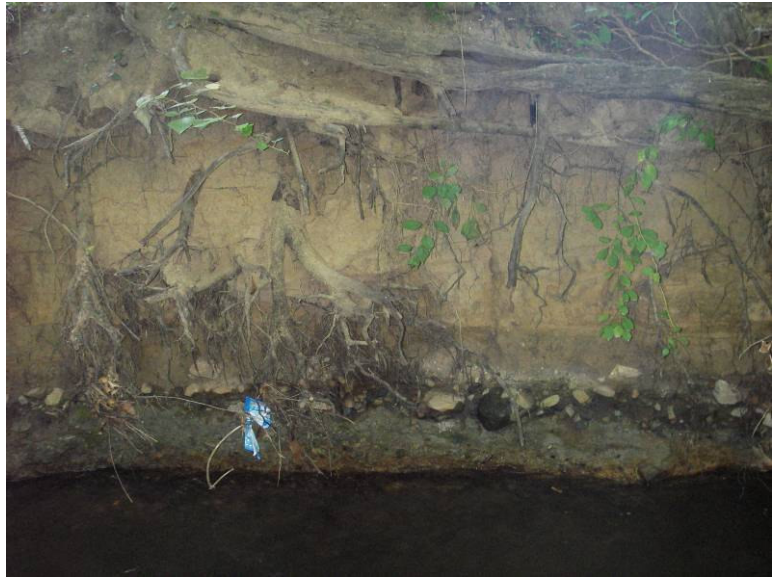
### **Impacted Stream Segment #50-51:**

While not observed on this occasion, reports of soapsuds discharging to the stream in this area exist. The stream has eroded banks and is entrenched approximately 5'. A combination of pedestrian bridges and floodway encroachments limit the amount of channel reshaping that could occur in this area. The picture to the right demonstrates the volume of sediment that exists in this area that disconnects the stream from its historic floodplain.

Monitor for wastewater discharges to stream. If additional discharges are observed, coordinate with borough representatives to ensure discharges are connected to the appropriate sewer lines. Where possible, bank stabilization should be considered to minimize erosion.

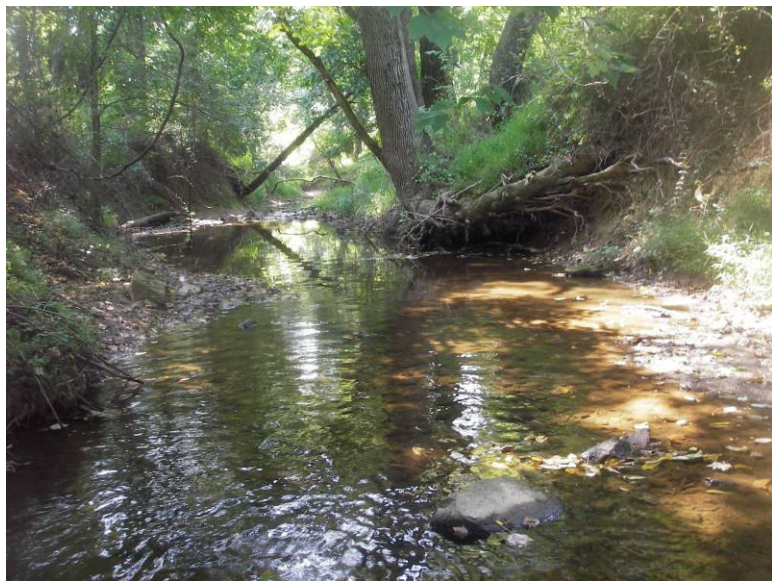
### **Impacted Stream Segment #19-65:**

This area includes legacy sediment from the Strode's Mill Dam. While the streambanks are 4-5' high with approximately 10' of buffer on each side of the stream, they are not as heavily eroded as the streambanks on the mainstem in this area. The stream appears overwidened.

Restoring the natural stream geometry with a floodplain restoration would be very appropriate. Riparian buffer enhancements in this area would include increasing the width of the existing buffer.

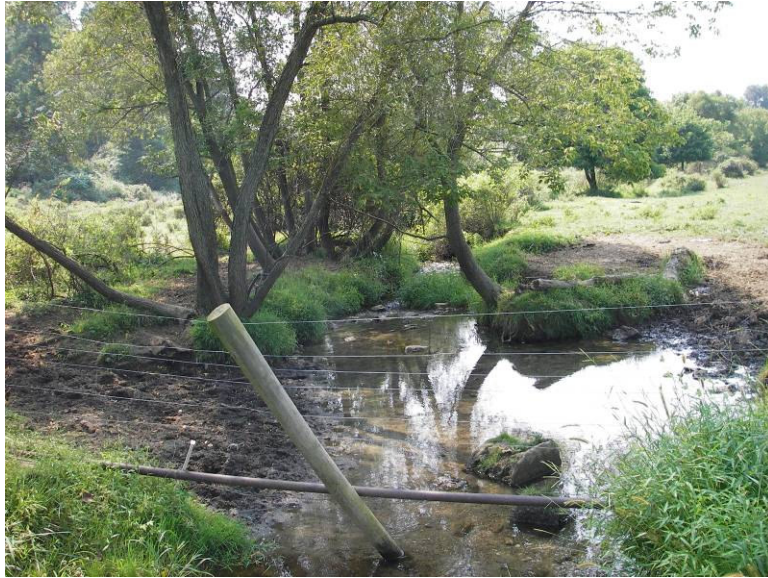
### **Impacted Stream Segment #65-66:**

A cattle pasture exists in this location. The cattle have access to the entire stream corridor and have grazed much of the desirable vegetation. Multiflora rose is growing throughout the pasture.

The first priority for this area is to install streambank fencing with stable stream crossings. This would promote herd health and minimize impacts to the stream. The stream buffer should be planted with native vegetation. One complimenting

benefit of the streambank fencing project would be to break the pasture into separate paddocks thus allowing the farmer to rotationally graze livestock. This would allow grazed paddocks to recover before livestock are rotated back into that section.
