**Restoration Plan for
Shamona Creek and East Branch Brandywine Creek
Chester County, Pennsylvania
May 2010**

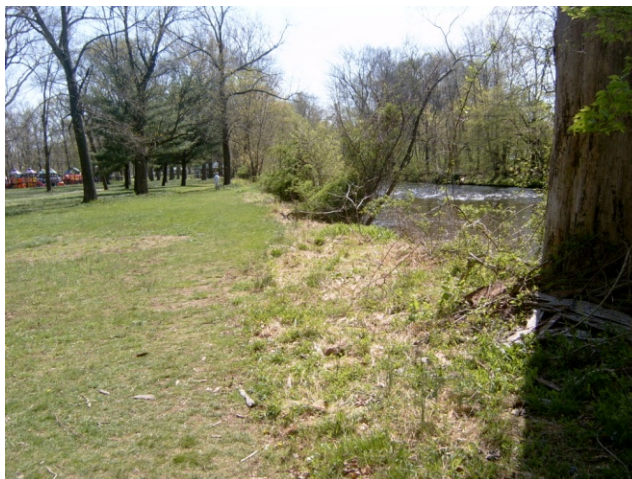
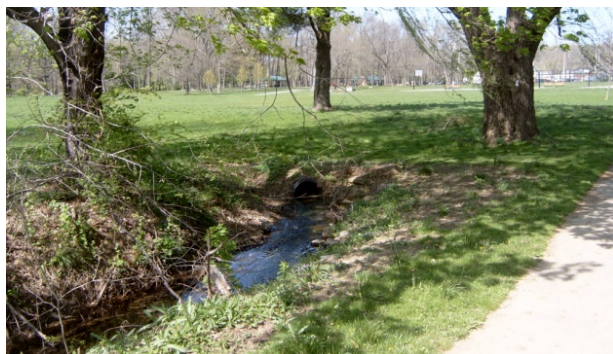
Impacted Stream Segment #22-27:

Kerr Park is a center for outdoor recreation within the Downingtown community. Several fish habitat enhancement structures have been installed within the park and are functioning well to provide habitat for both fish and macroinvertebrates within the stream. Within the park boundaries, a large section of the eastern streambank of the East Branch Brandywine Creek is mowed to within five feet of the stream. Within this area, trees to shade the stream are lacking and little buffer exists for waters leaving the mowed lawn areas.

One of the greatest assets within the park is a cooperative trout nursery. Waters flowing through the nursery discharge through a pipe that flows under a mowed lawn area and then discharges directly to the East Branch Brandywine Creek. The nursery contains a concentration of fish that are fed and managed intensively. Recently, such nurseries have been identified as potential sources of nutrient inputs to the stream system.

Several opportunities to enhance water quality and the riparian zone exist within the area that would build on the important in-stream habitat work that has already been completed. In order to provide additional shading and aid in maintaining cool water within the stream and corresponding high dissolved oxygen conditions that benefit aquatic life, a forested riparian buffer could be implemented. The buffer area should extend along the East Branch as well as an unnamed tributary that flows through the park. To enhance the trout nursery area, a portion of the mowed lawn area above the discharge could be converted into a wetland treatment cell that would aid in uptake of nutrient discharges from the outfall.

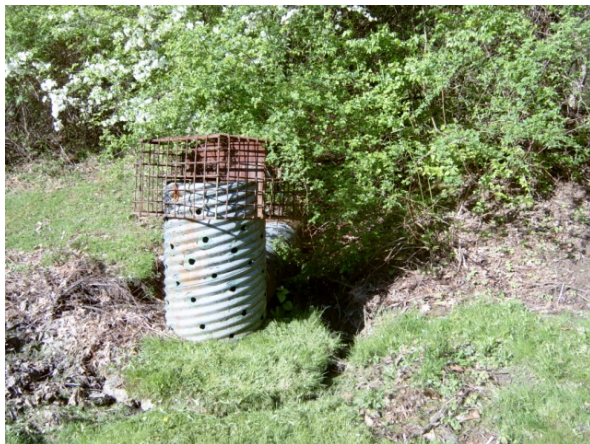
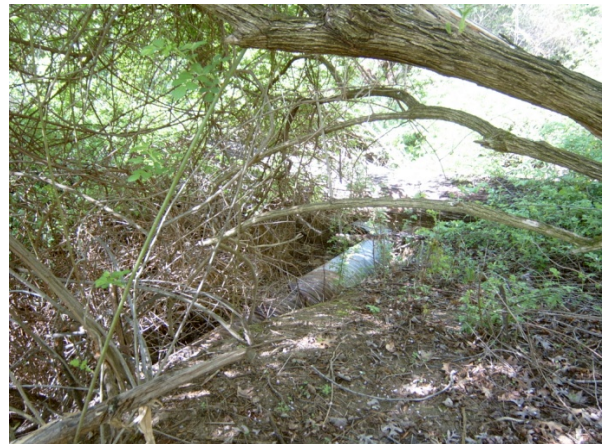
Impacted Stream Segment #31, 35:

Within the headwaters of Ludwig's Run, the majority of development was completed during the time when stormwater control focused on rate controls rather than volume controls. Under modern regulations, volume control has become a priority to minimize the impacts of development on stream channel conditions. At the location of each sample point, existing volume control stormwater best management practices (retention ponds) have been installed, but lack maintenance of the outlet structures. Evidence of erosion around the outfall structures indicates that the actual rate of release from the basin may differ from the design.

The existing stormwater basins at each of the sample points, as well as within this portion of the watershed, should be inspected by a qualified engineer to determine if the structure is currently functioning as designed. For those basins that have evidence of piping and erosion around the outfall structure pipe, antiseep collars should be considered for inclusion as part of the scope of any repairs. Opportunities for stormwater volume control should also be evaluated within this portion of the watershed. Best Management Practices such as stormwater basin retrofits, raingarden construction, and infiltration of rooftop drainage would likely benefit the hydrology and aquatic community of Ludwig's Run.

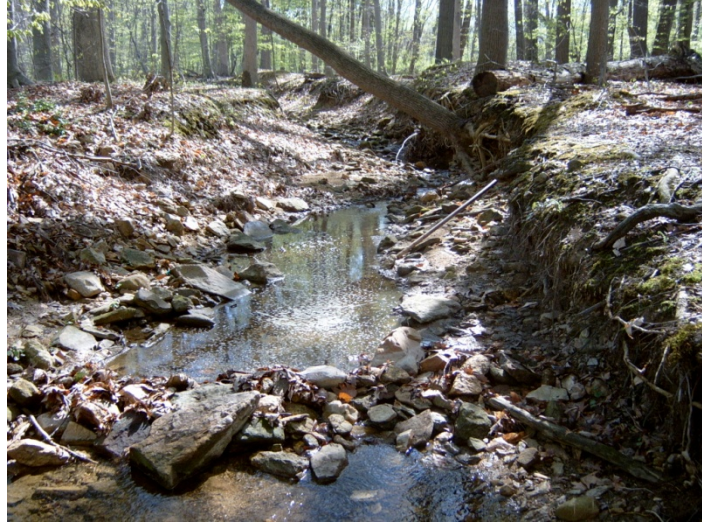
Impacted Stream Segment #37-38:

Within this forested stream segment, the stream has become severely eroded and entrenched. The streambanks are up to 10 feet high and are raw and actively eroding in a majority of this segment. The erosion appears to be closely linked to the impacts of stormwater discharges within the watershed.

While improved stormwater management within the areas tributary to this stream segment would be the best long-term solution, a more symptomatic response is likely more realistic within this stream segment. Conservation of this area should include stabilization of the streambanks and installation of in-stream grade control structures. Since this area is heavily shaded by the surrounding forest, streambank stabilization would likely include riprap and pulling back of the streambanks to a more stable slope.

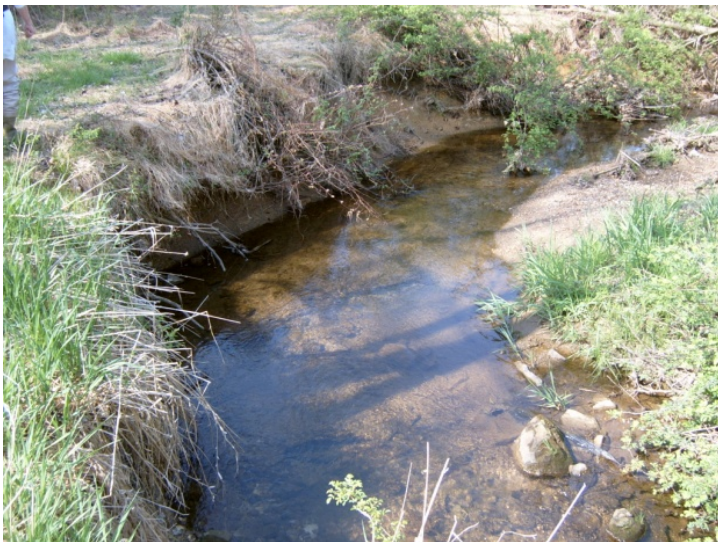
Impacted Stream Segment #73-74:

This portion of the headwaters of Shamona Creek includes streambanks that are actively raw and eroding that are about 3-4 feet high. The vegetation in this area includes a mix of meadow areas and early successional stage forest. A stormwater discharge channel that flows into the upstream portion of this stream segment from the highway to the east of the stream is actively eroding.

Restoration of this area should include floodplain restoration with stabilization of the streambanks and the channel that discharges stormwater to this area. The existing vegetation and amount of available sunlight in this area should allow for primarily vegetative stabilization of the streambanks. Best Management Practices (BMPs) such as installation of live stakes, willow whips, and brush mattresses should be considered.

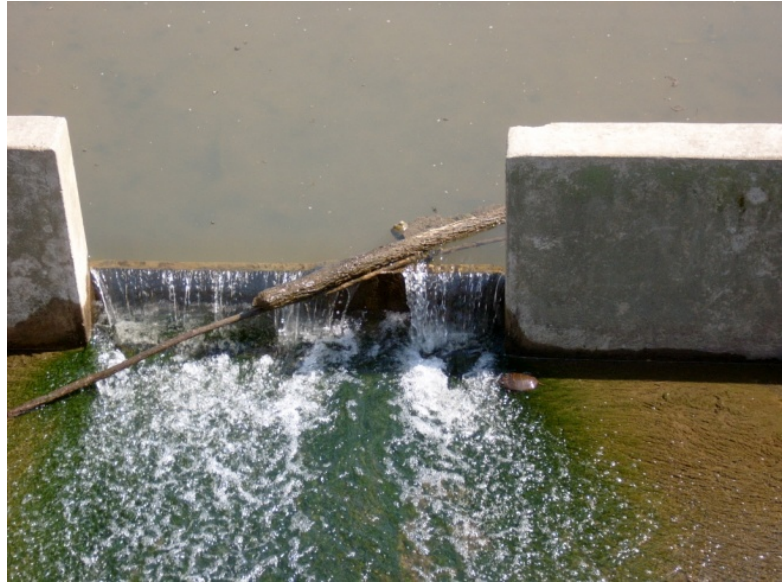
Impacted Stream Segment #76:

This on-line dam is a haven for populations of geese. While the geese are often aesthetically pleasing, they can provide excessive nutrient loading to aquatic ecosystems. When combined with nutrient inputs from over-fertilization of lawns and other sources, algal blooms may occur. With the eventual crash of the algal populations and resulting decomposition, dissolved oxygen levels within the stream may be depressed.

This on-line dam also includes a weir-type structure that allows for the water elevation within the dam to be manipulated. With boards installed, the weir-structure provides a barrier to fish and reptile migration within the watershed.

Conservation practices that should be considered for this area include planting a vegetative buffer around the dam. By planting taller vegetation or leaving an un-mowed buffer strip around the pond, overpopulation of the area by geese would be discouraged. In order to promote fish and reptile migration to the upper reaches of the watershed, the weir should either be retrofitted as a passage structure or, more easily, all boards should be removed from the structure during times when migrations of fish and reptiles are most prevalent.

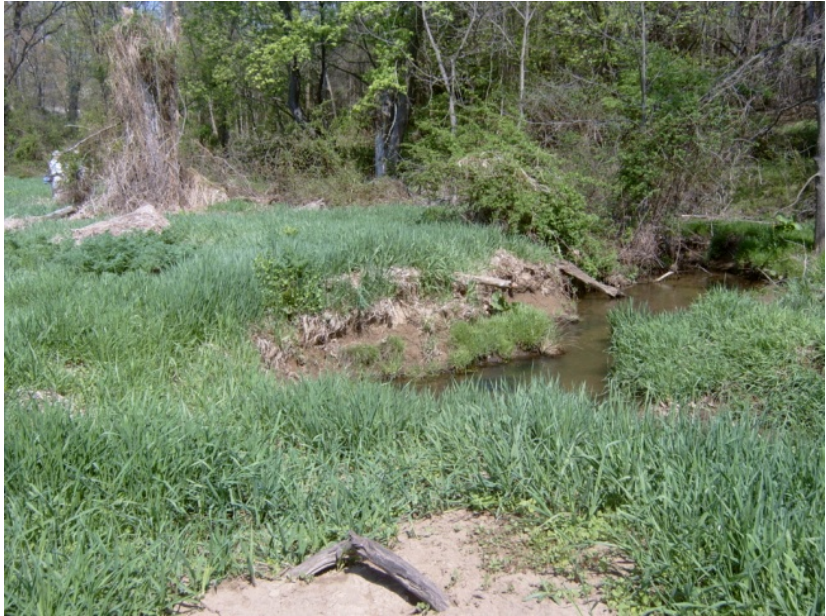
Impacted Stream Segment #79-84 and 80-84:

This stream segment includes severely eroded streambanks that are approximately 1-4 feet high along both the mainstem of Shamona Creek and an unnamed tributary that drains into Shamona Creek within this stream segment. The sediment that has been deposited within the floodplain was likely deposited during flooding events in which the Wharton Dam located at the downstream end of this segment was functioning to back up water and allow the sediment to settle out. The function of this flood control dam to properly regulate flows to Shamona Creek is an essential component to maintaining the downstream flow conditions.

Conservation work in this area should include an investigation of the function of the Wharton Dam by a qualified engineer to determine if it is functioning as designed and if that design is optimum under current watershed conditions. If any alterations are required to improve the function of the dam, the dam should be retrofitted. In order to minimize sedimentation and corresponding nutrient inputs to the downstream areas, the areas where sediment has been deposited should be maintained to restore the original floodplain elevations within those areas. After restoring the original floodplain elevations, the streambanks should be stabilized and riparian buffers should be restored to shade the stream. The engineering evaluation of this structure is ongoing under a 2010 Growing award to Township.

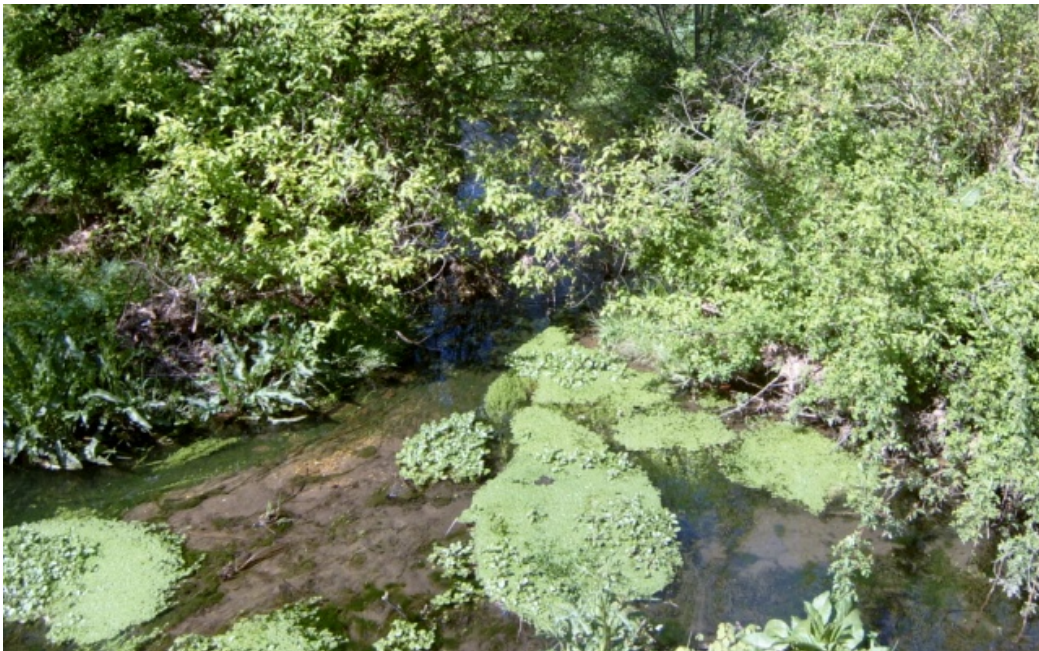
Impacted Stream Segment #106:

During the streamwalk on April 29, 2010, extensive algal blooms were present upstream of this point within the Park Run tributary to the East Branch Brandywine Creek. The algal blooms were comprised of cyanobacteria (blue-green algae) that had formed extensive long strand shaped colonies that entirely covered the stream bottom in some areas.

Algal blooms typically correspond to high levels of nutrient inputs to the stream coupled with high levels of sunlight reaching the stream bottom. In the case of the observed bloom, leaf-out of trees within the riparian corridor over the following weeks would likely shade the stream and cause a population crash for the algal colonies. With a population crash of this nature, bacteria populations typically increase and utilize the available dissolved oxygen during the decay of the algae and can deplete the dissolved oxygen levels below the threshold of tolerance for other aquatic organisms.

Restoration of this area should focus on nutrient reductions within the headwater areas of Park Run. The commercial, educational, residential, and recreational areas are all potential sources of nutrient enrichment through the use of lawn care products. A workshop should be considered for the late winter that is titled “Environmentally Sensitive Maintenance of Lawn Areas”. The target audience should be local landscapers and groundskeepers (including those from the local golf course and school). Part of the discussion at the workshop should include naturalization of stormwater basins. Another opportunity would be to partner with local lawncare supply stores to prepare a handout on the importance of not overapplying lawn fertilizers within the watershed. Additionally, establishing a riparian buffer where it is lacking or minimal including the area of the upstream golf course would likely aid in reducing nutrient flows to the stream.

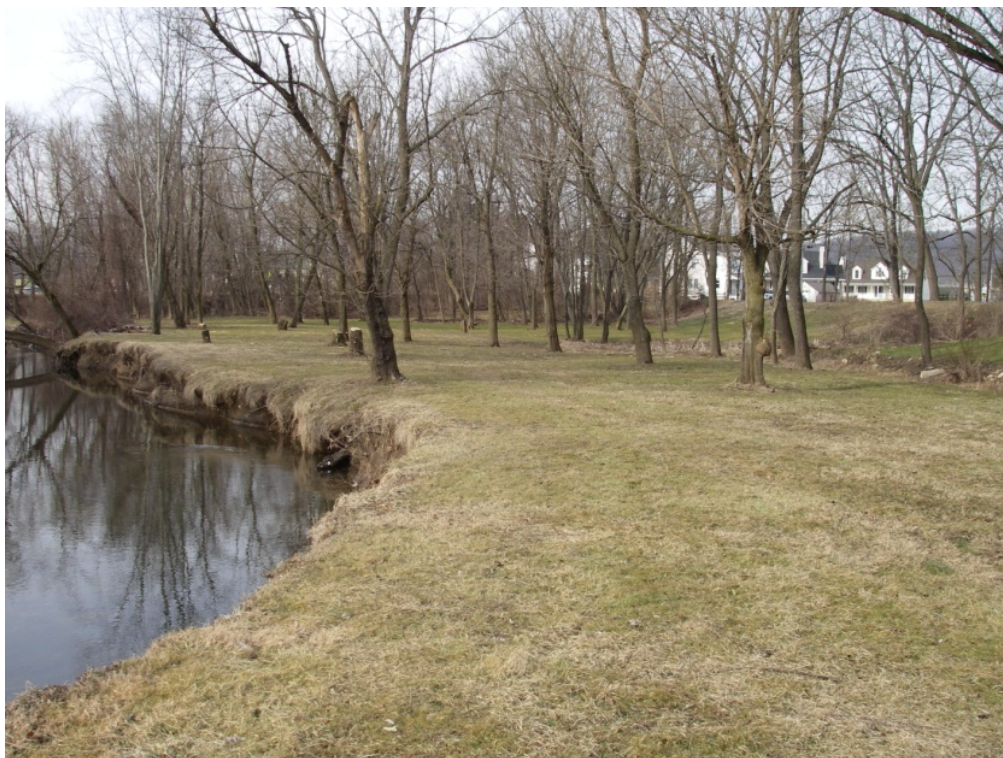
Impacted Stream Segment #116:

Beaver Creek discharges to the East Branch Brandywine Creek near the downstream end of the study area. During the assessment stage of this project, sample point 4 was located on Beaver Creek. Sample point 4 was impaired for both biology and habitat. The location of sample point 4 includes a breached dam breast where the streambanks are eroded several feet high. The sediment appears to be legacy sediment that was deposited in the backwater of the dam.

Restoration of this area should include legacy sediment removal to restore the floodplain of Beaver Creek. The restoration plan should include installation of a forested riparian buffer in the area that is currently mowed and stabilization of the streambanks.

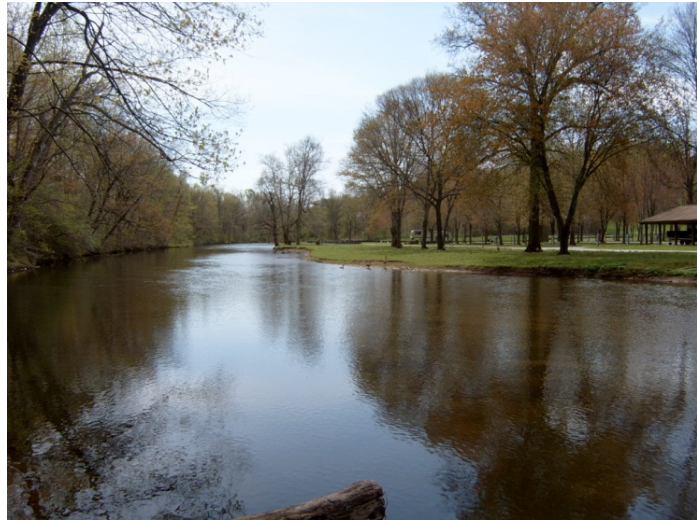
Impacted Stream Segment #11-14:

In this stream section, the western streambank has been cleared and mowed to the top of bank in the area of a campground. This area is within the backwater conditions created by the downstream dam and does not exhibit extensive streambank erosion although several smaller areas have approximately 2 foot high eroded streambanks. Geese are common in this area of relatively flat water and mowed lawn to the stream edge.

Restoration of this stream segment should primarily focus on installation of a riparian forested buffer and stabilization of the small areas of erosion. By installing a riparian buffer comprised primarily of shrubs and trees with periodic access points to the stream, the stream will be better shaded and overpopulation of geese will be discouraged.

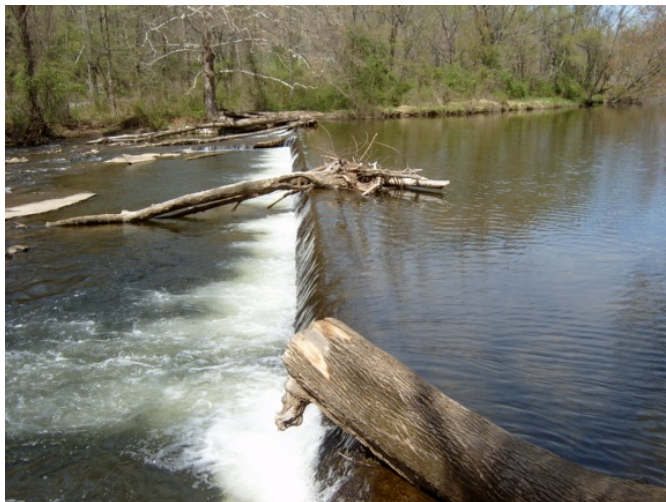
Impacted Stream Segment #16:

The approximately 4-foot high on-line dam in this area functions to deliver water through a diversion to the ponds in Kardon Park. The ponds are an important feature in the community and require water from the East Branch Brandywine Creek. The on-line dam provides a barrier to fish passage in all but the highest flooding conditions.

Restoration of this area should focus on restoration of fish passage. Fish passage could be restored by either retrofitting the dam or dam removal. As the dam is utilized for recreation and diverting water to the Kardon Park ponds, it is currently functional so a fish passage retrofit is likely more feasible at this time.

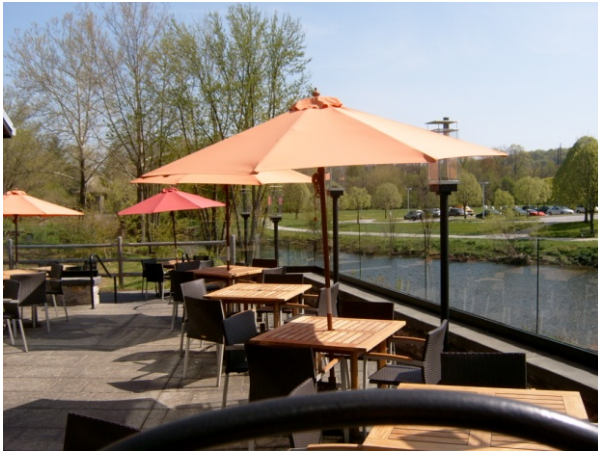
Impacted Stream Segment #27-30:

This location near the downstream end of the study area includes a minimal riparian buffer on the western streambank. The western riparian zone includes mowed lawn areas, a parking area, and a walking trail. The in-stream fish habitat is minimal.

This stream segment would benefit from riparian buffer plantings along the western streambank, extension of the fish habitat enhancement work that was completed upstream into a new phase in this area, and stormwater management retrofits to the parking area to the west of the stream. Stormwater management retrofits to be considered should include a demonstration rain garden and a bio-filtration swale.

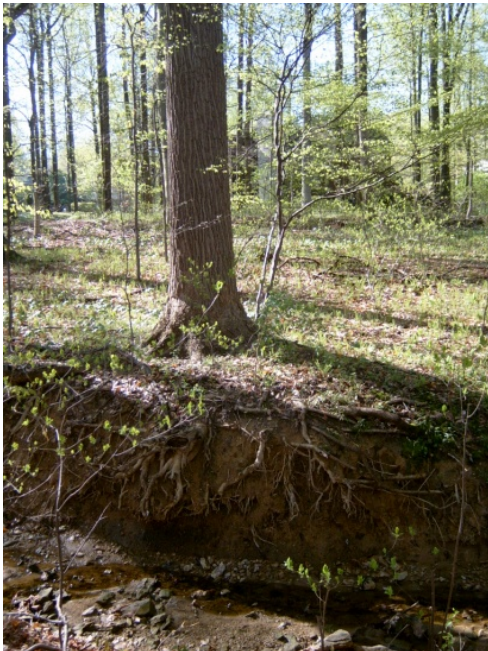
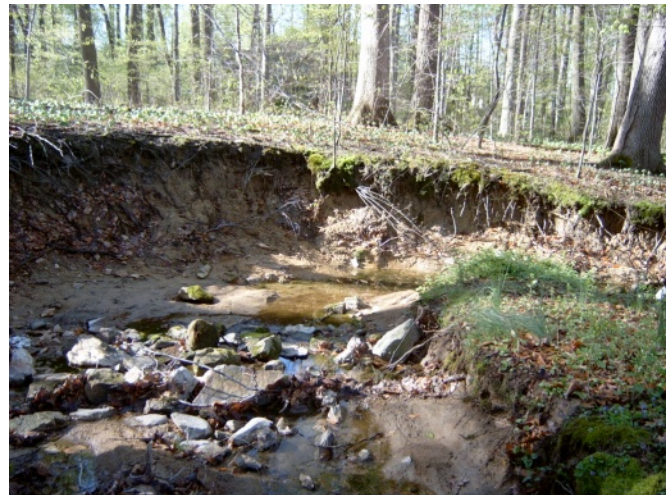
Impacted Stream Segment #31-34:

The streambanks in this section of Ludwig's Run and an unnamed tributary to Ludwig's Run are eroded approximately 3 - 6 feet high. The eroded streambanks in this area appear to be related to stormwater impacts.

Restoration of this stream segment should focus on decreasing the upstream stormwater impacts as well as streambank stabilization. The method of streambank stabilization for this area should be designed to have minimal impacts on the existing forest while providing long-term stability of the stream. One consideration would be to install cross vanes for grade control within the stream to ensure that additional downward cutting of the stream is minimized.

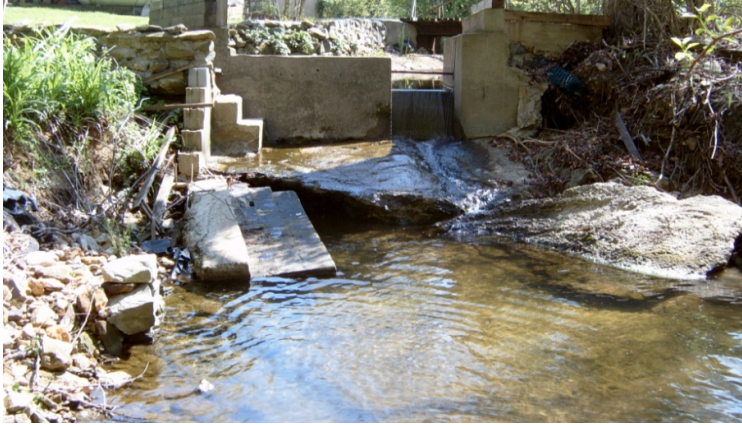
Impacted Stream Segment #42:

A small on-line dam in this location is utilized to provide water to an off-line pond. The on-line dam blocks fish passage within the stream.

This dam should either be removed or retrofitted to allow for fish passage into the headwaters. If dam removal is selected, the restoration of the area should include installation of cross vanes for grade control to minimize the risk of this stream segment down-cutting.

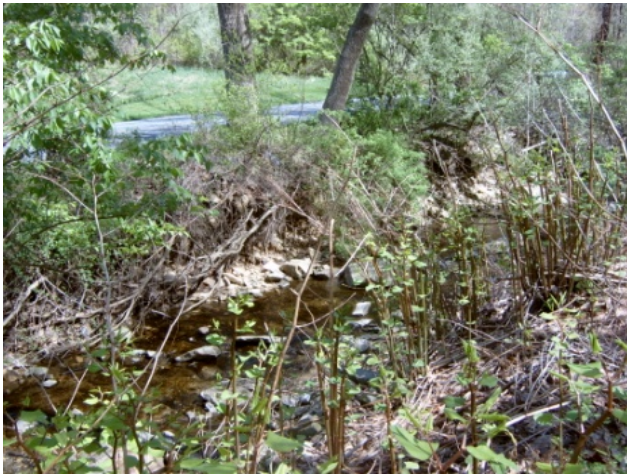
Impacted Stream Segment #51:

The on-line dam in this area blocks fish passage within the stream. The dam is utilized to provide water to a small off-line pond. Just downstream of the dam area, Japanese knotweed (*Polygonum cuspidatum*) dominates the southern streambank.

This dam should either be removed or retrofitted to allow for fish passage into the headwaters. The water intake for the pond could be designed into the dam removal project to allow for an in-stream intake. The invasive species within the area should be removed to minimize the risk of the plants spreading to other areas within the watershed. Native riparian zone plants should be planted in the area after the invasive removal.

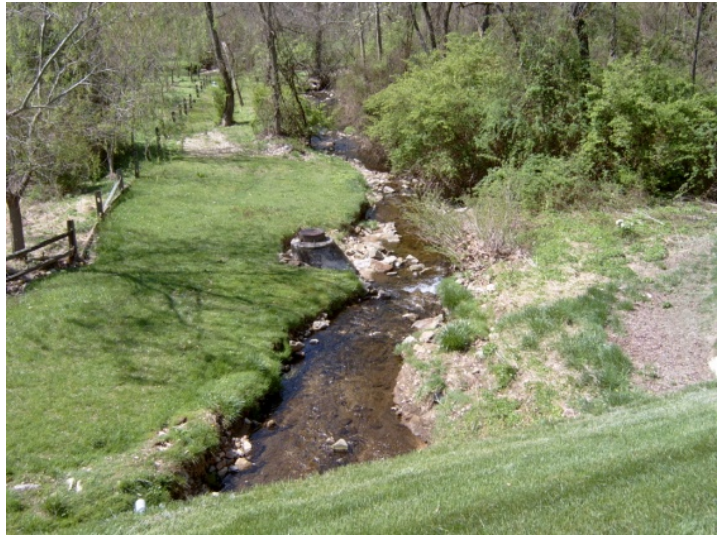
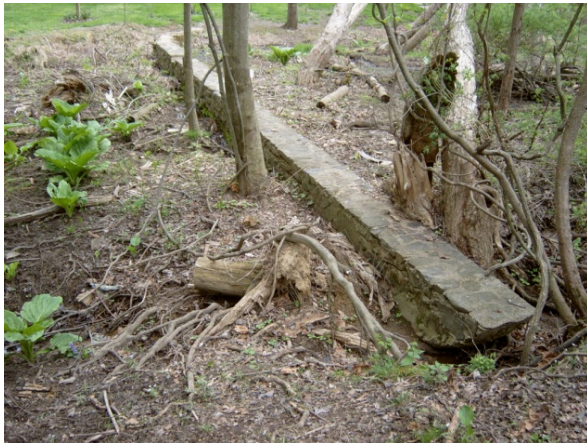
Impacted Stream Segment #54-55:

A sewer line right-of-way within this area is being maintained as mowed lawn. The mowed lawn area extends to the edge of the streambanks where the stream is actively causing erosion around a sewer line manhole. The southern streambank is eroded approximately 2-3 feet high.

Restoration of this area should include a minor streambank stabilization project and planting of native species within the riparian zone. The area of erosion around the sewer line manhole should be maintained.

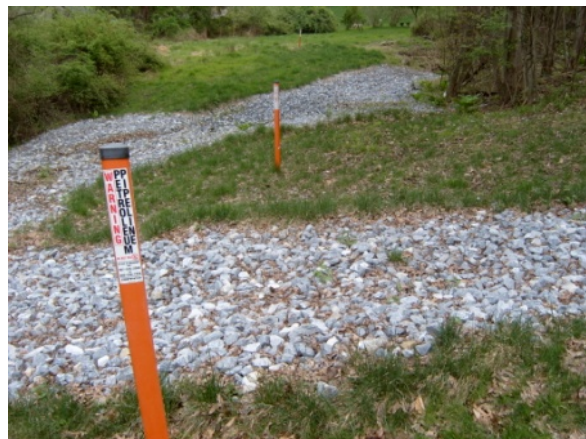
Impacted Stream Segment #87-88:

A dam breast in this area is no longer functional with an unnamed tributary cutting around the sediment filled dam structure. Downstream of the structure, the stream channel is eroded with approximately 4 feet high streambanks. In the location of a pipeline crossing at the downstream end of the segment, riprap has been placed within the eroding channels in an effort to stabilize the channels.

The eroding streambanks within this area should be stabilized. In the location of the dumped riprap, a stabilized channel should be implemented in place of the riprap. The dam structure could be removed if desired, as it is no longer functional.

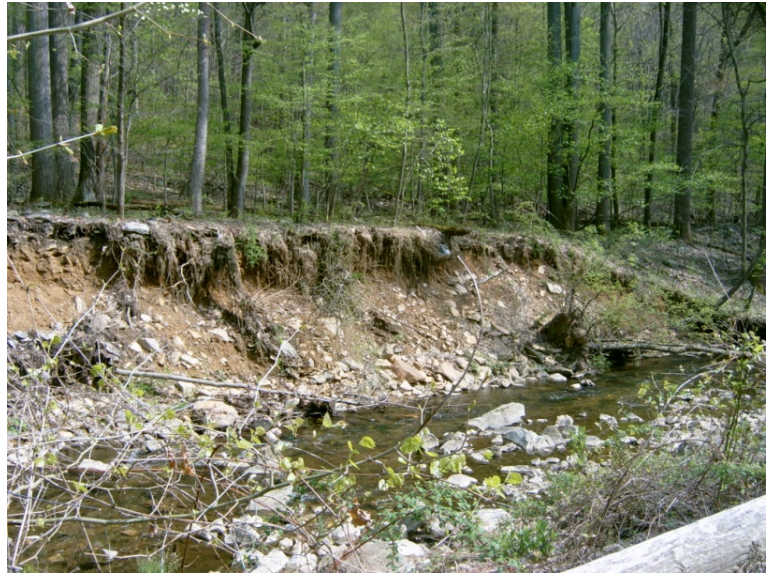
Impacted Stream Segment #100:

About 250 feet of the southern streambank at this location is eroded approximately 12 to 15 feet high. Just downstream of the eroded area, a major streambank stabilization project utilizing riprap and gabion baskets has been installed.

The area of erosion should be targeted for streambank stabilization. As the amount of material that would be required for removal to develop a more stable slope would be substantial, it is likely that stabilization of this area would best be accomplished by implementing riprap in combination with live stake plantings on the slope.

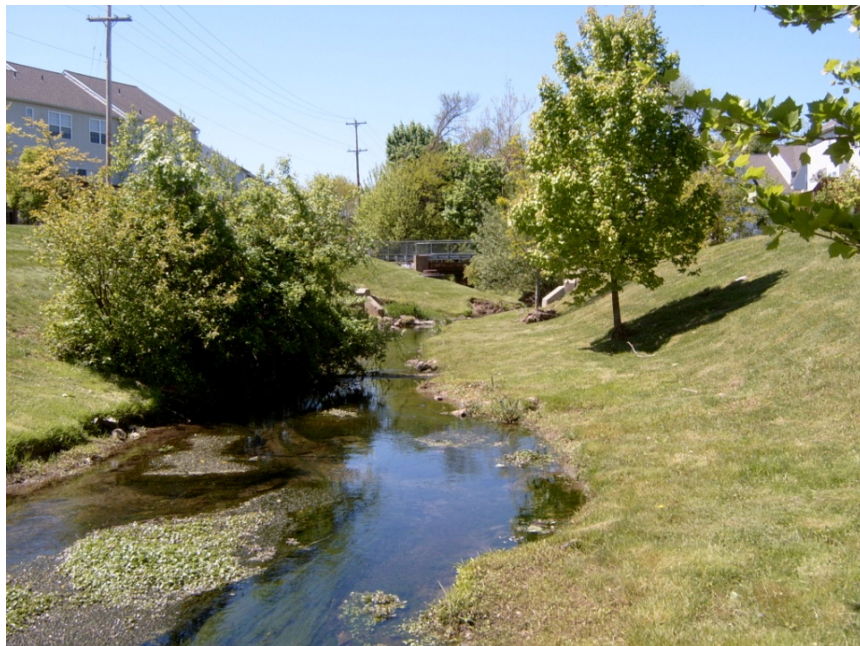
Impacted Stream Segment #112-113:

In this location, a Growing Greener Grant funded stream restoration project was implemented years ago. The existing streambanks and floodplain are being maintained in mowed grass to the edge of the stream.

The riparian buffer in this area would benefit from plantings of a riparian zone forest and buffer to filter water discharging to Park Run from the lawn areas.
