**Restoration Plan
for
Valley Run Watershed
Chester County, Pennsylvania
December 2008**

Prepared by:
RETTEW Associates, Inc.
Natural Sciences Group
950 East Main Street, Suite 220
Schuylkill Haven, PA 17972
(570) 385-2270
(570) 385-2217 fax
RETTEW Project No. 07-07568-004

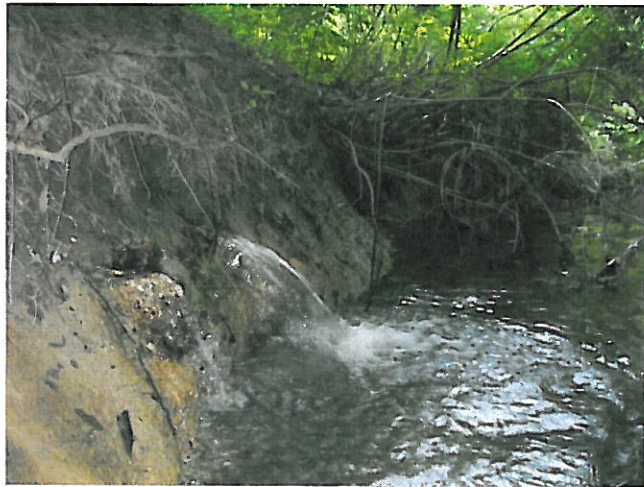
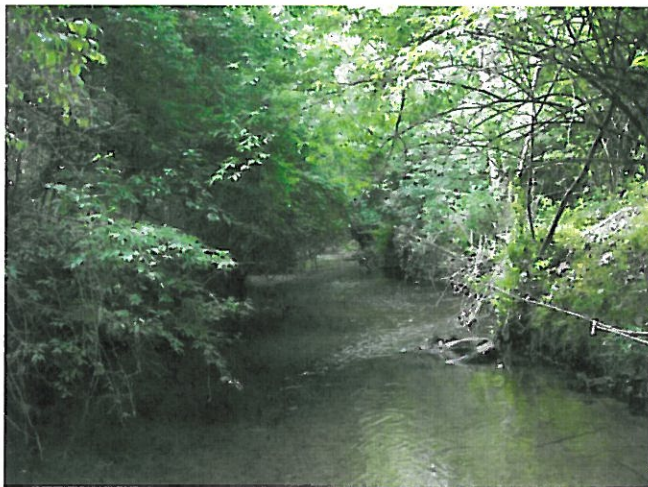
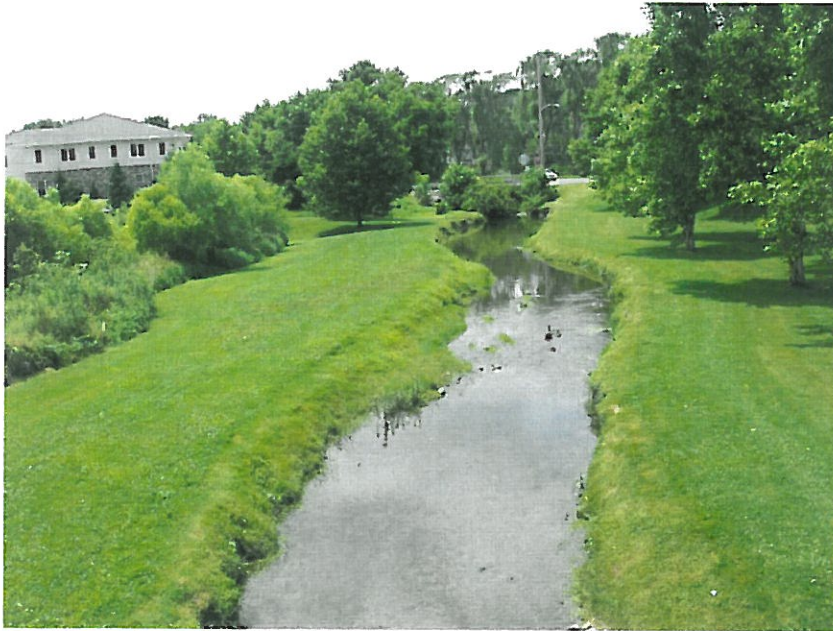
Impacted Stream Segment #2-5:

This area of the watershed includes a large pond with Valley Run flowing along its western edge. The pond berm appears to be in need of maintenance as water from the pond is seeping through the berm/streambank along the top of a layer of clay soils, approximately 1-2' above the stream bed. The water is discharging into the stream. During high water conditions, water from the pond also likely overflows the berm and enters Valley Run. At the location of the overflow, an approximately 6' wide gully is down-cutting thru the berm. In the southwestern section of the pond berm, the stream is

eroding the berm. The stream in this area appears straightened and has a silt bottom that lacks habitat.

The stability of the pond berm should be immediately evaluated by a qualified engineer. The berm likely requires extensive repair to properly fix the leaks. Drawing down the pond will likely be necessary to make these repairs. Long-term solutions for restoring this section of stream should consider fluvial geomorphology practices.

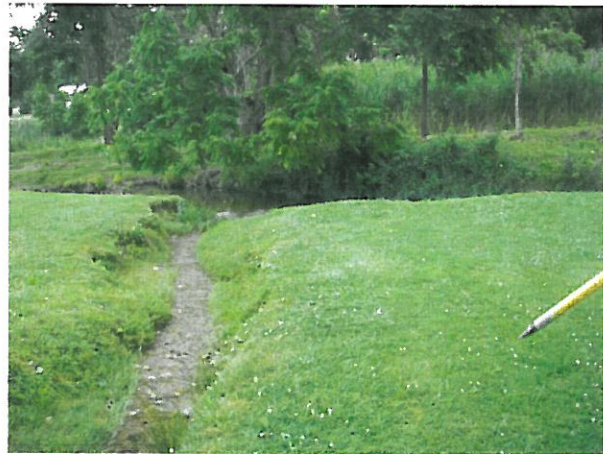
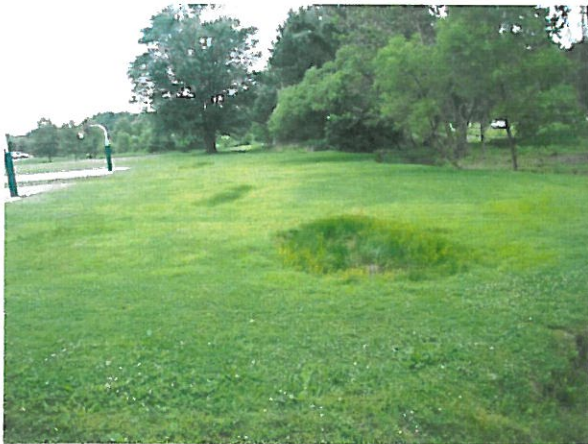
Impacted Stream Segment #21-23, 21-73:

This section of the watershed includes the Caln Township park area. Valley Run and an unnamed tributary flow through the park. The streambanks are mowed and in some places are eroding about 1-2 feet. The stream bottom has a substantial amount of sediment. The unnamed tributary plunges out of a culvert thus eliminating the possibility of fish passage further up into the headwaters of the tributary.

A primary focus of any conservation effort in this area should be on riparian buffer restoration. Before the riparian buffer is installed, the restoration of this section of the stream should include some in-stream restoration with a fluvial geomorphological approach to maintain sediment transport

through the reach. The use of fish habitat enhancement structures in this section would increase the diversity of the available stream habitat. At Point #73, the culvert carrying the unnamed tributary should be evaluated for methods of restoring fish passage.

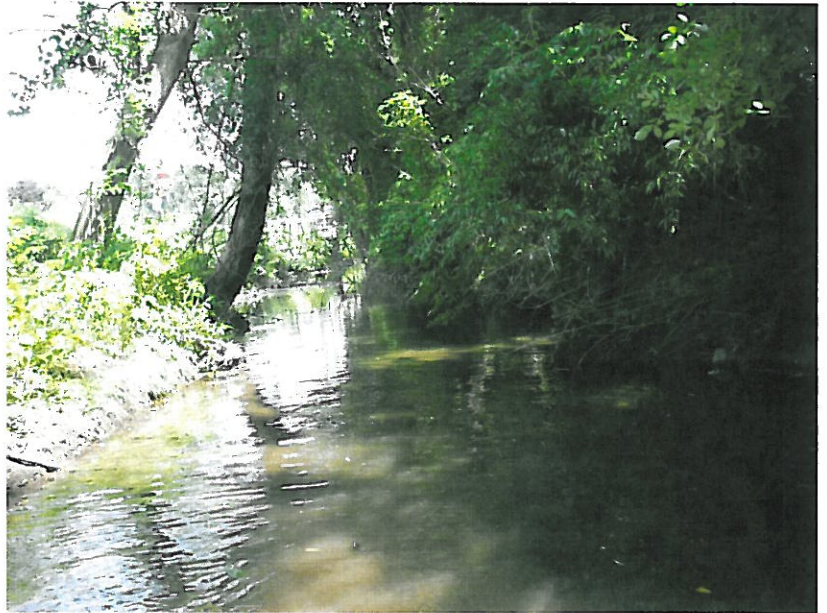
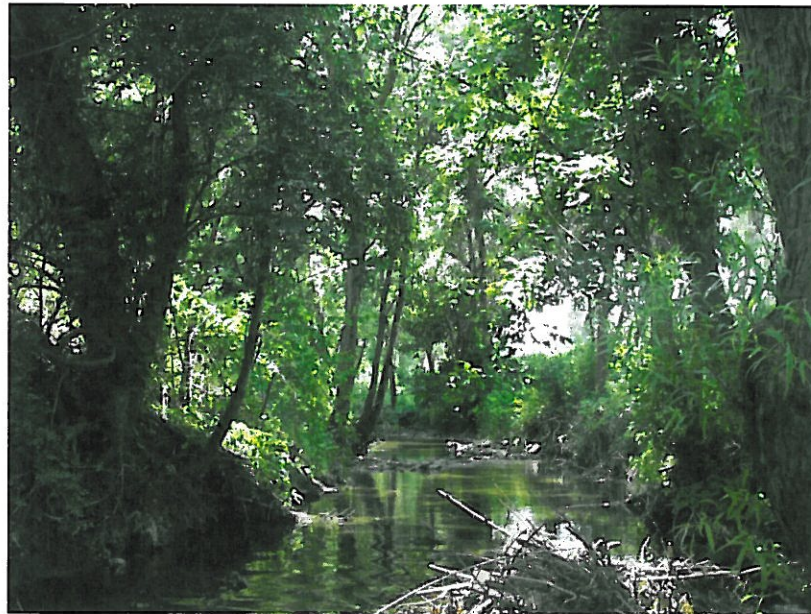
Impacted Stream Segment #24-26:

This section of Valley Run has eroded streambanks that are 3-4 feet high. The stream appears to have been straightened and has a sediment laden bottom that lacks adequate fish cover. Large stormwater basins on the north side of G.O. Carlson Blvd. discharge in this area.

This stream segment would be an excellent candidate for a full stream channel and floodplain restoration utilizing a fluvial geomorphological approach. While the stream corridor is restricted due to development, a patchwork approach to restoration would likely not provide long-term success in this location. The large stormwater basins that drain to this area should be considered for stormwater volume and water quality retrofits.

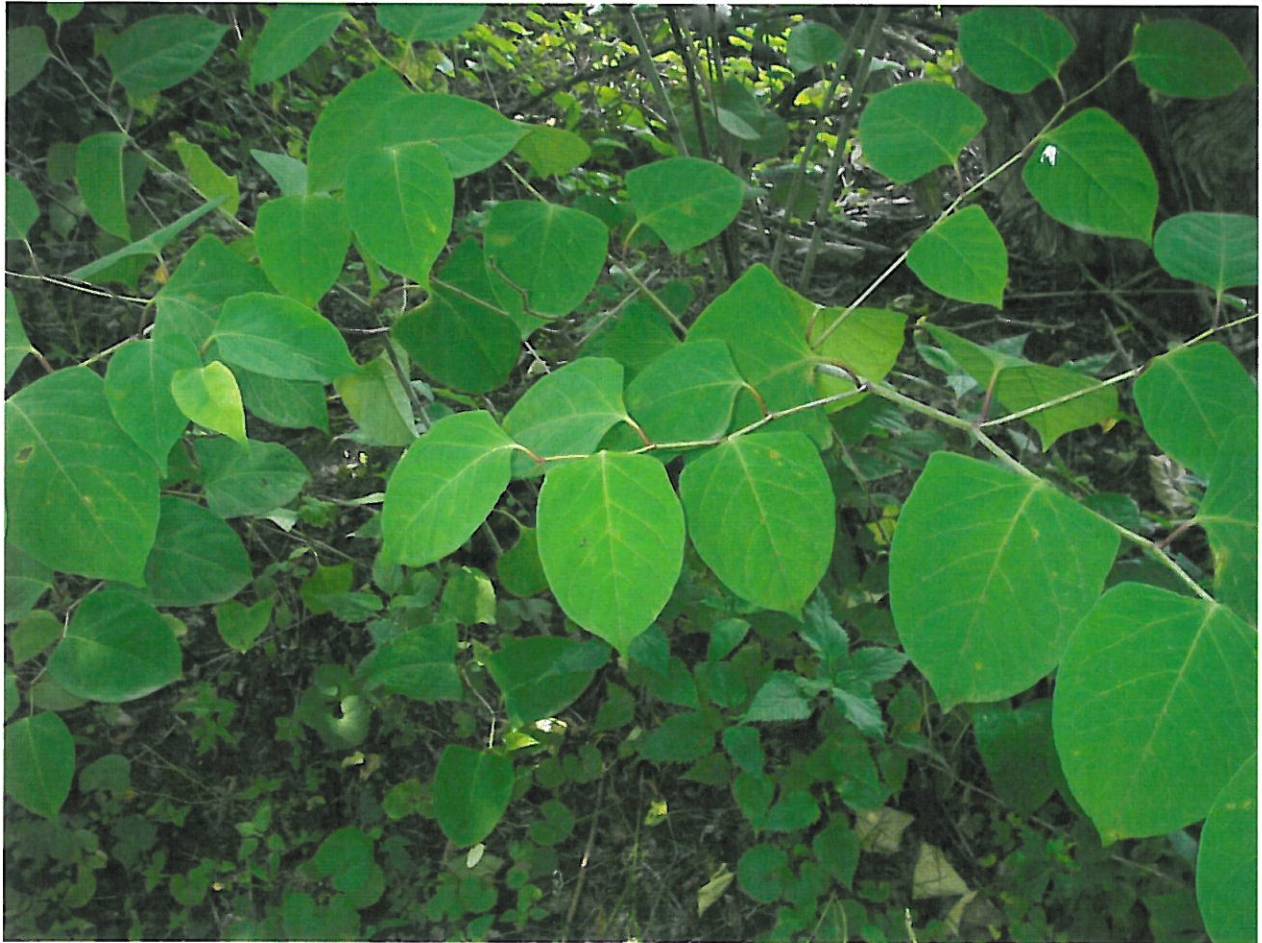
Impacted Stream Segment #57:

Japanese Knotweed (*Polygonum cuspidatum*) has established a small population at this location and near Stream Segment #63. Japanese Knotweed is a vigorous invader and is able to extensively alter the plant community after it becomes established.

This invasive species should be targeted for immediate removal. Eradication of the two small existing patches is possible at this time and is necessary to help avoid further expansion of the population. As invasive species may be transported into the watershed from other areas in the future, volunteers and municipal work crews should be educated on identifying invasive species and proper eradication methodology.

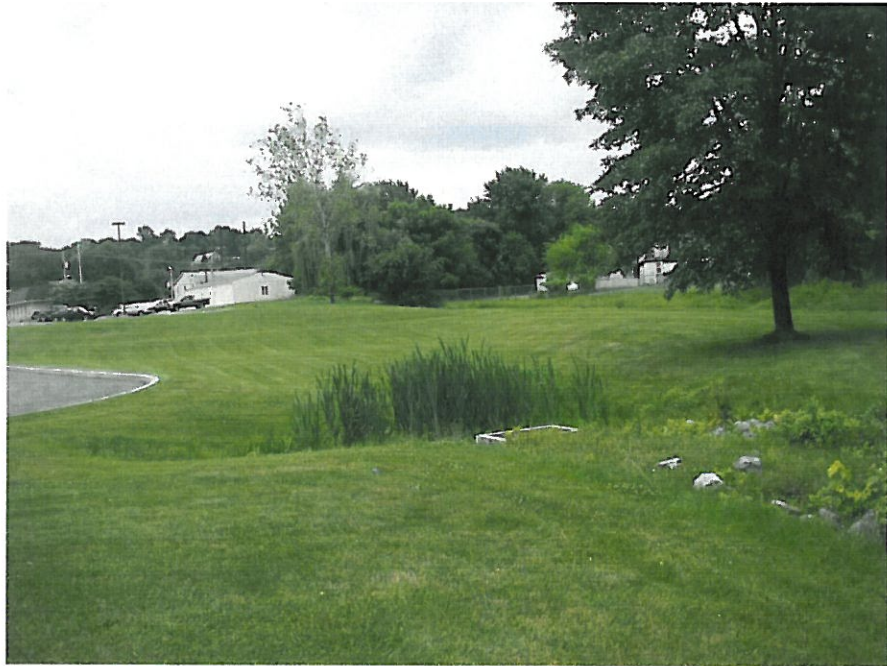
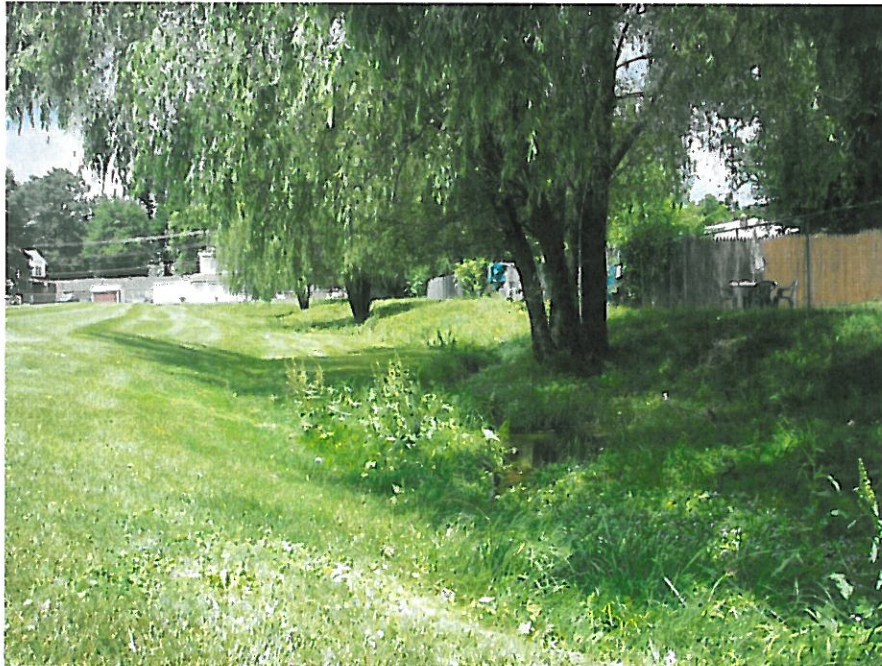
Impacted Stream Segment #65-68:

This area includes a large mowed area behind a commercial building. Valley Run and an unnamed tributary flow through the mowed area. While a few willows are present along the stream, it is primarily exposed to the sun. Most of the residential areas draining to this point lack stormwater BMP's. A mowed stormwater basin is present on the commercial property.

This area would be a great target for construction of a treatment wetland system. The construction of a wetland system in this area could minimize nutrient and contaminant inputs to the stream. The residents of this area, as well as those throughout the watershed, should be targeted with homeowner based stormwater management initiatives. At a minimum, this area would be an excellent location for riparian buffer enhancement through the TreeVitalize program.

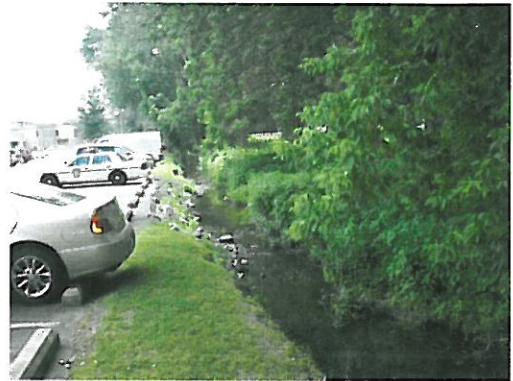
Impacted Stream Segment #32-36:

In this section of the stream, stormwater outfalls from the parking lot immediately adjacent the stream and large stormwater basins to the north discharge to the stream. The stream throughout this reach is eroding and heavily laden with sediment.

The ideal solution would include restoring the floodplain by removing the encroachments and performing a stream restoration with a fluvial geomorphologic approach. A more feasible and immediate approach to reducing the impacts of this area would include installing urban stormwater retrofits (such as those installed under parking lots for water quality improvement) and naturalizing the stormwater basin. The upstream end of the segment should be evaluated for streambank stabilization and gravel bar removal to maintain the capacity of the bridge structure.

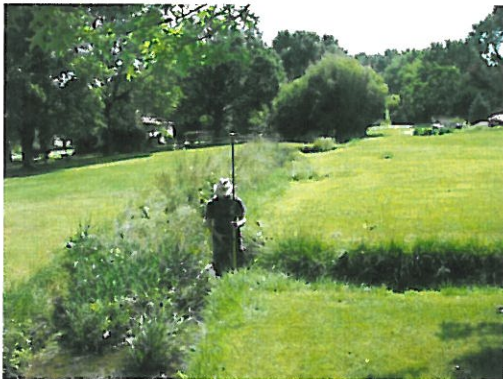
Impacted Stream Segment #49-53:

Throughout this section, the stream appears unnaturally straight with 2-3' banks and a silt bottom. The stream is surrounded by residential properties with mowed lawn to the edge of the stream. The stream in this residential area is dominated by 3' high eroding banks and a silt bottom.

Riparian buffer enhancements and streambank stabilization. Restoring the stream with a fluvial geomorphological approach would be ideal, but the limited work area in some sections of this segment would likely limit the scope of the project.

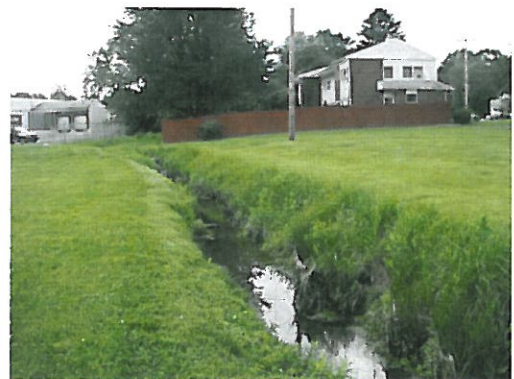
Impacted Stream Segment #62-65:

This stream segment appears to be artificially straightened, with 2-3' eroded banks and a silt/gravel streambed. Litter and debris line the stream channel. Invasive species dominate the thin riparian corridor in areas where the vegetation is not mowed to the streambank. Stormwater discharges to the stream in this area have minimal to no BMP's installed.

This segment would benefit from riparian buffer enhancements, urban stormwater retrofits, a community litter cleanup, stream signage, and stream restoration with a fluvial geomorphological approach or fish habitat improvement project.

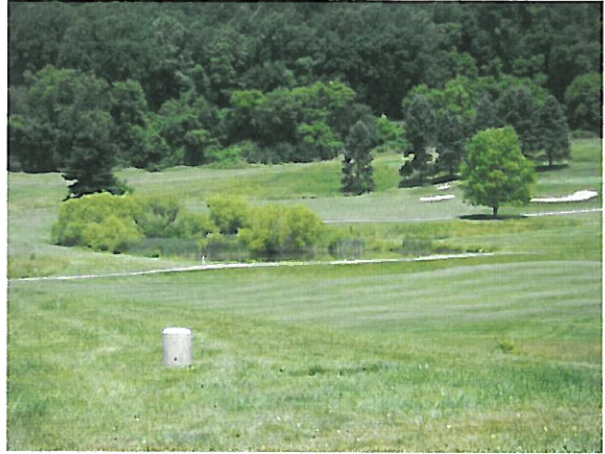
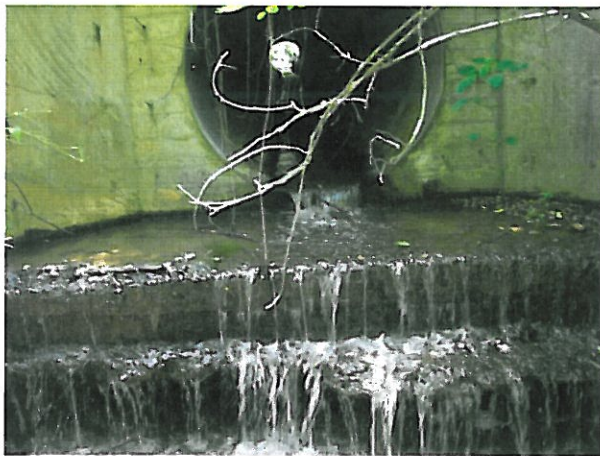
**Impacted Stream Segment #99:**

A culvert (5' CMP) crossing to access an industrial plant off of South Bailey Road discharges with a 3-4' drop into a scour pool. This drop effectively blocks the upstream passage for fish.

99	Center of culvert (5' CMP) crossing accessing industrial plant off of South Bailey Road. The downstream end of the culvert has a 3-4' drop into a scour pool, which creates a total block of fish passage.	Replace culvert to allow for better fish passage	Landowner, Agencies	Medium Priority	
100	Center of new culvert crossing tributary, to access new residential development. Stream section below crossing appears to be relatively stable, with significant areas of bedrock along the streambed.	N/A	N/A	N/A	
101	Nice section of forested riparian corridor, along small tributary west of intersection of South Bailey and Stouff Roads. Downstream of South Bailey Road the stream becomes more entrenched and shows some sign of stormwater impairments	Stormwater retrofits along roadways and in headwater areas	Landowners, Caln Township	Low Priority	
102	Small dam breached along headwater tributary, east of Stouff Road.	Streambank stabilization in former impoundment area	Landowner, Agencies	Low Priority

Fish passage could be restored in this area by modification of the outfall structure.
