Lower West Branch Red Clay Creek Watershed Restoration Plan

New Garden Township, Kennett Square Borough, and Kennett Township Chester County, Red Clay Watershed, Pennsylvania

August 4, 2023

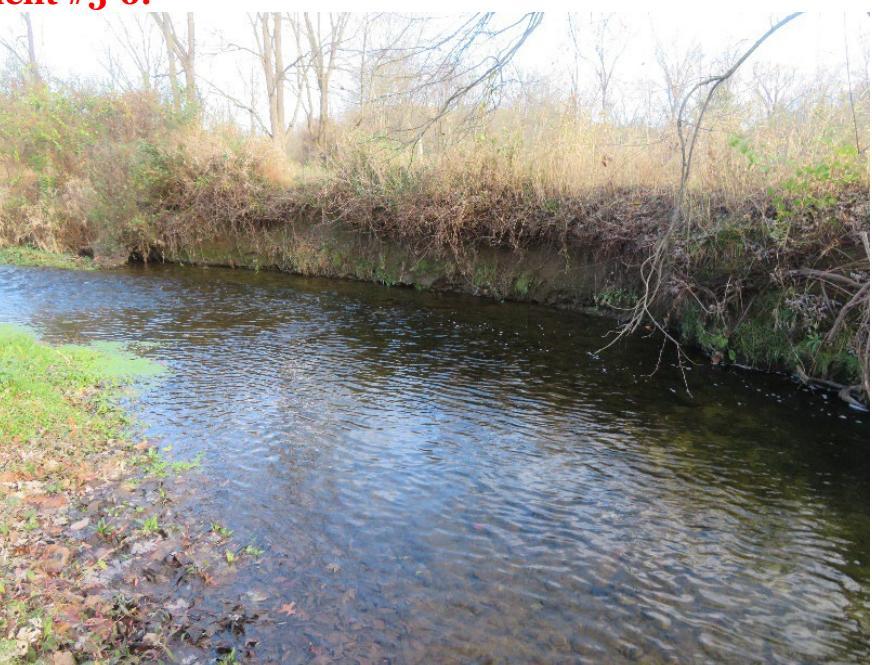
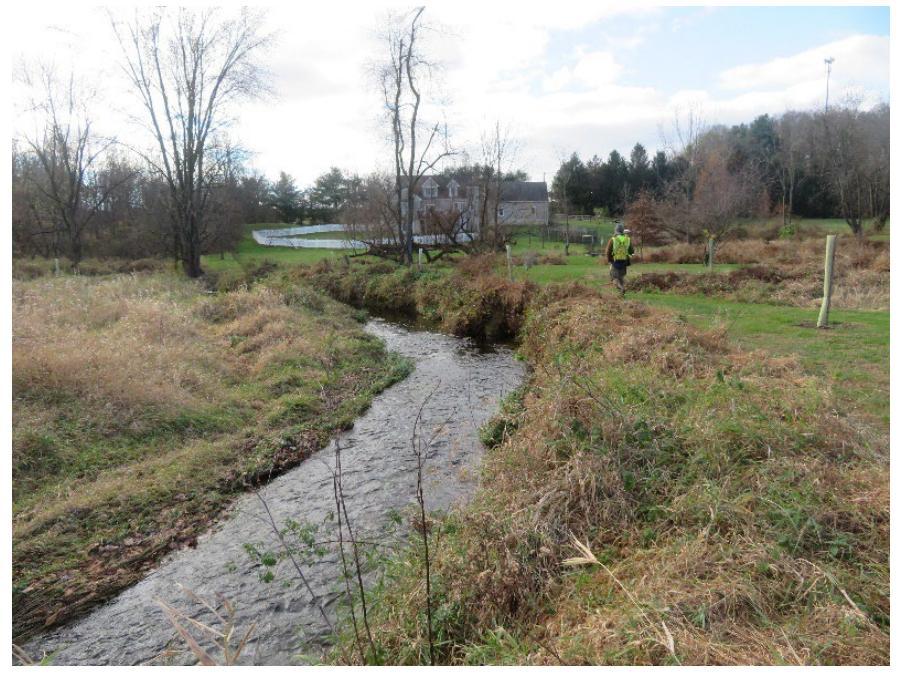
Along this stretch of substantial stream. legacy sediment has built up since colonial times and has disconnected the floodplain. The streambanks are undercut and actively eroding in over 60 percent of this stream section. The eroding streambanks average 4 feet high. Throughout this stretch of stream, portions of the riparian zone are mowed to the top of the streambanks.

This stream section requires a holistic approach to restoration. The most effective way to restore this section of the stream would likely include reconnecting the floodplain through the removal of legacy sediment to create an active floodplain bench. Within the created

floodplain. active of wetlands pockets could be created to aid in retaining flooding flows and filtering pollutants. Grading the streambanks to a stable slope would minimize additional erosion and allow for native vegetation to be planted help secure the to streambanks. Instream structures such as log vanes and root wads should be installed to create fish habitat and reduce near-bank friction during

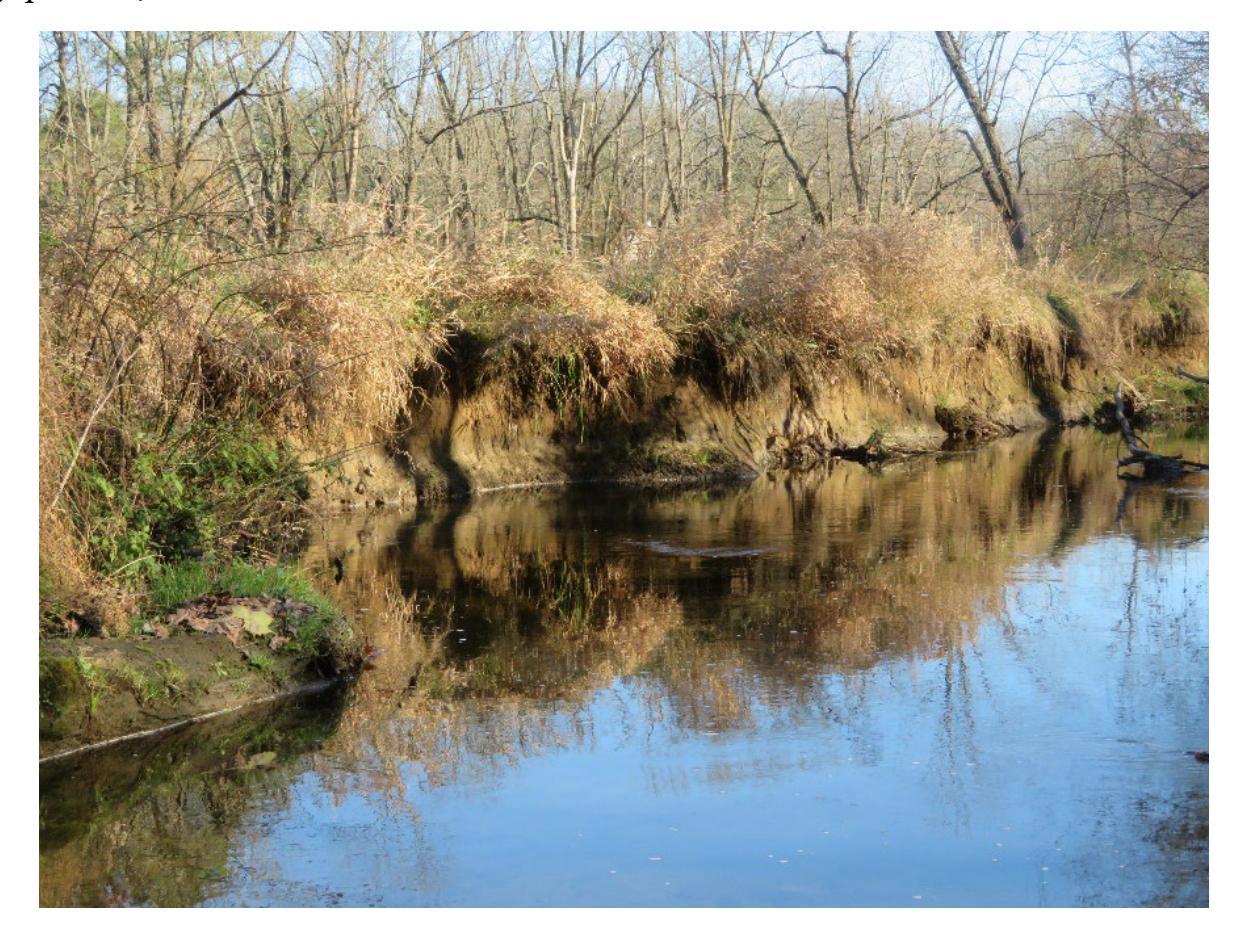
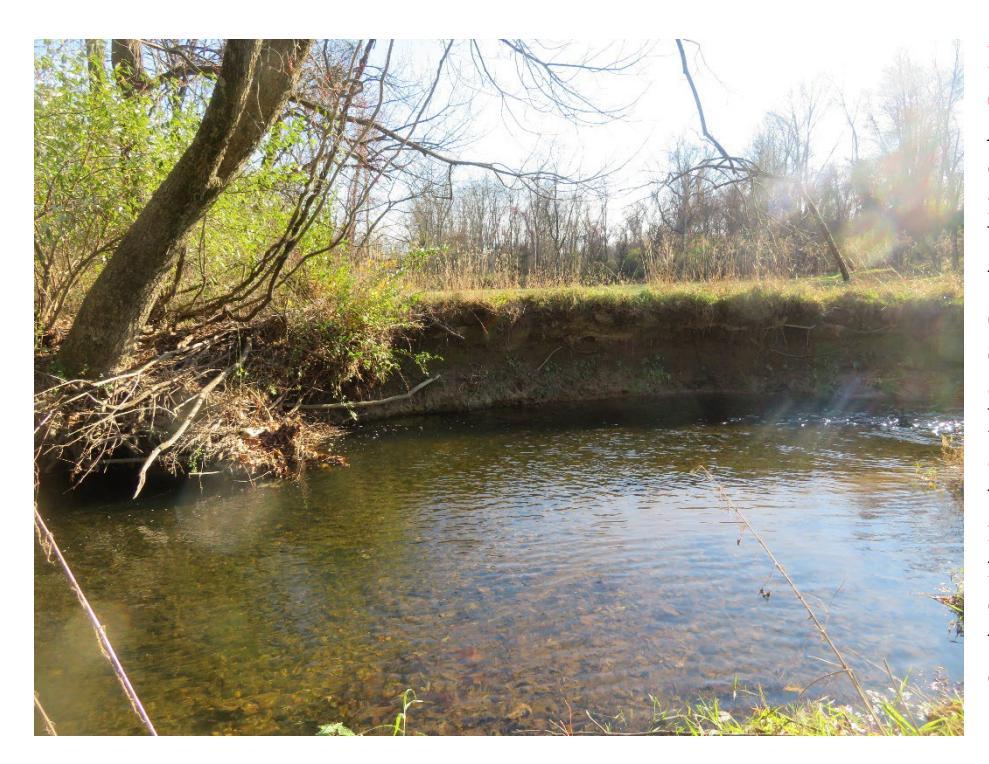
The streambanks in this segment are approximately 4 feet high and actively eroding. The active erosion is contributing sediment to the stream system that degrades the aquatic habitat and water quality on the site and downstream. The riparian buffer is minimal along this section of the stream and limits the available habitat within the stream corridor. This segment of the stream has been the site of previous buffer plantings. Despite these plantings, the area is currently dominated by invasive Japanese hops (*Humulus japonicus*).

The area along this section of stream is well suited for wetland creation. The creation of wetlands in addition to floodplain reconnection would help to mitigate future flooding and protect the stream channel from future erosion. The invasive Japanese hops (*Humulus japonicus*) should be removed and replaced with native vegetation including the expansion of the riparian buffer. The proposed multi-use trail system upgrades in the watershed will include work within the riparian zone of this stream section and surrounding areas. Kennett Trails Alliance should be actively involved with coordination related to the restoration of this area so the stream and riparian improvements complement the proposed work on the trail system.

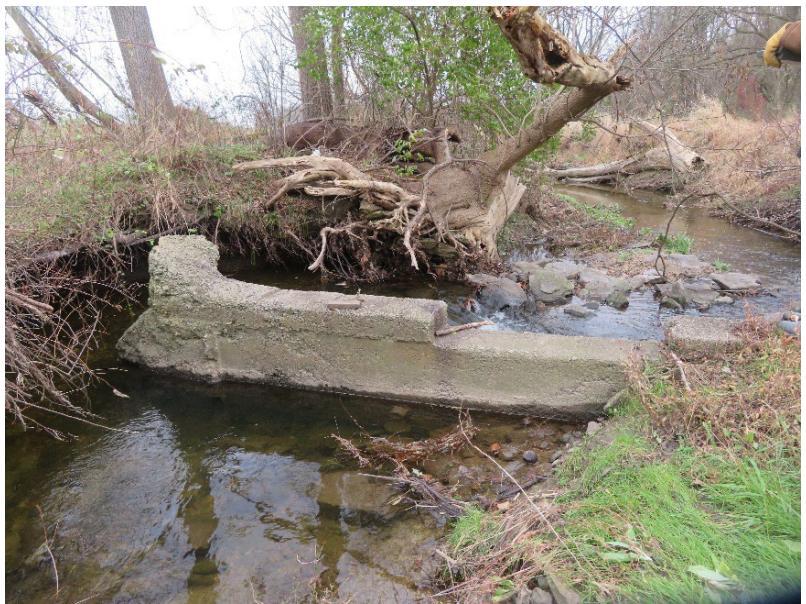
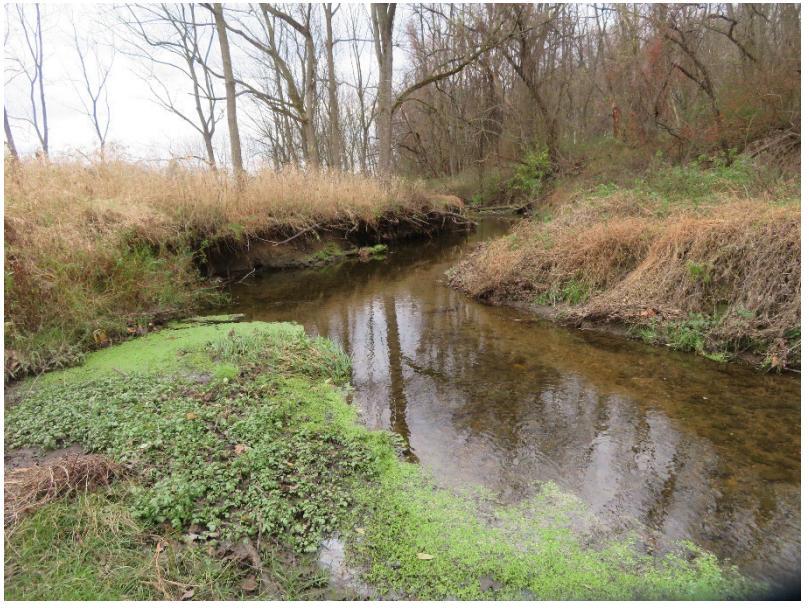
Impacted Stream Segment #71-76:

from the upslope commercial and residential developments. The stream channel is incised with streambanks that are 3 to feet high and actively 5 eroding. The eroding streambanks discharge nutrients and sediment to the stream channel that impacts water quality on the site and downstream. At point 73, a breached dam blocks the flow of the stream through the channel and is exacerbating the erosion of the streambanks in that area. Though there has been a riparian buffer planting

in the downstream area of the segment, invasive species are prevalent and have overtaken most of the planted trees. Restoration of this area should address a lack of floodplain connection and the dominance of invasive species including Japanese hops (*Humulus japonicus*) and reed canary grass (*Phalaris arundinacea*).

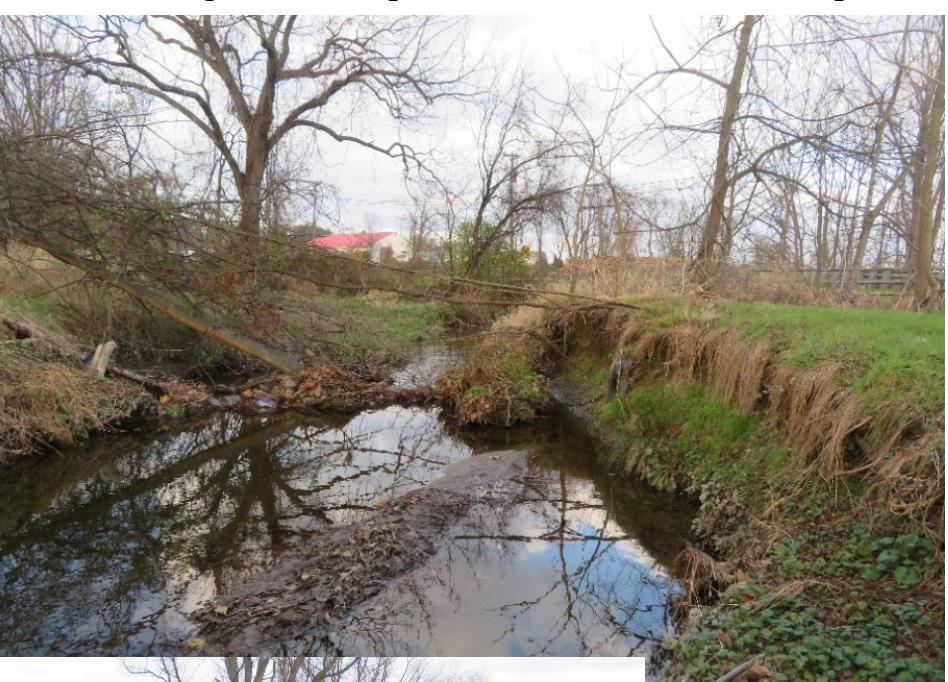
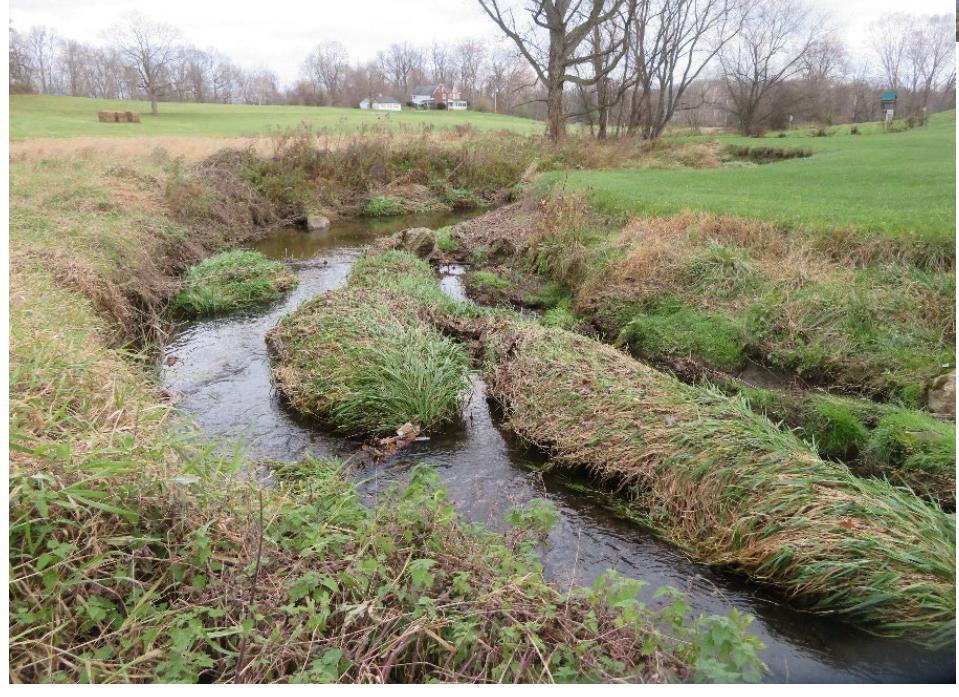
streambank. Along this section of the stream. the floodplain is disconnected and invasive Japanese hops (Humulus *japonicus*) and reed canary grass (Phalaris arundinacea) dominate the riparian zone and have outcompeted and killed many of the native trees that were planted in this area.

maintenance plan in place to limit the impacts of the invasive species that currently dominate the riparian zone. With a restored floodplain and stream channel, floodwaters from the upslope developed areas may be dissipated and absorbed. From a water quality standpoint, the newly created floodplain that has a vegetated slope to the stream channel would allow sediment and contaminants a place to settle out where they can be broken down by the sun and ecological processes.

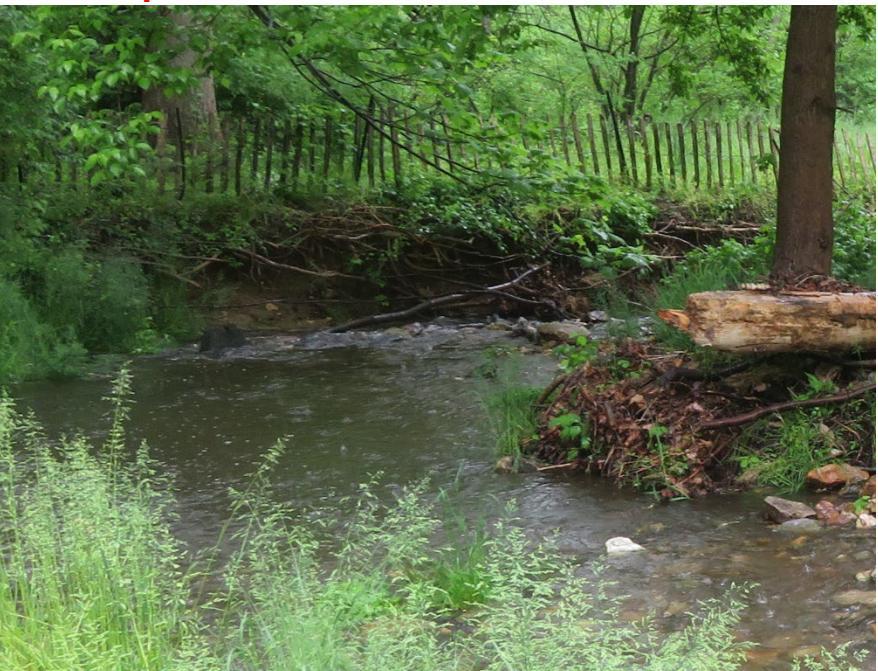
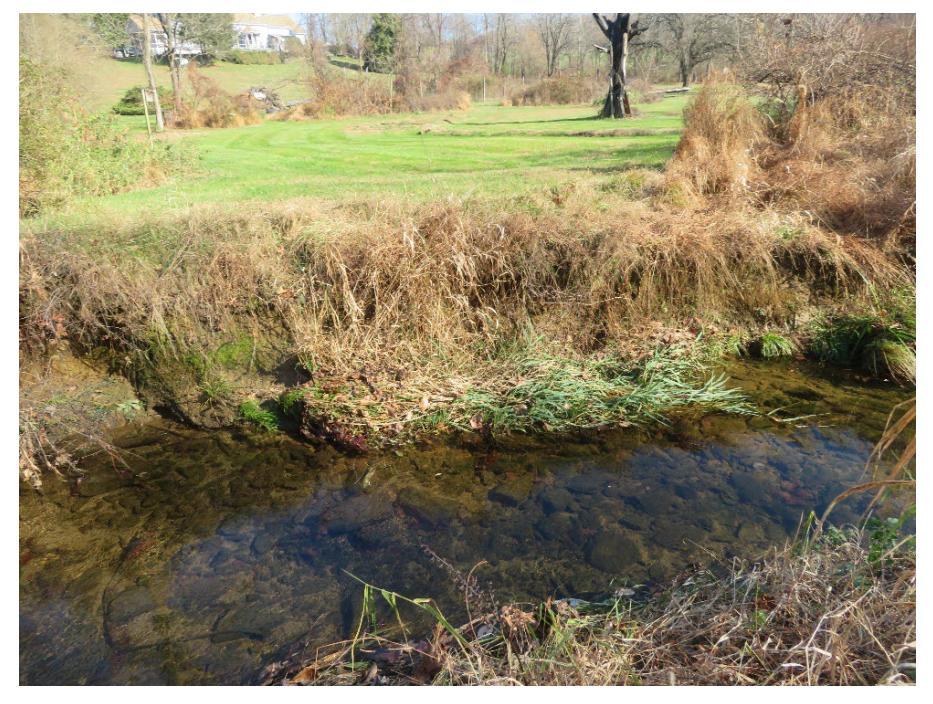
This segment consists of the portion of Bucktoe Creek that flows through White Feather Farm as well as the downstream portion of Agnew Run. Within this section of the stream. the streambanks are actively eroding and are currently 3-4' high. In a portion of the site, a lawn is mowed to the top of the streambank. The riparian zone includes trails for farm visitors to walk along the stream.

The design and permitting of the restoration of this section of the stream is already completed, and a portion of the construction funding has been secured. A grant for the balance of the construction funds is under review. Throughout this section of the stream, streambank stabilization, riparian buffer enhancement, and removal of invasive species

planned. are The streambank stabilization will incorporate native plantings and instream structures that were designed with a natural stream design The approach. completion of this project should be leveraged as a matching project for future restoration work in other sections of the watershed.

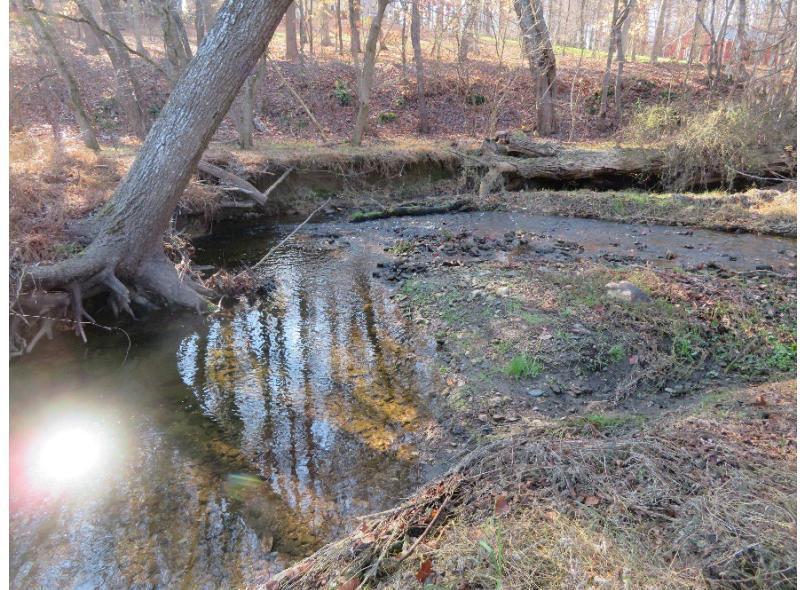
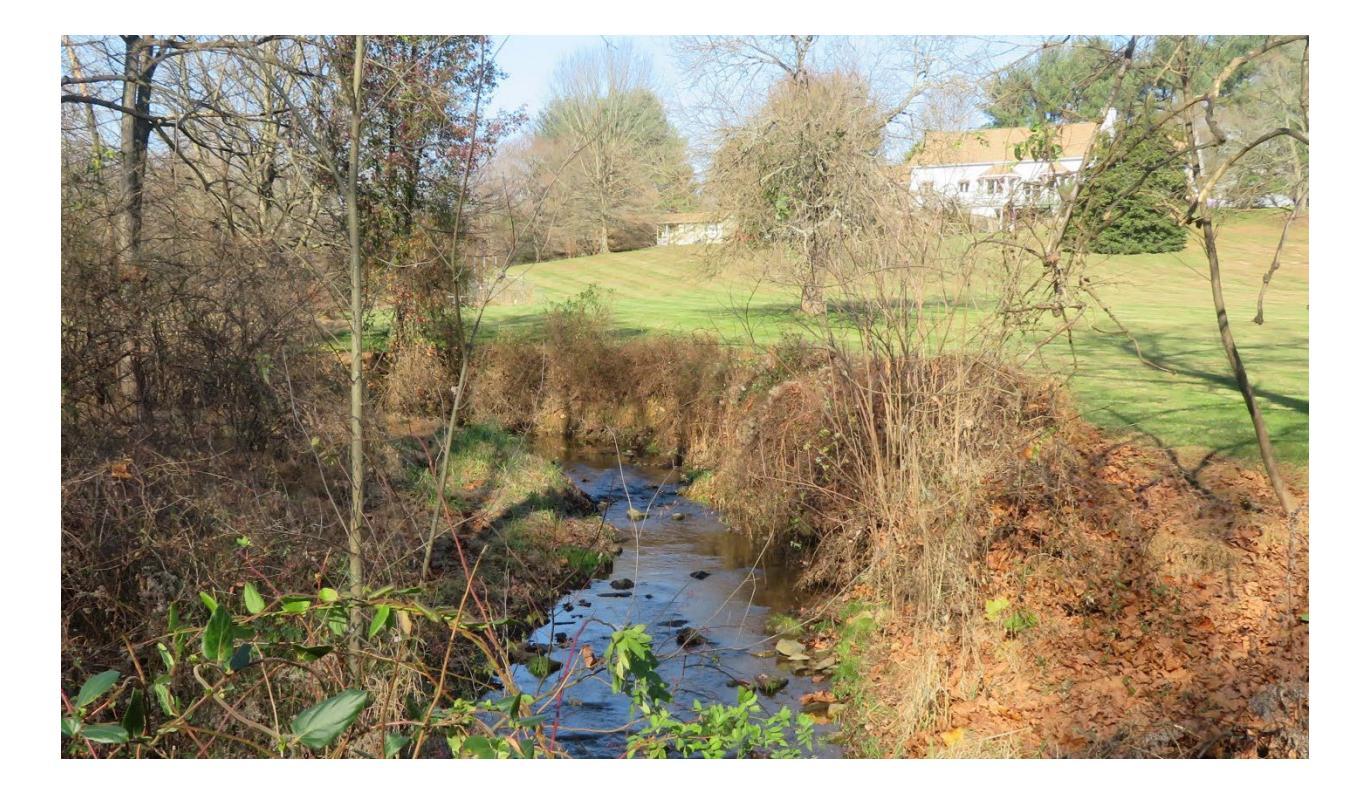
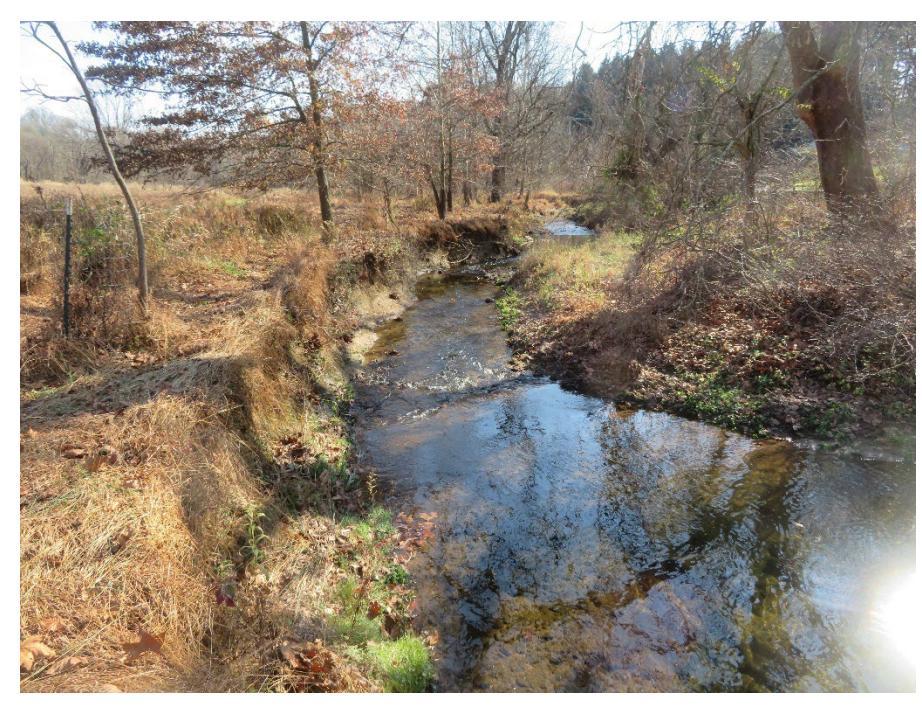
Throughout 50% of this reach, the streambanks are actively eroding legacy sediment and are approximately 3-4' high. The floodplain is disconnected. There are only patches of riparian buffer throughout the stream segment, and all other mowed. areas are The streambank erosion is progressing in the direction of sewer manholes just upstream of the Sharp Road stream crossing.

stabilization and reconnection of the floodplain is necessary for the restoration of this stream segment. As the floodplain is excavated, wetland pockets should be installed to aid in filtering contaminants, retaining floodwaters, and recharging the groundwater. Streambank stabilization work should include natural stream design techniques to install instream structures for fish habitat and bank protection during the establishment of native plantings. The native plantings should include native grasses and forbs, live stakes from the water's edge to the top of the streambank as well as trees and shrubs throughout the riparian zone to improve the stream buffer.

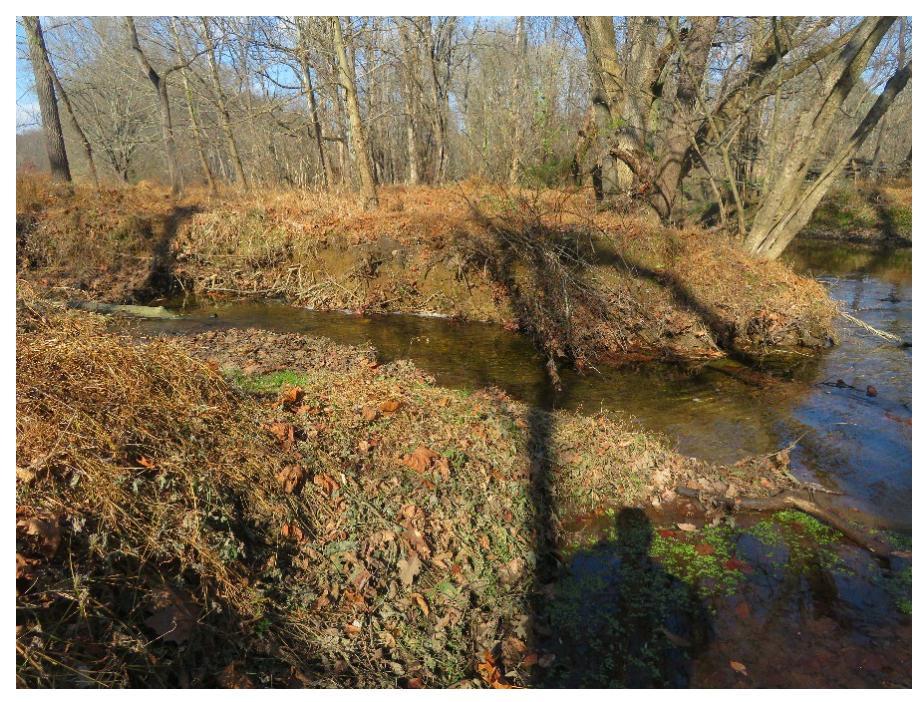
Impacted Stream Segment #110-112:

Throughout this stream section, the 3 to 4 feet high streambanks are actively eroding. The channel stream is disconnected from the floodplain by sediment that settled in this gradient lower area during the backwater flooding conditions created when Bucktoe Creek enters The Lower West Branch Red Clay Creek during flooding conditions.

wetland slope. The cells. floodplain grading areas, and restored streambanks should be planted with native vegetation and maintained to limit the establishment of invasive species. structures Instream such as log vanes and root wads should be thoughtfully installed they where will improve fish habitat and aid in stabilizing streambanks during vegetation establishment.

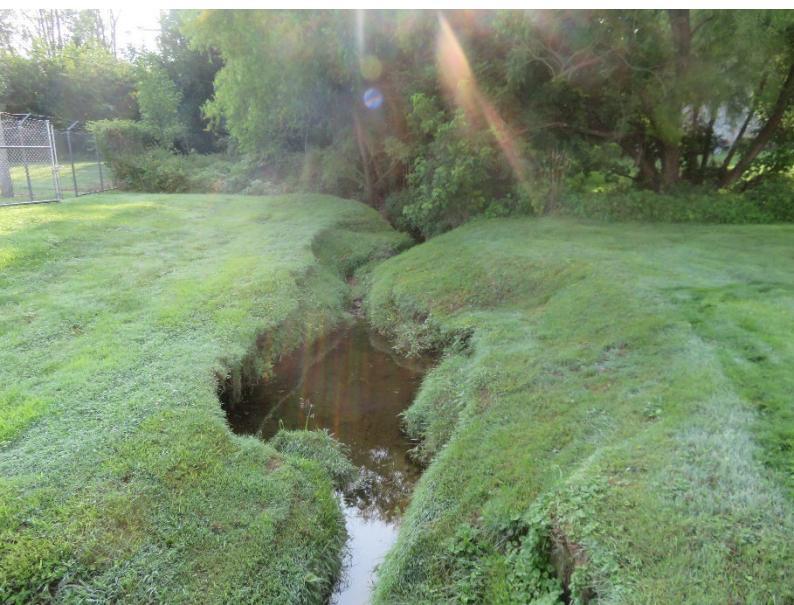
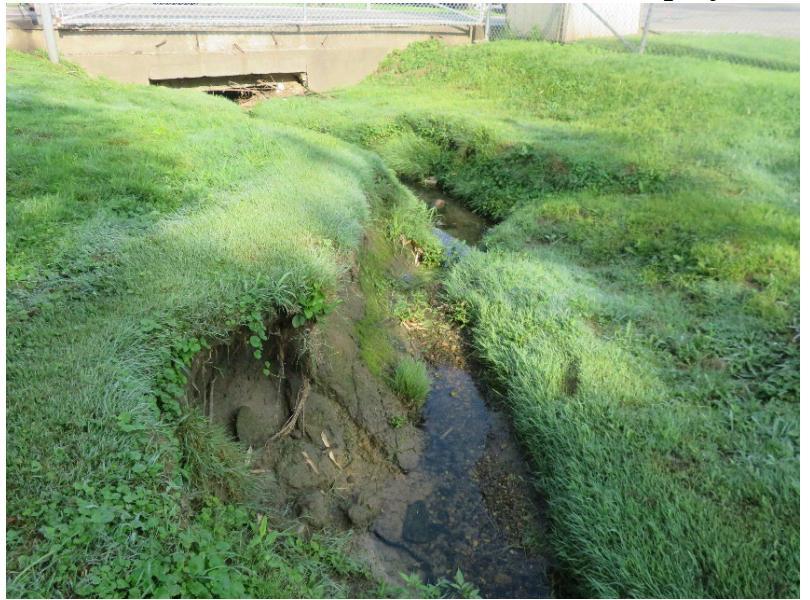
Impacted Stream Segment #134-135:

This stream section includes a small unnamed tributary that flows through the South Mill Champs mushroom farm. The tributary receives substantial stormwater discharges from the farm's rooftops and paved areas as well as the Borough of Kennett Square upstream of this stream section. Any work to address stormwater in this tributary should be considered part of this high priority project. Within the segment, stream several potentially undersized stream crossings restrict the flow of water within the channel and

likely contribute to the flooding of the mushroom farm facilities during large storm events. The flooding has caused substantial damage and is a concern for downstream water quality as well as the local economy. The stream channel is mowed to the stream edge. Additionally, a swale that is dominated by invasive species discharges stormwater to the stream from the south.

Restoration of this stream section should begin with an assessment of the existing stream crossings on the site. Where feasible, the stream crossings should be upgraded to reduce the role they play in flooding the site. In the headwaters and on the site, stormwater should be managed to decrease the rate and volume of flow to the tributary. On the South Mill Champs Site, a constructed stormwater basin with water quality features should be installed and additional stormwater retrofit projects should be evaluated. Along the

stream channel, grading to create floodplain capacity and stable, vegetated streambanks should be completed. The riparian zone should then be planted with native vegetation. Within the stormwater swale that discharges to the stream from the south, a regenerative stormwater convevance installation that retains and filters stormwater through a compost/ sand bed between constructed riffle areas should be installed.

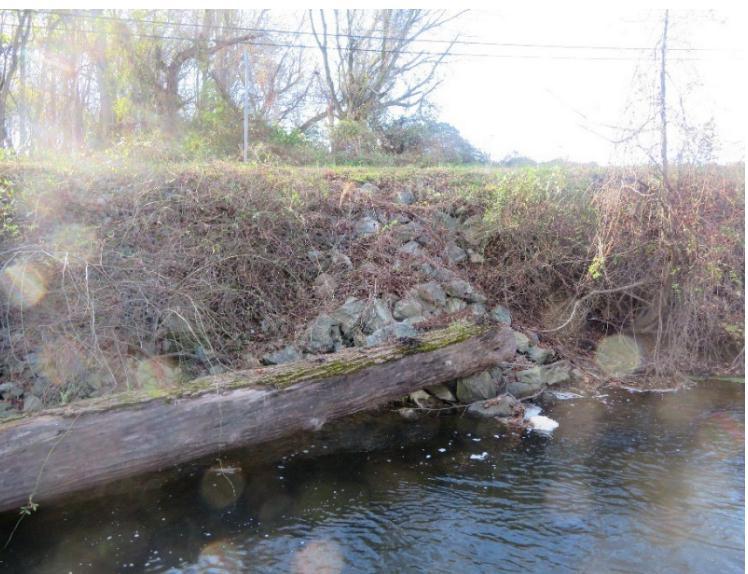
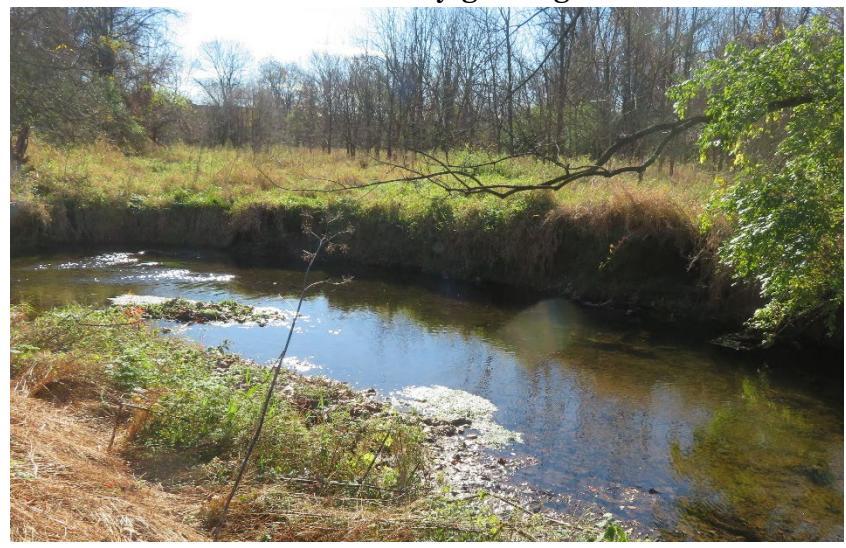
In this section of the stream, the banks are actively eroding and are 4-10 feet high. Although evidence of past dumped riprap remains along the base of Pemberton Road, the roadway base is actively eroding. The riparian zone along this stretch of stream is dominated by invasive hops (Humulus Japanese *japonicus*), reed canary grass (Phalaris arundinacea), and multiflora (Rosa rose multiflora).

Work within this stream section should focus on the creation of an active floodplain, stabilization of streambanks by grading them to a stable slope, installing natural stream

design structures to create fish habitat and protect the streambanks, creating floodplain wetlands, planting native species, and controlling invasives. Completing design, the permitting, and construction of this project in conjunction with the restoration of Impacted Stream Segment #15-16 would minimize costs for both projects.

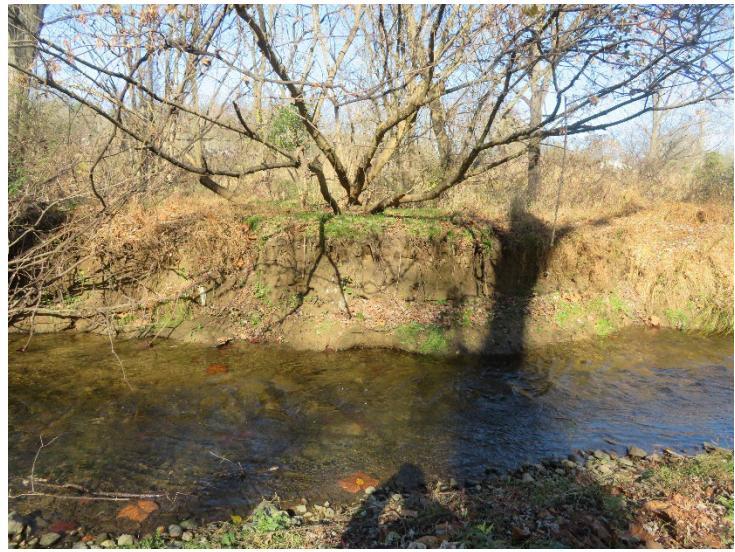
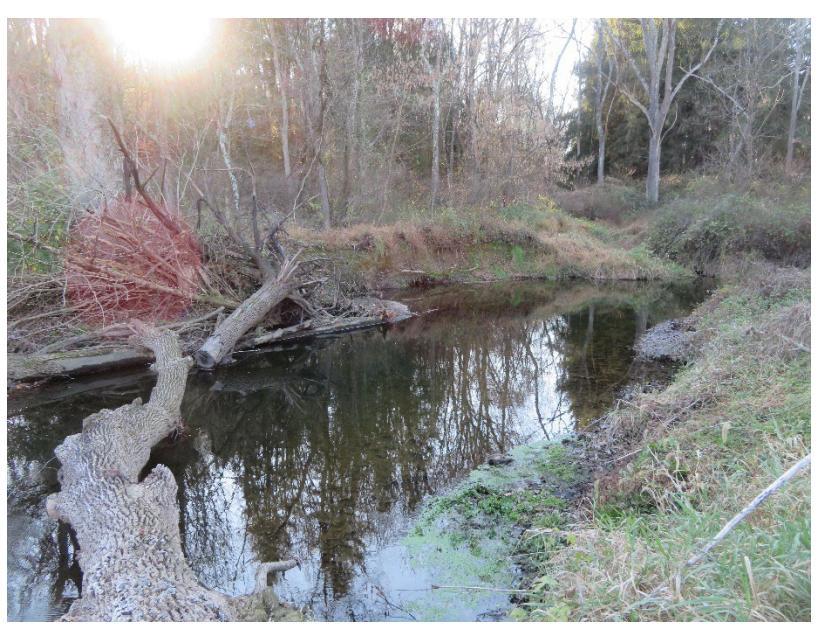
Within this stream segment, erosion has impacted both banks of the stream. From point 21 to point 22, approximately 50% of the reach has actively eroded legacy sediment on the 3 to 6 feet high streambanks. In addition to the problem of erosion, invasive species including Japanese hops (Humulus *japonicus*), reed canary grass (Phalaris arundinacea), and tree of heaven (Ailanthus altissima) dominate the riparian zone.

Conservation practices in this area should focus on streambank stabilization and

removal of invasive species. Floodplain reconnection would improve water quality and native habitat along the stream. Native trees and shrubs should be planted to aid in the replacement of some of the dying ash trees. Downstream of this segment, the riparian buffer is forested, and the streambanks are stable.

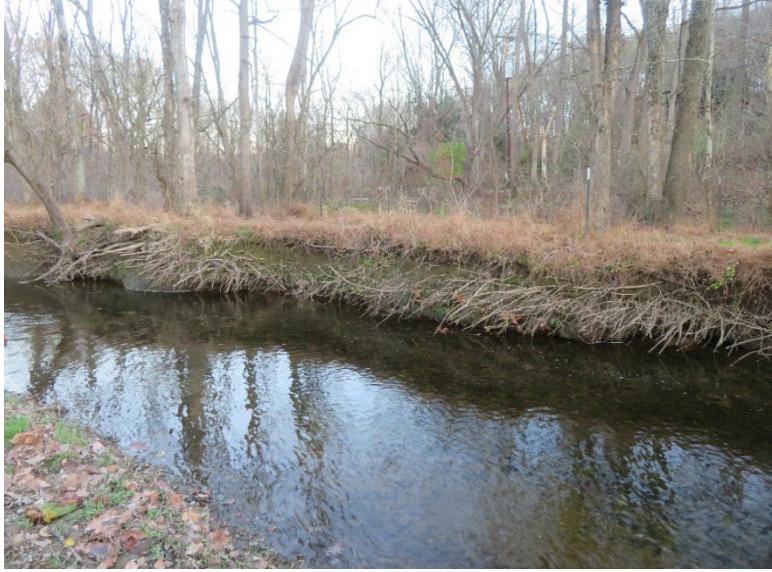
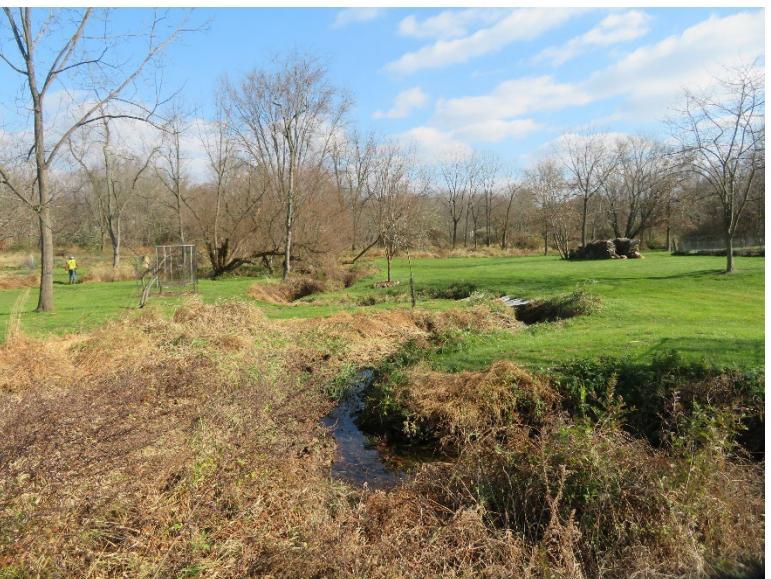
Within this stream segment, the streambanks are actively eroding and are approximately 4 feet high. The stream segment is disconnected from the floodplain. The combination of streambank erosion and floodplain disconnection is likely to have negatively impacted the water quality of the stream.

The topography and hydrology of this stream segment lend themselves to the creation of wetlands to filter pollutants, absorb flood waters, and create habitat within wildlife the riparian Minor zone. streambank grading would allow for native plantings to stabilize the steam channel. After the stream channel is restored and wetlands are created. the

riparian zone could be planted with native trees and shrubs to aid in improving water quality and habitat creation. Invasive species should be targeted for removal as the restoration project becomes established.

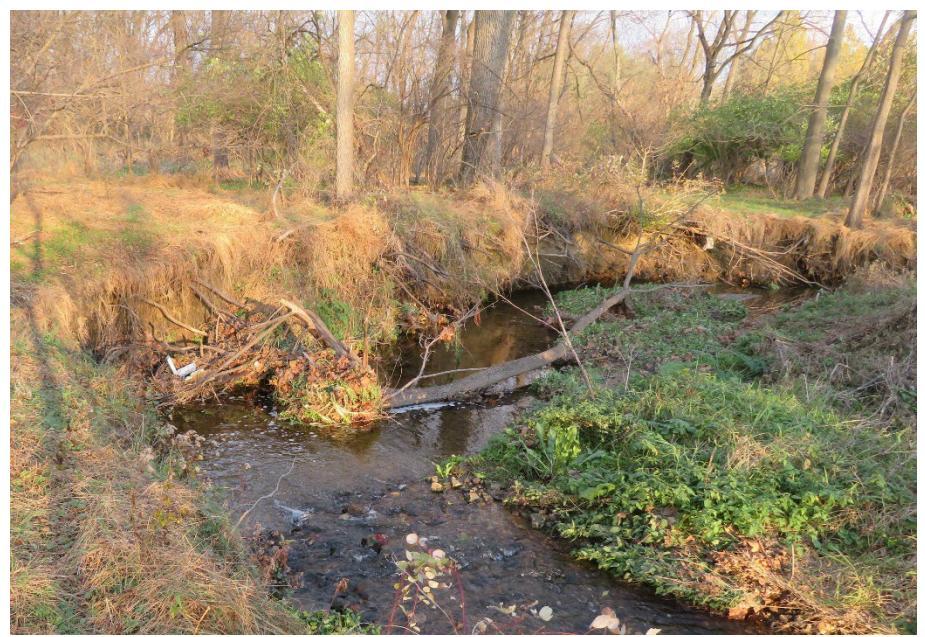
Impacted Stream Segment #81-83:

The streambanks along this stream section are between 3 and 4 feet high and are undergoing active erosion. The stream channel is incised and disconnected from an active floodplain. A portion of the stream segment is mowed to the top of the streambanks. In the un-mowed areas, the riparian zone is dominated by invasive Japanese hops (*Humulus japonicus*).
