**Restoration Plan
for
Little Buck Run Watershed
Chester County, Pennsylvania
August 2008**

RETTEW Associates, Inc.
Natural Sciences Group
950 East Main Street, Suite 220
Schuylkill Haven, PA 17972
(570) 385-2270
(570) 385-2217 fax
RETTEW Project No. 07-07568-003

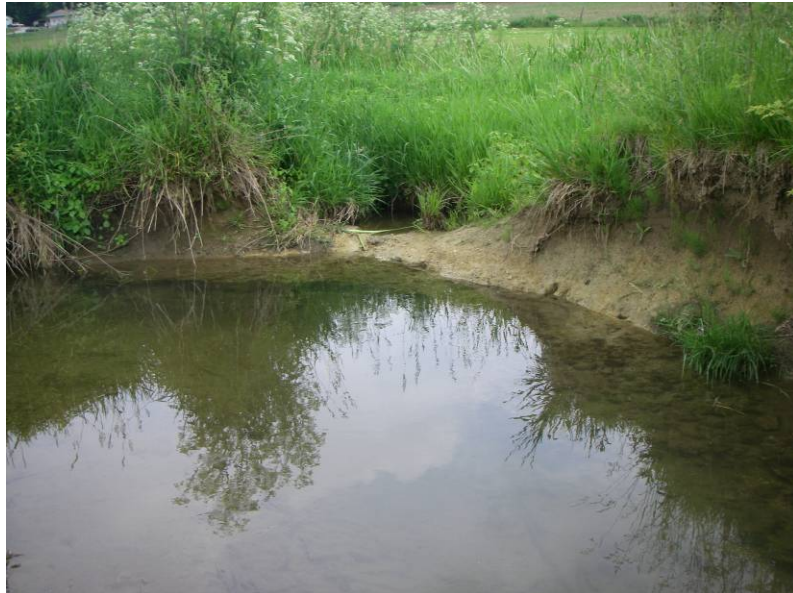
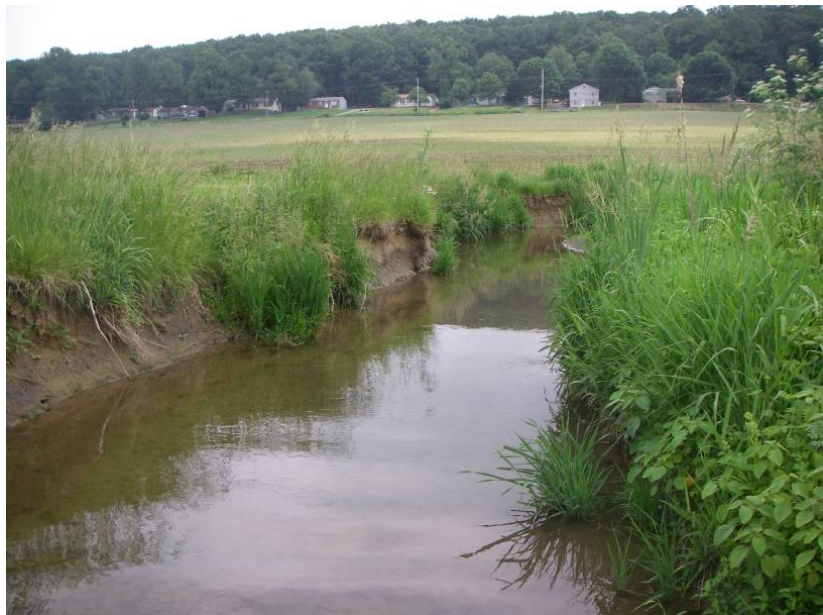
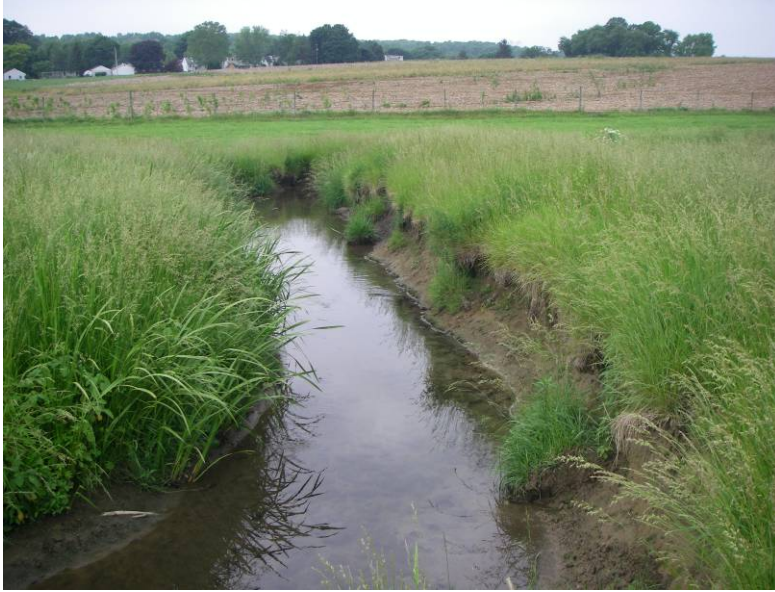
Impacted Stream Segment #9-13:

From points 9 through 13, approximately 40 percent of the streambank is eroded and is incised approximately 3-4 feet deep. The south side of the stream is in hay within 5-15 feet of the stream. The north side of the stream has an emergent wetland/meadow buffer that extends approximately 50 feet from the stream. The buffer is bordered by active agricultural fields. The irregular meander bends and unstable stream banks are indicative of a stream that is transitioning in form. Upstream of point 13, the streambanks are stable, but the stream appears unnaturally straightened, downstream of point 14, the streambanks are unstable and the meander wavelength appears very short and irregular.

This unstable stream reach is an excellent candidate for stream restoration with an applied fluvial geomorphology (natural stream design) approach. The restoration project will likely include creating a new stable stream channel. The stable channel should be re-connected to a floodplain that is planted with native trees and shrubs. When implemented, this project will likely have defined, measurable water quality benefits including decreased sediment and nutrient loading and temperature reduction as well as habitat benefits for fish and other aquatic organisms.

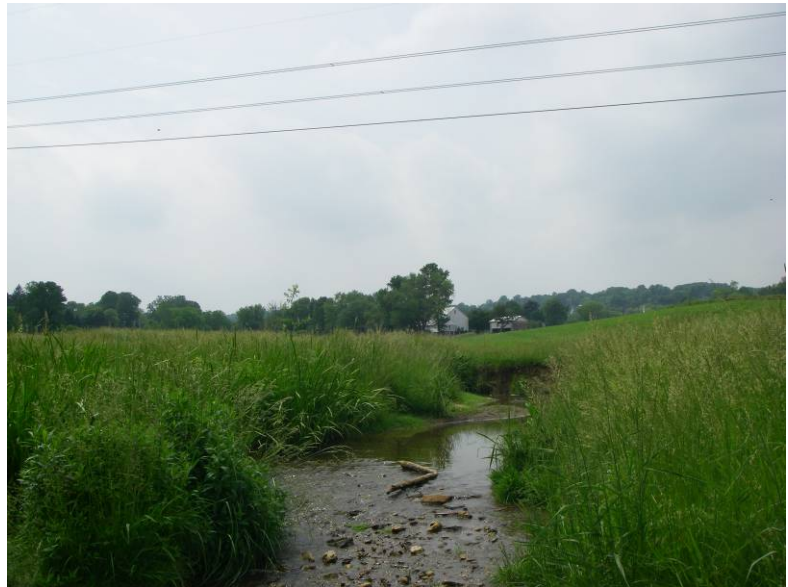
Impacted Stream Segment #15-17:

The streambanks from points 15 through 17 are highly unstable and are 3-6 feet high and severely eroded. The stream bottom is comprised of fine sediment. This area is the most impaired in the watershed (RETTEW 2008). The project area is in a pasture that was not being grazed. An unnamed tributary enters this reach from the southwest and suffers similar degradation as the mainstem from where it crosses under SR-10 to its confluence with Little Buck Run.

The restoration of this section of stream will include applying fluvial geomorphological concepts to design a stable stream reach. The design will likely include the use of instream structures for interim stabilization and then a combination of trees, shrubs, and herbaceous vegetation to provide long-term stability. While some existing wetlands will potentially increase the rigor of the permitting process, most of the area immediately adjacent to the existing stream is upland. One strategy that should be considered is incorporating floodplain wetlands into the design to help mitigate the effects of stormwater and other pollutants discharged from the borough. If this area is to remain in pasture, streambank fencing, forested riparian buffer, and stone cattle crossings should be incorporated into the design.

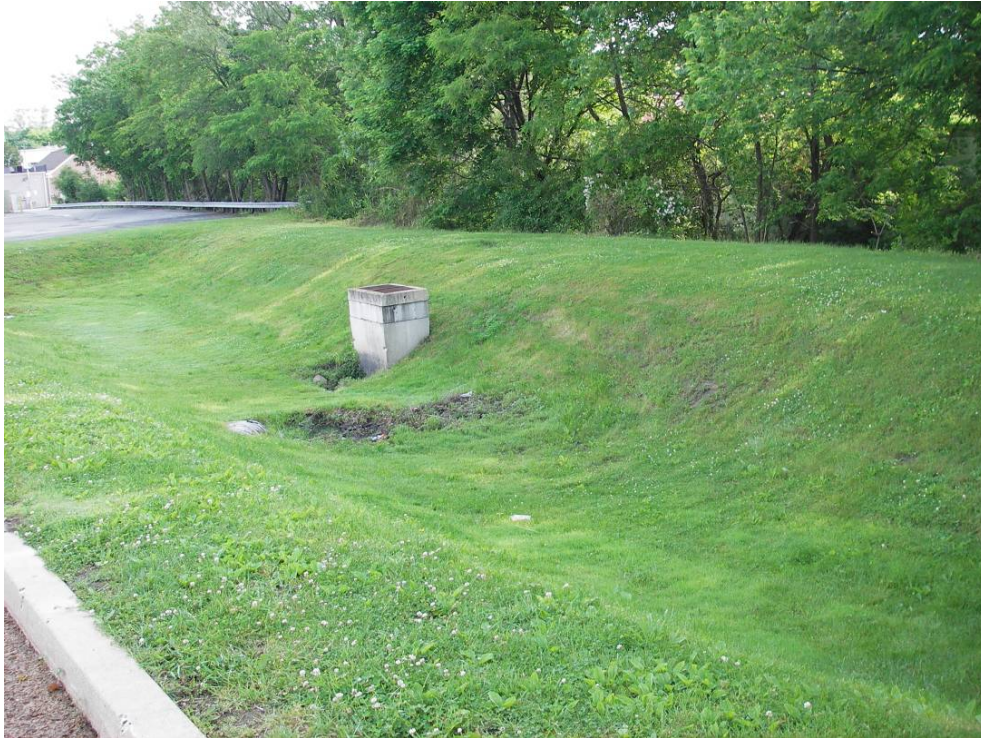
Impacted Stream Segment #19:

Parkesburg Borough has a very nice small-town atmosphere that experienced little change over the last fifty plus years. With that, the stormwater management infrastructure lacks many of the volume and rate controls that are now standard with land development. Little Buck Run receives most of the stormwater runoff and corresponding pollutants that discharge from the borough.

Urban stormwater management retrofits that consider volume, rate, and water quality should be included with any work that drains into Little Buck Run (including areas that drain via the storm sewer system). Educational programs in this community should focus on reducing the discharge of stormwater to Little Buck Run. A park reforestation project that includes community volunteers to expand the riparian corridor through the borough park and rewards each participating volunteer with a rainbarrel would be a good first step. The event could include an informative table presentation where information on construction of small raingardens and use of rainbarrels and stormwater cisterns is provided. Other stormwater retrofit best management practices that have been shown to be effective include extended detention ponds, wet ponds, constructed wetlands, bioretention areas, filtering practices, infiltration practices (including drywells, infiltration trenches, permeable pavers, etc.), vegetated swales, green roofs, and stormwater planters.

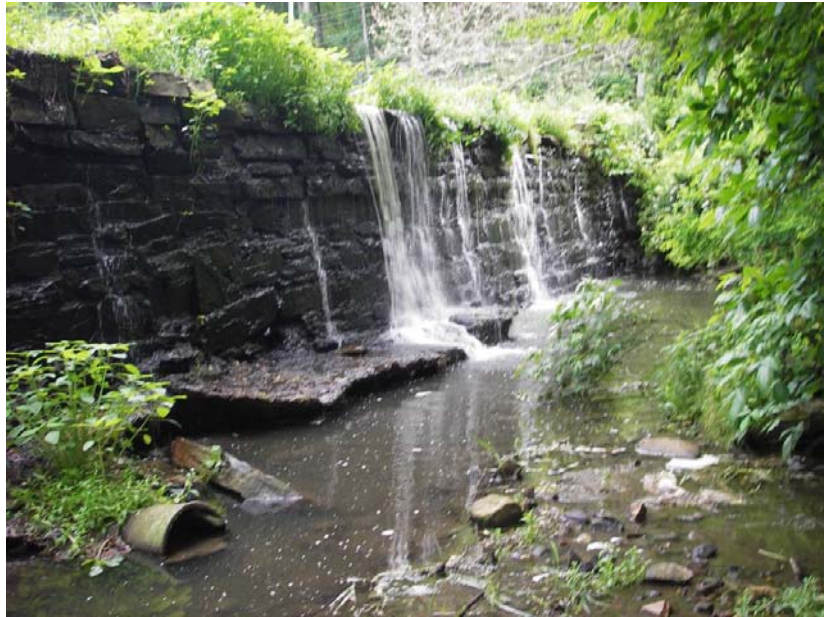
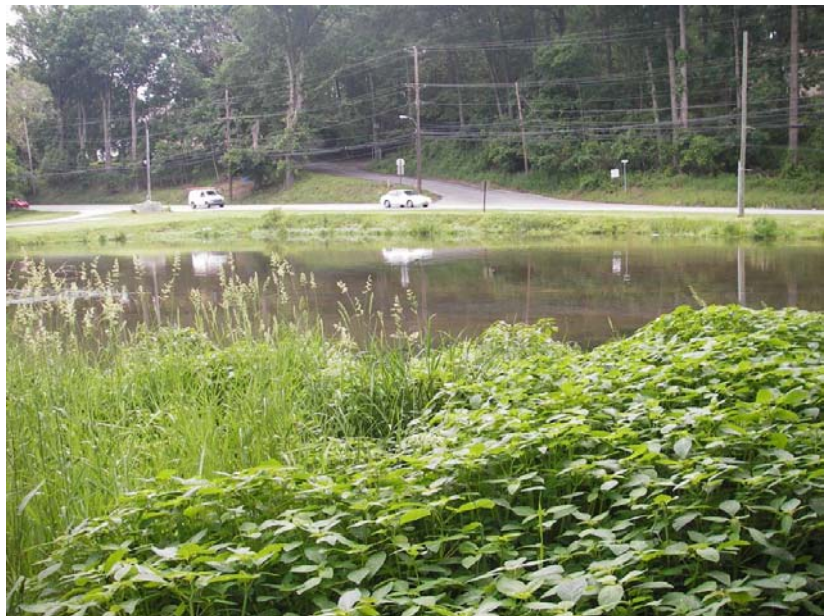
Impacted Stream Segment #35:

The dam at this location is the largest on-line dam in the Little Buck Run Watershed. The dam currently is full of sediment and appears less than 2' deep at the deepest point. The shallow depth and lack of shading likely allow the water in the dam pool to increase in temperature. The upstream nutrient discharges likely contribute to excessive algal growth (in a process called eutrophication) in the dam pool. Anoxic conditions (reduced dissolved oxygen) typically result from algal population crashes and sometimes result in severe impacts to fish populations. The dam also blocks upstream fish migration.

The best solution for this dam and improvement of water quality in the Little Buck Run Watershed would be its removal to allow for fish passage and reduce the potential for increasing the stream water temperature. A removal design that includes a floodplain with wetlands connected to the stream could help to mitigate the effects of upstream nutrient additions. The use of native trees and shrubs in the design to shade the stream should also be included. As per Parkesburg Borough representatives, the dam is currently being considered for removal.

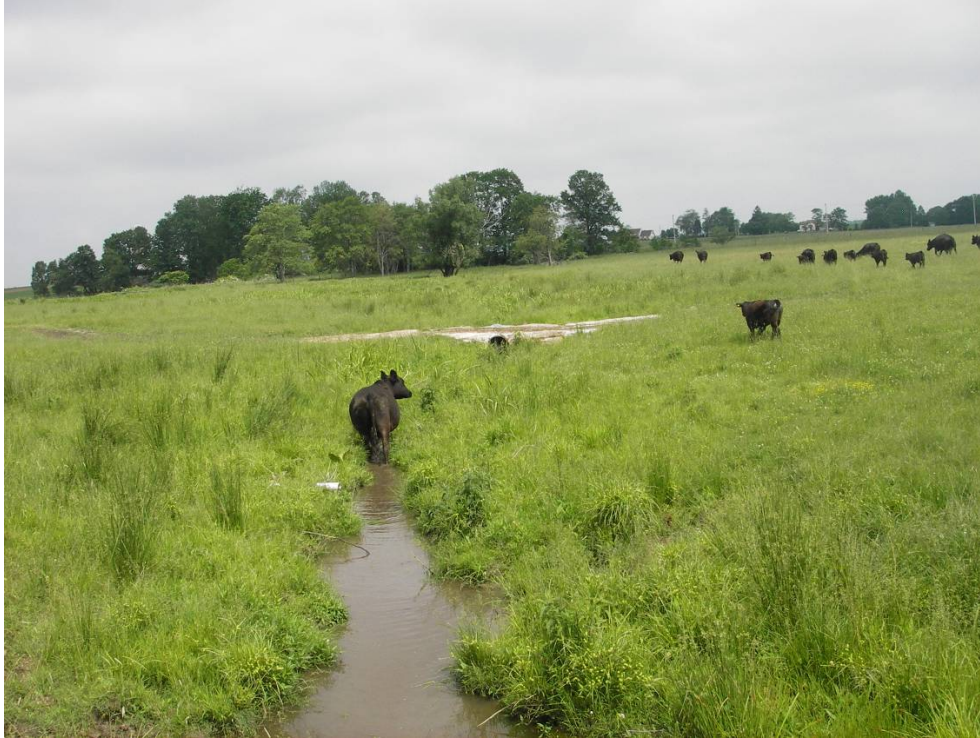
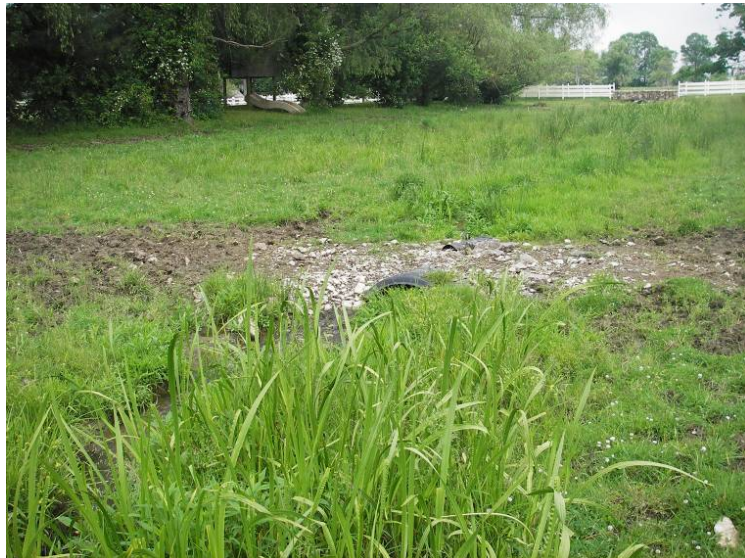
Impacted Stream Segment #39-Headwaters:

The headwaters of Little Buck Run consists of several unnamed tributaries that drain through several dairy/beef farms that have pasture around the stream. Cattle have unrestricted access to the stream and likely contribute to nutrient pollution throughout the watershed.

While some efforts have been made at a headwaters farm to install agricultural best management practices such as agricultural stream crossings (rather than fords) and a manure storage tank, more remains to be done. Of critical importance to restoring the stream is the installation of streambank fencing and cattle crossings in pasturelands. The fenced-in area should include riparian tree and shrub plantings to help shade the stream. While work immediately adjacent to the stream is often viewed as most critical, the upland areas that drain to the stream should not be overlooked. The NRCS and county conservation district should be contacted to ensure that up-to-date conservation plans are being implemented by farmers in the headwaters (and throughout the watershed).

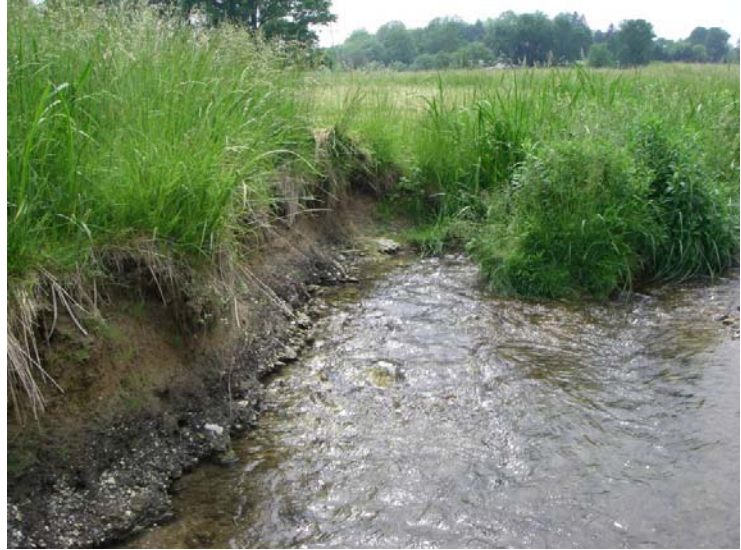
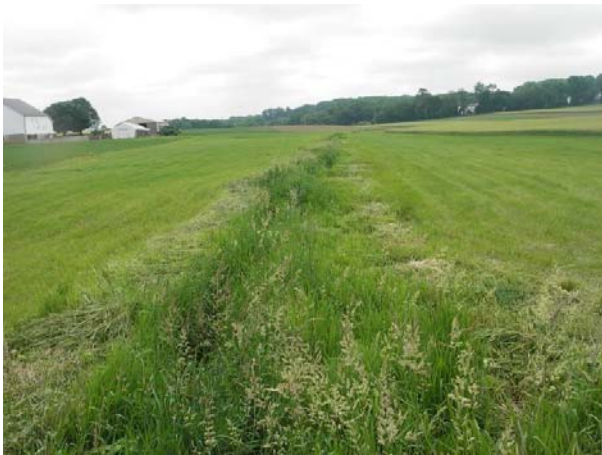
Impacted Stream Segment #14-15:

The southern streambank in this section is eroding and includes a 2 to 3 feet high eroded bank. Some areas of the bank have been undermined and have fallen into the stream via mass wasting. The vegetation is mowed to within five feet of the streambank.

Stream restoration using traditional bank re-grading, fluvial geomorphology techniques, and riparian buffer enhancement.

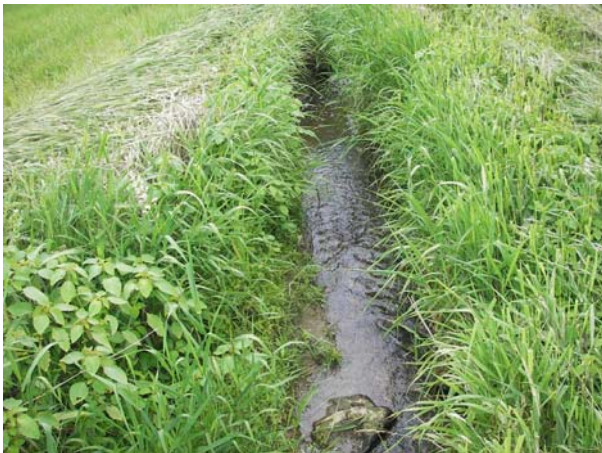
Impacted Stream Segment #36-38:

The stream channel through this section appears to have been straightened and altered through agricultural operations. The stream is incised approximately 3 feet deep and is disconnected from its floodplain, but most of the streambank is stable with thick vegetation. The fields on both sides of this stream segment are in hay and are mowed within several feet of the stream.

The primary focus of restoration in this area should be on riparian buffer enhancement. The NRCS and conservation district should be contacted to ensure up-to-date conservation plans are being implemented. The fields immediately adjacent to the stream should be considered for a project similar to those of the CREP program. While floodplain reconnection would be ideal, the minimal impervious area of the headwaters, typically low flows of the channel and stable streambanks make floodplain reconnection in this area less of a priority than in other areas of the watershed.

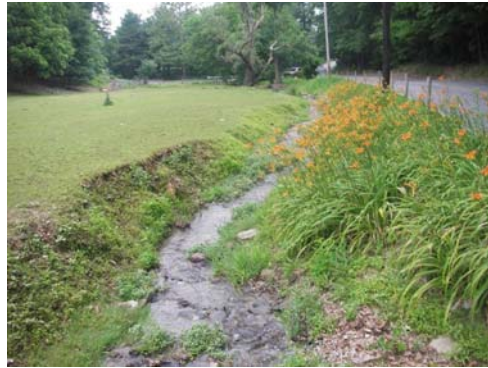
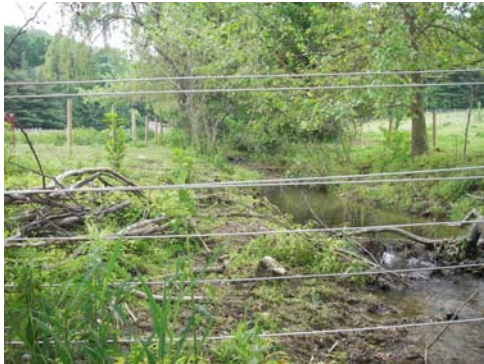
Impacted Stream Segment #42-46:

The majority of this stream segment has minimal to no buffer from surrounding encroachments. The upper section of the segment includes mowed lawn to the streambank. The lower section includes an area where sheep and horses have direct access to the stream. Fill in the floodway for roadways and several bridges over the stream has resulted in several areas with eroded streambanks. However, the areas of erosion are not severe and are infrequent.

The installation of streambank fencing to keep the sheep and horses out of the stream would be a benefit. This section would be a great candidate for installation of a riparian buffer that incorporates native tree and shrub plantings. Landowner education will be key in developing the buffer and ensuring it is appropriately managed to minimize the colonization of the area by invasive species.

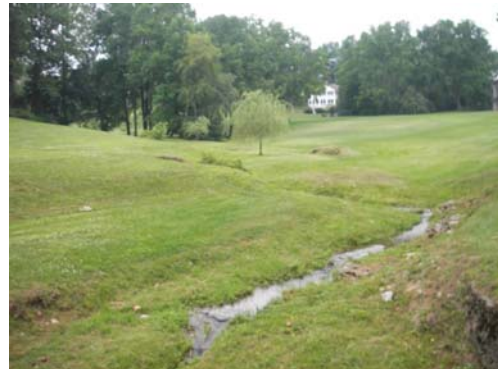
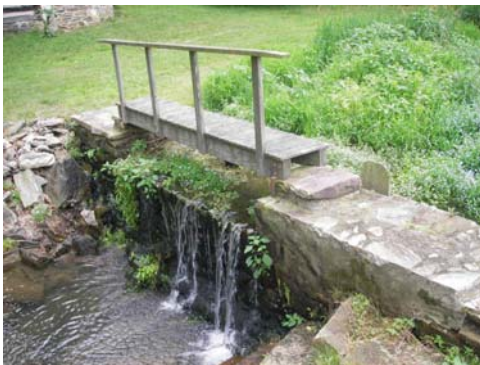
Impacted Stream Segment #48-50:

A lack of riparian buffer in this area exposes the stream to warming by the sun. A buffer could also filter runoff with potential pollutants from the lawn areas that the stream flows through. A small area of erosion exists near point 48, the remainder of the reach has mowed lawn to the ordinary high water mark. A small on-line dam also blocks fish passage into the headwaters area.

Riparian buffer enhancements including native tree and shrub plantings to shade the stream and create a more diverse terrestrial wildlife habitat would be a great benefit. A removal of the small dam would open the tributary up to fish passage and should encourage small fish to move into the headwaters of the unnamed tributary.

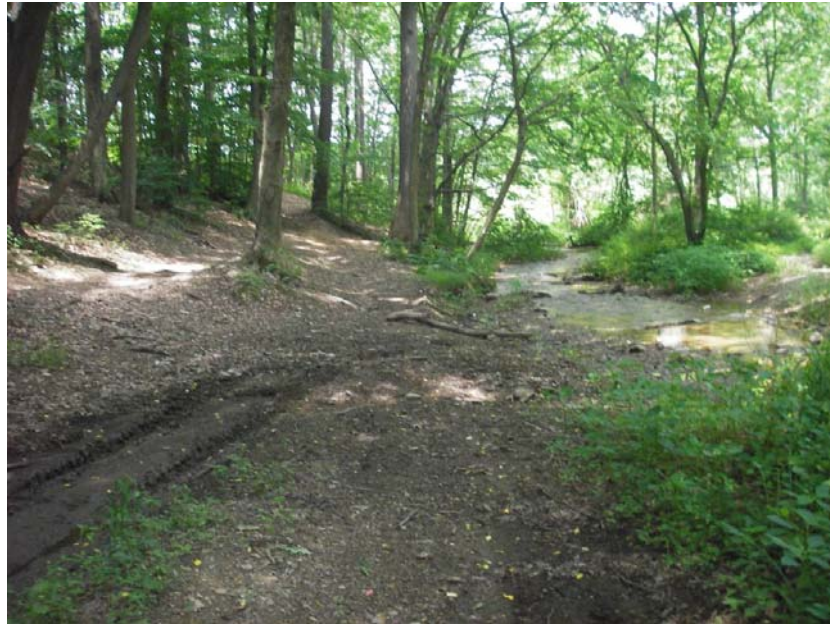
Impacted Stream Segment #56:

This stream reach flows through mature forest. The forest includes SR-10. Some impacts from the highway drainage are possible. This area includes several All-Terrain Vehicle (ATV) trails and stream crossings. The trails leading to the stream cut across the sloping hill above the stream and collect runoff. The runoff is eroding the trails and is contributing to sediment discharging to the tributary.

Install waterbars/trail improvements to dissipate water that collects in the trails leading to the point of the crossing. Upgrade crossings so that they are perpendicular to the stream and have level, natural rock approaches.
