# Lower West Branch Red Clay Creek Watershed Restoration Plan

New Garden Township, Kennett Square Borough, and Kennett Township  
Chester County, Red Clay Watershed, Pennsylvania

August 4, 2023

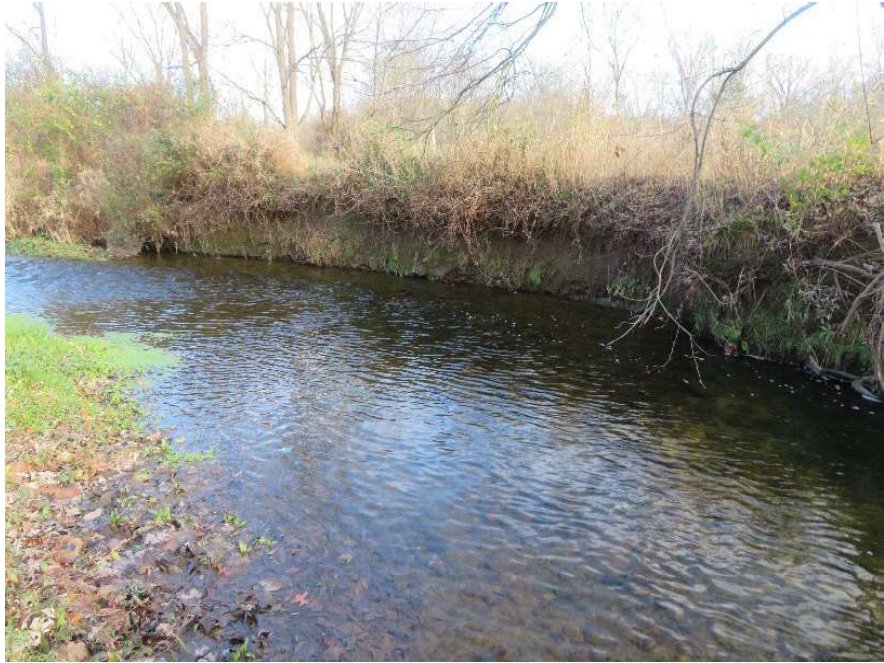
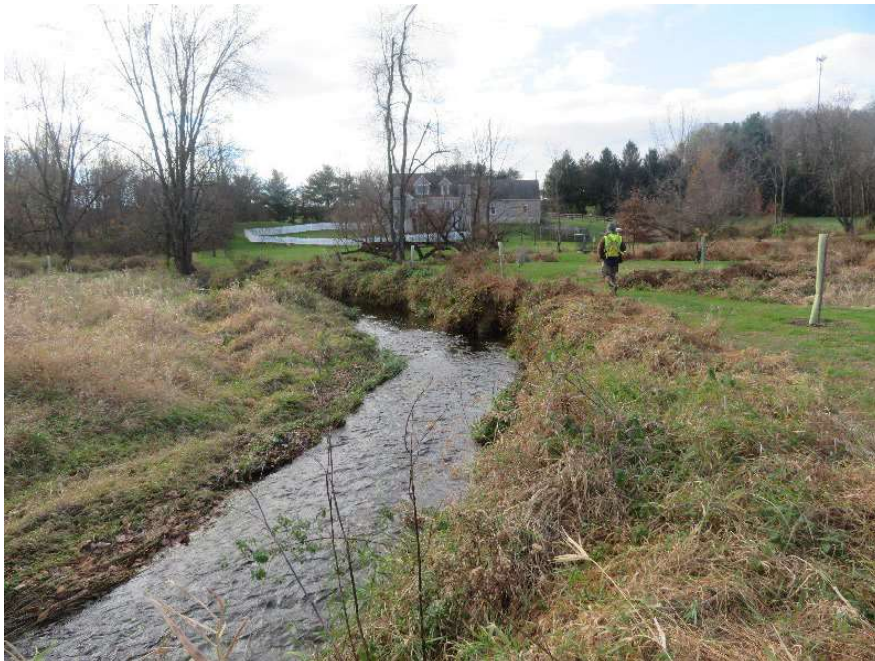
Along this stretch of stream, substantial legacy sediment has built up since colonial times and has disconnected the floodplain. The streambanks are undercut and actively eroding in over 60 percent of this stream section. The eroding streambanks average 4 feet high. Throughout this stretch of stream, portions of the riparian zone are mowed to the top of the streambanks.

This stream section requires a holistic approach to restoration. The most effective way to restore this section of the stream would likely include reconnecting the floodplain through the removal of legacy sediment to create an active floodplain bench. Within the created

active floodplain, pockets of wetlands could be created to aid in retaining flooding flows and filtering pollutants. Grading the streambanks to a stable slope would minimize additional erosion and allow for native vegetation to be planted to help secure the streambanks. Instream structures such as log vanes and root wads should be installed to create fish habitat and reduce near-bank friction during

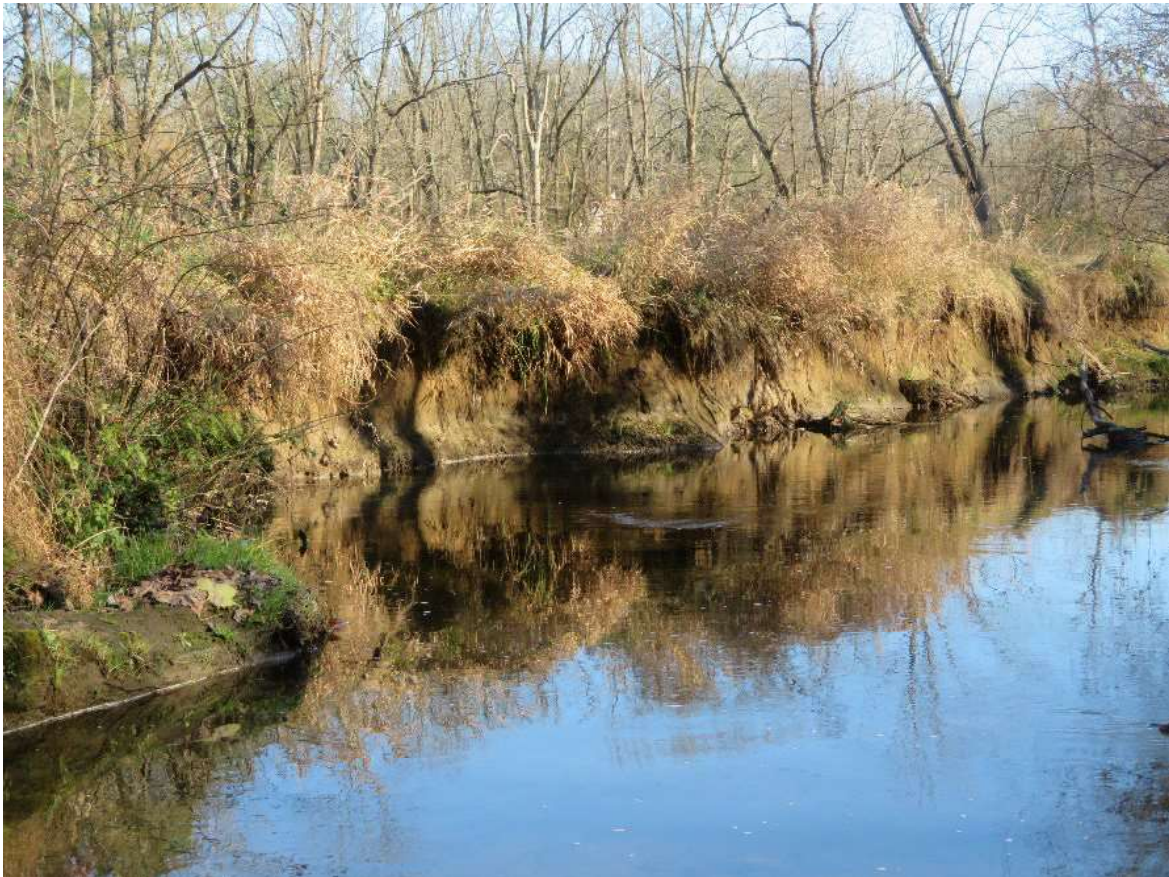
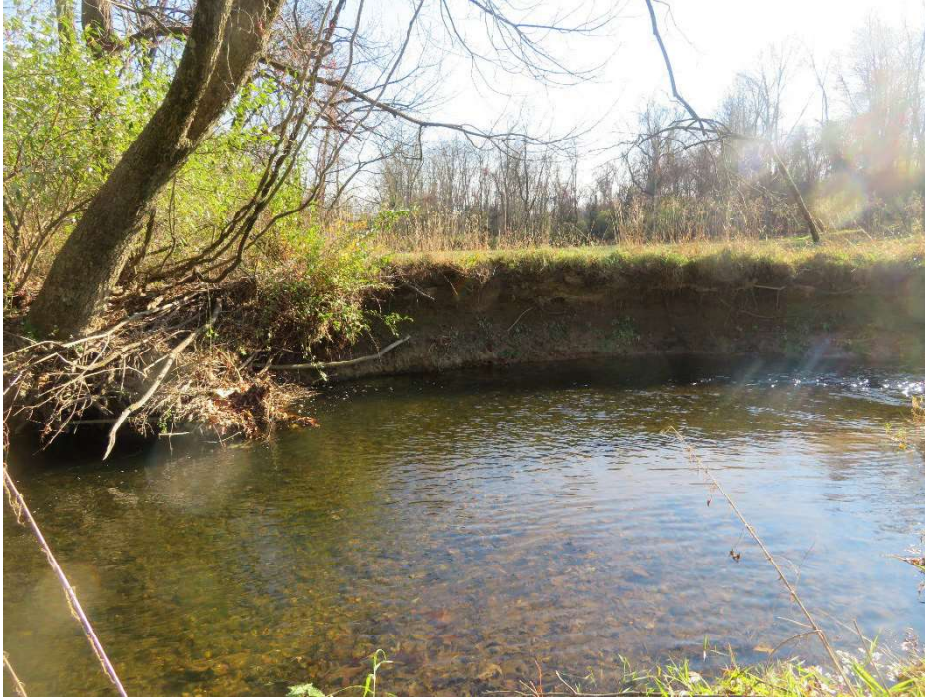
### **Impacted Stream Segment #26-27:**

The streambanks in this segment are approximately 4 feet high and actively eroding. The active erosion is contributing sediment to the stream system that degrades the aquatic habitat and water quality on the site and downstream. The riparian buffer is minimal along this section of the stream and limits the available habitat within the stream corridor. This segment of the stream has been the site of previous buffer plantings. Despite these plantings, the area is currently dominated by invasive Japanese hops (*Humulus japonicus*).

The area along this section of stream is well suited for wetland creation. The creation of wetlands in addition to floodplain reconnection would help to mitigate future flooding and protect the stream channel from future erosion. The invasive Japanese hops (*Humulus japonicus*) should be removed and replaced with native vegetation including the expansion of the riparian buffer. The proposed multi-use trail system upgrades in the watershed will include work within the riparian zone of this stream section and surrounding areas. Kennett Trails Alliance should be actively involved with coordination related to the restoration of this area so the stream and riparian improvements complement the proposed work on the trail system.

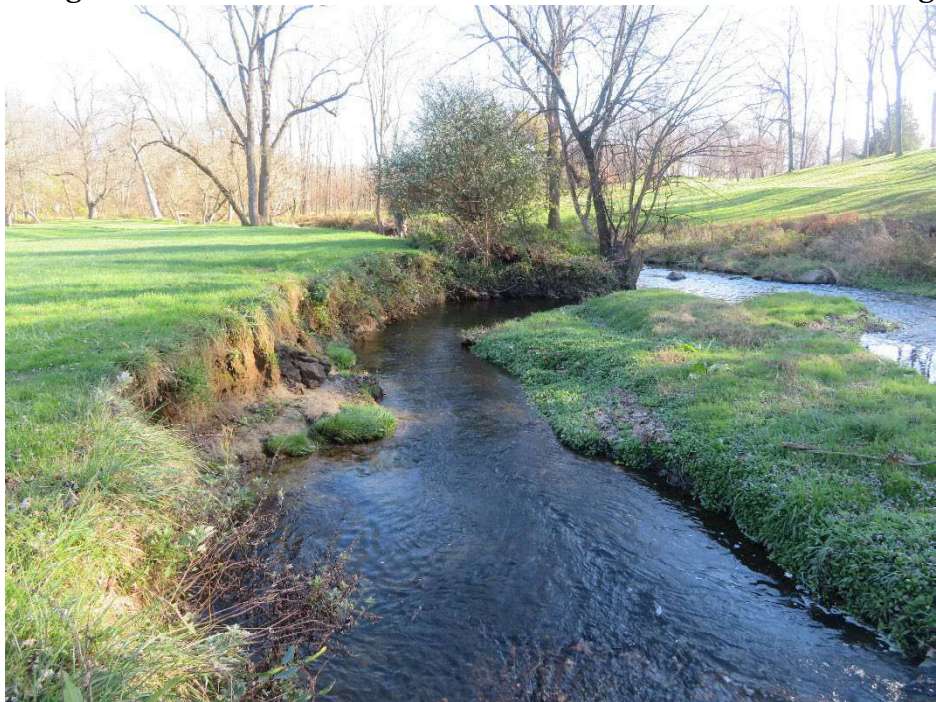
Restoration of this stream section should focus on reconnecting the active floodplain to the stream channel. The streambanks should be graded to a stable slope of 4:1 or flatter and planted with native vegetation. The use of instream structures such as rock and log structures will improve fish habitat and protect the restored streambanks as the vegetation becomes established. The installation of floodplain wetlands should be evaluated. Enhancement of the riparian buffer should be accomplished through the elimination of mowing and planting native tree and shrub species.

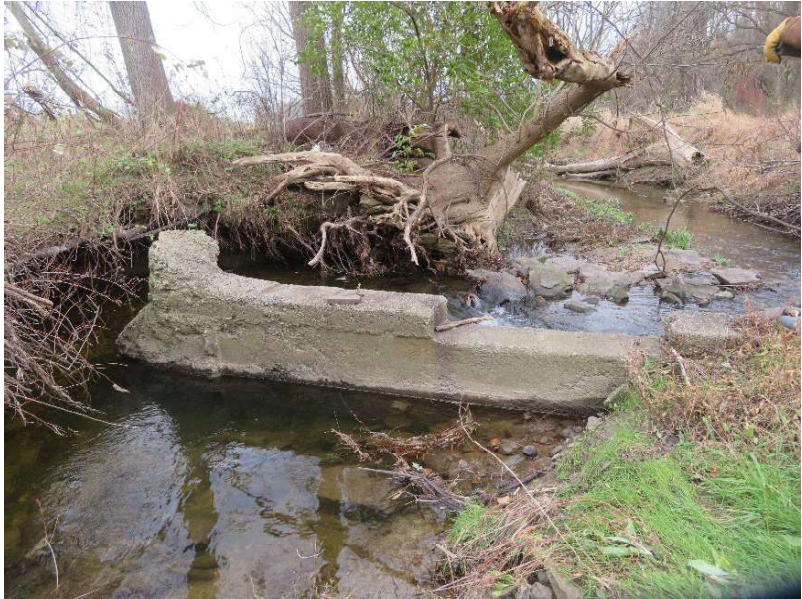
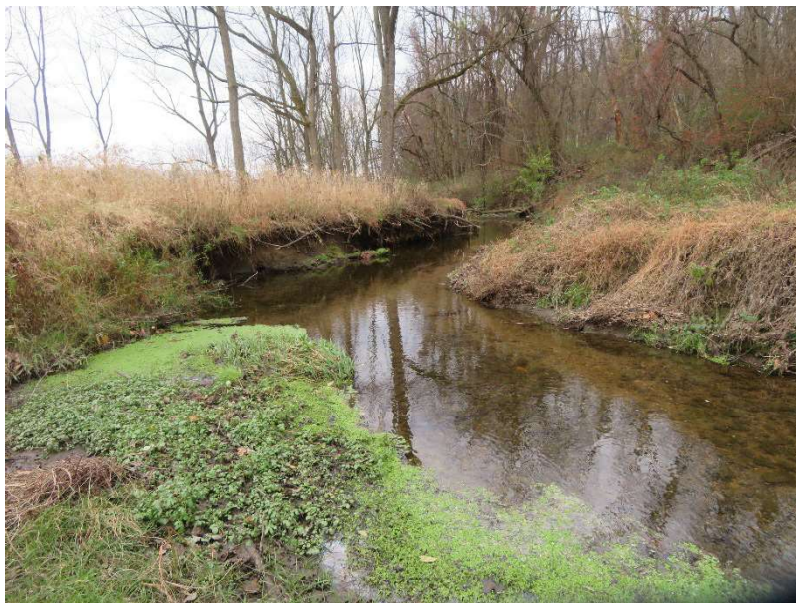
### **Impacted Stream Segment #71-76:**

The upstream portion of this segment begins at the Thompson Street crossing. The area contains substantial amounts of legacy sediment that is being impacted by stormwater from the upslope commercial and residential developments. The stream channel is incised with streambanks that are 3 to 5 feet high and actively eroding. The eroding streambanks discharge nutrients and sediment to the stream channel that impacts water quality on the site and downstream. At point 73, a breached dam blocks the flow of the stream through the channel and is exacerbating the erosion of the streambanks in that area. Though there has been a riparian buffer planting in the downstream area of the segment, invasive species are prevalent and have overtaken most of the planted trees. Restoration of this area should address a lack of floodplain connection and the dominance of invasive species including Japanese hops (*Humulus japonicus*) and reed canary grass (*Phalaris arundinacea*).

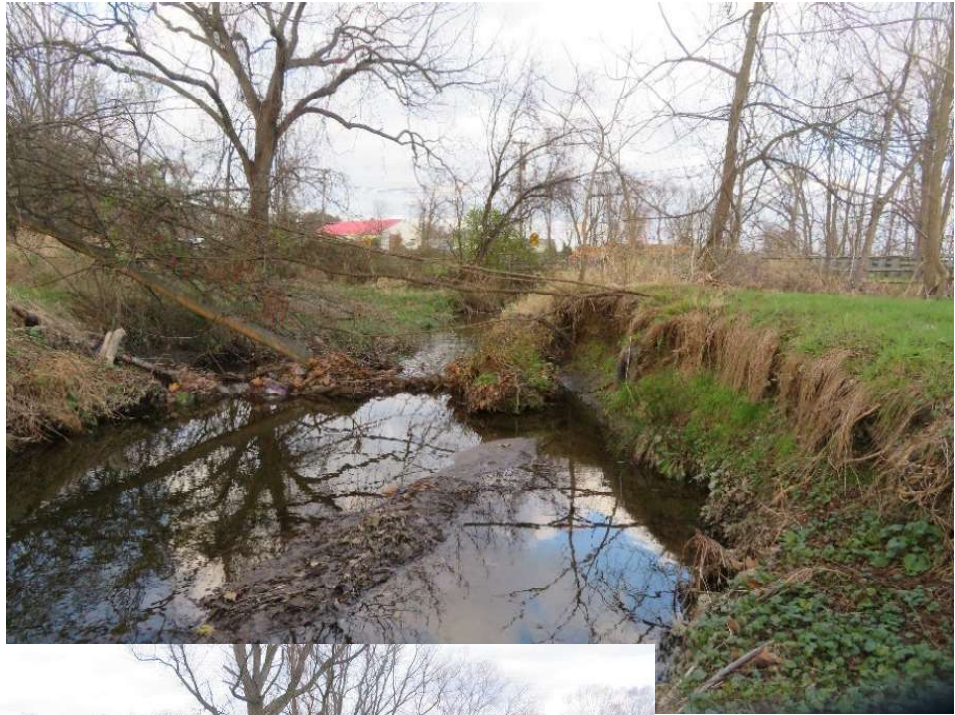
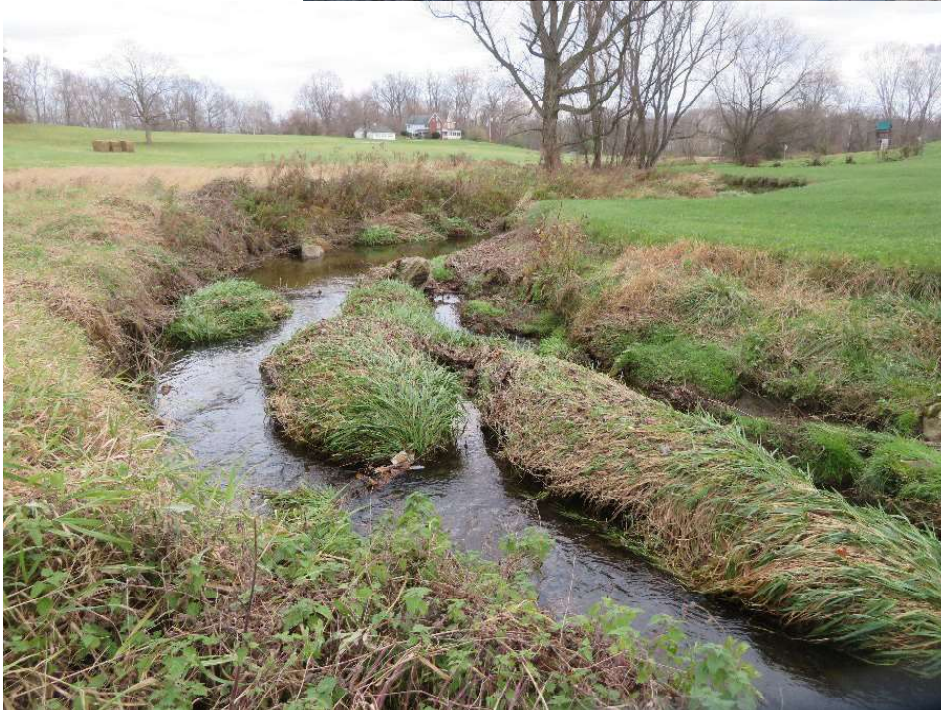
The streambanks are 3 to 4 feet high and are actively eroding throughout this segment of the stream. In some areas of the segment, the riparian zone is mowed to the top of the streambank. Along this section of the stream, the floodplain is disconnected and invasive Japanese hops (*Humulus japonicus*) and reed canary grass (*Phalaris arundinacea*) dominate the riparian zone and have outcompeted and killed many of the native trees that were planted in this area.

maintenance plan in place to limit the impacts of the invasive species that currently dominate the riparian zone. With a restored floodplain and stream channel, floodwaters from the upslope developed areas may be dissipated and absorbed. From a water quality standpoint, the newly created floodplain that has a vegetated slope to the stream channel would allow sediment and contaminants a place to settle out where they can be broken down by the sun and ecological processes.

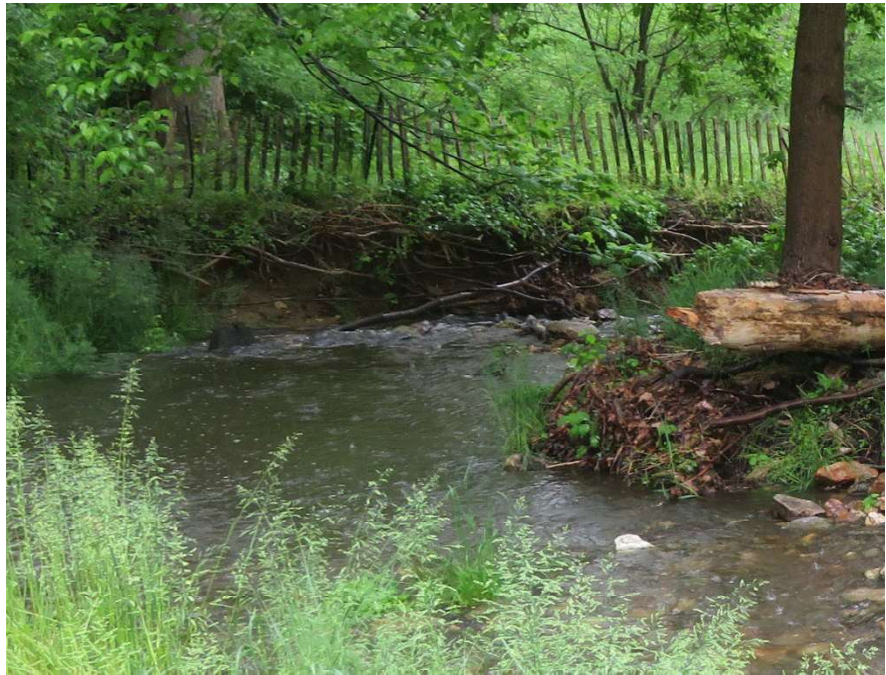
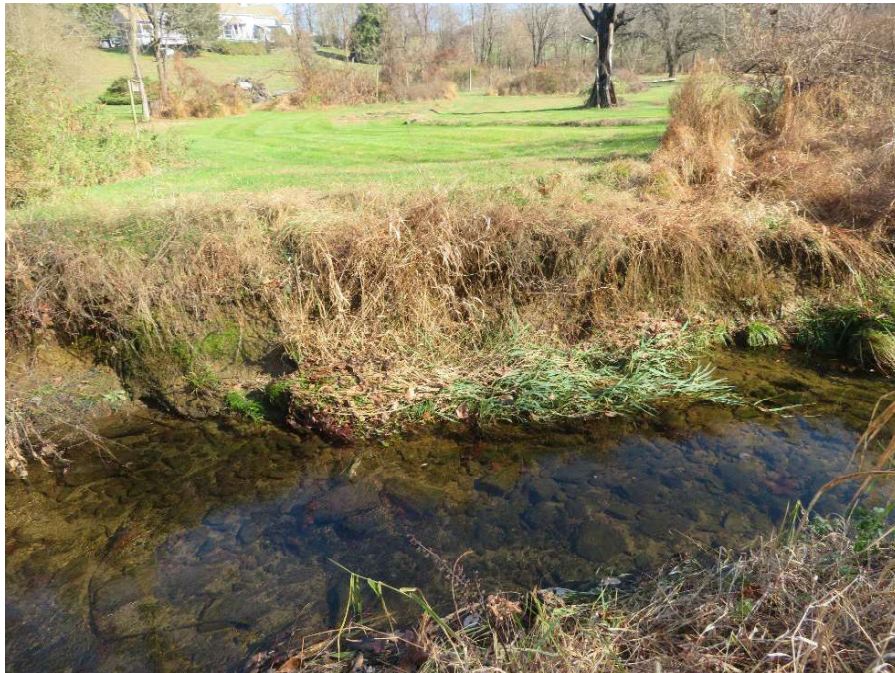
This segment consists of the portion of Bucktoe Creek that flows through White Feather Farm as well as the downstream portion of Agnew Run. Within this section of the stream, the streambanks are actively eroding and are currently 3-4' high. In a portion of the site, a lawn is mowed to the top of the streambank. The riparian zone includes trails for farm visitors to walk along the stream.

The design and permitting of the restoration of this section of the stream is already completed, and a portion of the construction funding has been secured. A grant for the balance of the construction funds is under review. Throughout this section of the stream, streambank stabilization, riparian buffer enhancement, and removal of invasive species

are planned. The streambank stabilization will incorporate native plantings and instream structures that were designed with a natural stream design approach. The completion of this project should be leveraged as a matching project for future restoration work in other sections of the watershed.

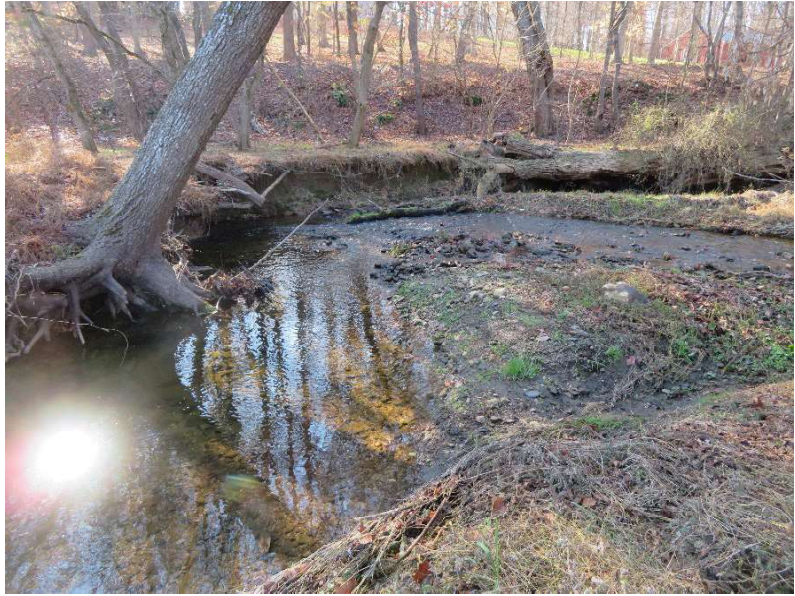
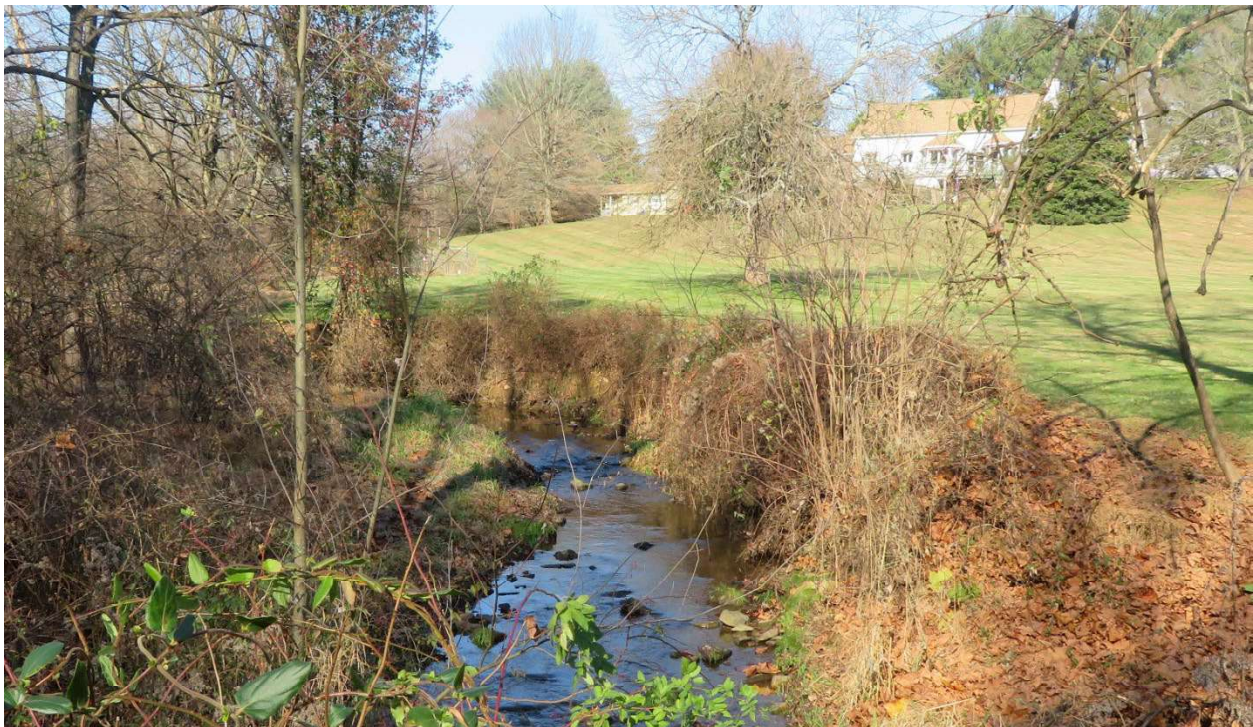
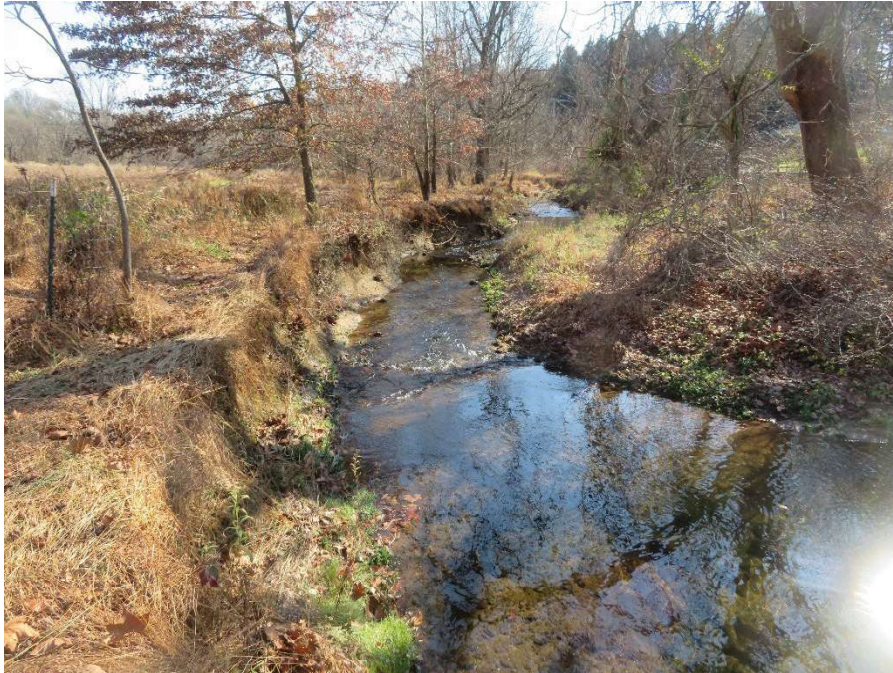
### **Impacted Stream Segment #106-107:**

Throughout 50% of this reach, the streambanks are actively eroding legacy sediment and are approximately 3-4' high. The floodplain is disconnected. There are only patches of riparian buffer throughout the stream segment, and all other areas are mowed. The streambank erosion is progressing in the direction of sewer manholes just upstream of the Sharp Road stream crossing.

A combination of streambank stabilization and reconnection of the floodplain is necessary for the restoration of this stream segment. As the floodplain is excavated, wetland pockets should be installed to aid in filtering contaminants, retaining floodwaters, and recharging the groundwater. Streambank stabilization work should include natural stream design techniques to install instream structures for fish habitat and bank protection during the establishment of native plantings. The native plantings should include native grasses and forbs, live stakes from the water's edge to the top of the streambank as well as trees and shrubs throughout the riparian zone to improve the stream buffer.

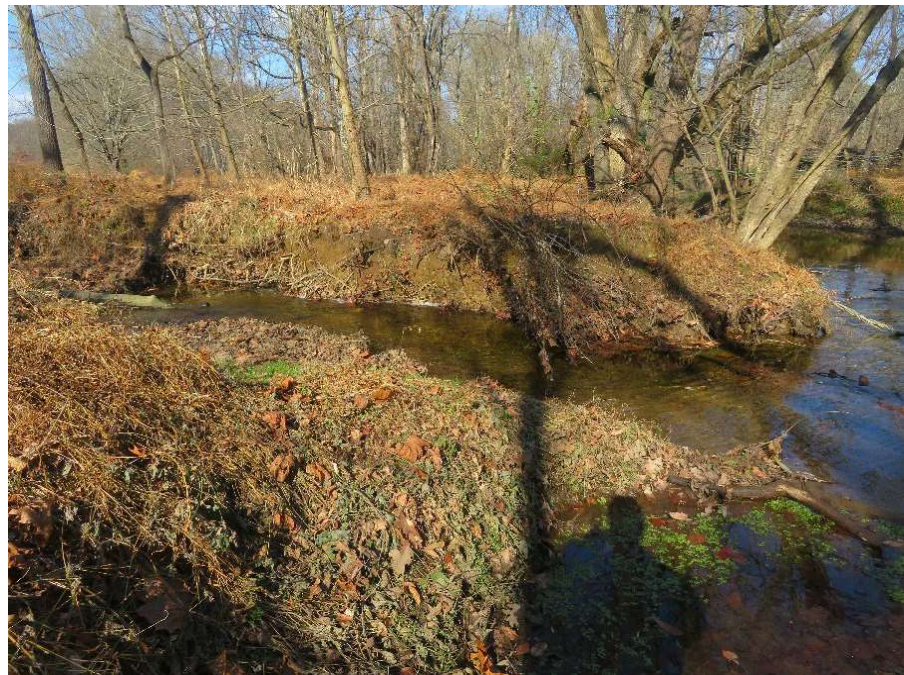
### **Impacted Stream Segment #110-112:**

Throughout this stream section, the 3 to 4 feet high streambanks are actively eroding. The stream channel is disconnected from the floodplain by sediment that settled in this lower gradient area during the backwater flooding conditions created when Bucktoe Creek enters The Lower West Branch Red Clay Creek during flooding conditions.

This stream segment is a high priority due to the potential for floodplain wetland creation on land that is already being used for conservation. Restoration of the area should include creating multiple wetland cells that provide wildlife habitat, improve water quality, help recharge the groundwater, and aid in absorbing flooding flows. Work along the stream channel should focus on connecting the stream to the newly created wetland cells, expanding the floodplain capacity, and grading actively eroding streambanks to a stable slope. The wetland cells, floodplain grading areas, and restored streambanks should be planted with native vegetation and maintained to limit the establishment of invasive species. Instream structures such as log vanes and root wads should be thoughtfully installed where they will improve fish habitat and aid in stabilizing streambanks during vegetation establishment.

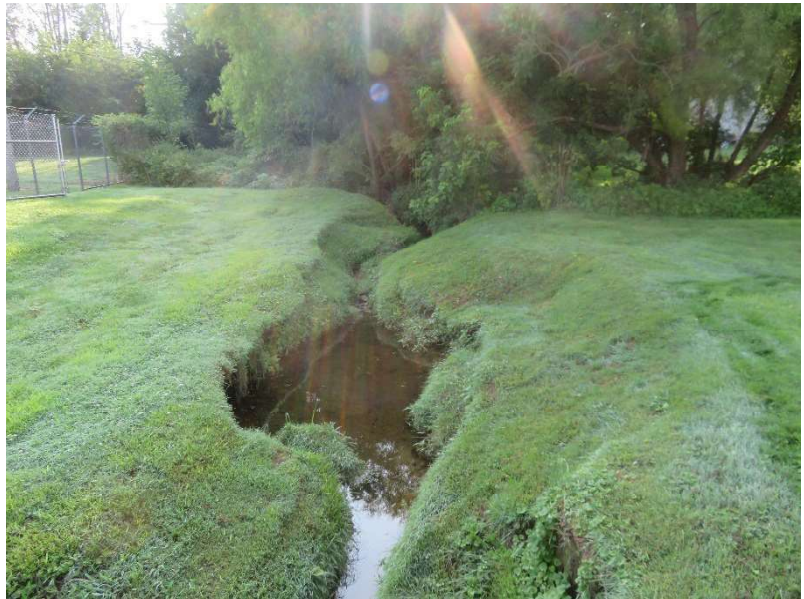
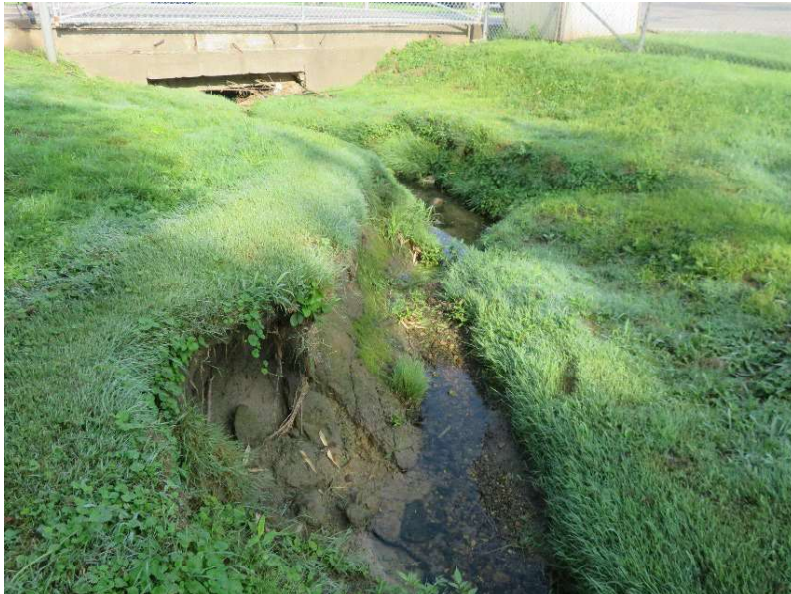
### **Impacted Stream Segment #134-135:**

This stream section includes a small unnamed tributary that flows through the South Mill Champs mushroom farm. The tributary receives substantial stormwater discharges from the farm's rooftops and paved areas as well as the Borough of Kennett Square upstream of this stream section. Any work to address stormwater in this tributary should be considered part of this high priority project. Within the stream segment, several potentially undersized stream crossings restrict the flow of water within the channel and likely contribute to the flooding of the mushroom farm facilities during large storm events. The flooding has caused substantial damage and is a concern for downstream water quality as well as the local economy. The stream channel is mowed to the stream edge. Additionally, a swale that is dominated by invasive species discharges stormwater to the stream from the south.

Restoration of this stream section should begin with an assessment of the existing stream crossings on the site. Where feasible, the stream crossings should be upgraded to reduce the role they play in flooding the site. In the headwaters and on the site, stormwater should be managed to decrease the rate and volume of flow to the tributary. On the South Mill Champs Site, a constructed stormwater basin with water quality features should be installed and additional stormwater retrofit projects should be evaluated. Along the

stream channel, grading to create floodplain capacity and stable, vegetated streambanks should be completed. The riparian zone should then be planted with native vegetation. Within the stormwater swale that discharges to the stream from the south, a regenerative stormwater conveyance installation that retains and filters stormwater through a compost/ sand bed between constructed riffle areas should be installed.

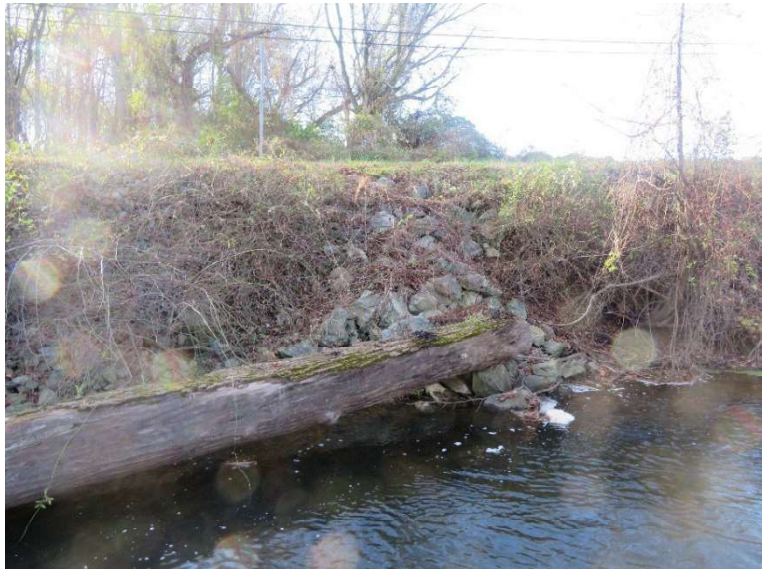
In this section of the stream, the banks are actively eroding and are 4-10 feet high. Although evidence of past dumped riprap remains along the base of Pemberton Road, the roadway base is actively eroding. The riparian zone along this stretch of stream is dominated by invasive Japanese hops (*Humulus japonicus*), reed canary grass (*Phalaris arundinacea*), and multiflora rose (*Rosa multiflora*).

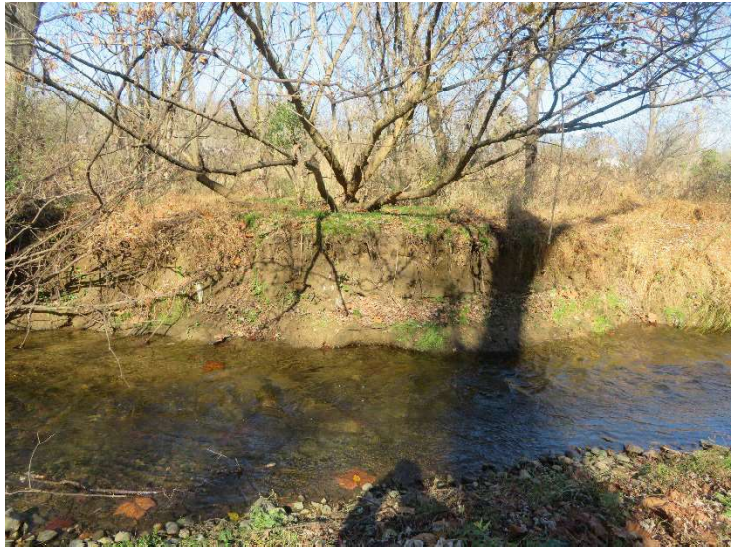
Within this stream segment, erosion has impacted both banks of the stream. From point 21 to point 22, approximately 50% of the reach has actively eroded legacy sediment on the 3 to 6 feet high streambanks. In addition to the problem of erosion, invasive species including Japanese hops (*Humulus japonicus*), reed canary grass (*Phalaris arundinacea*), and tree of heaven (*Ailanthus altissima*) dominate the riparian zone.

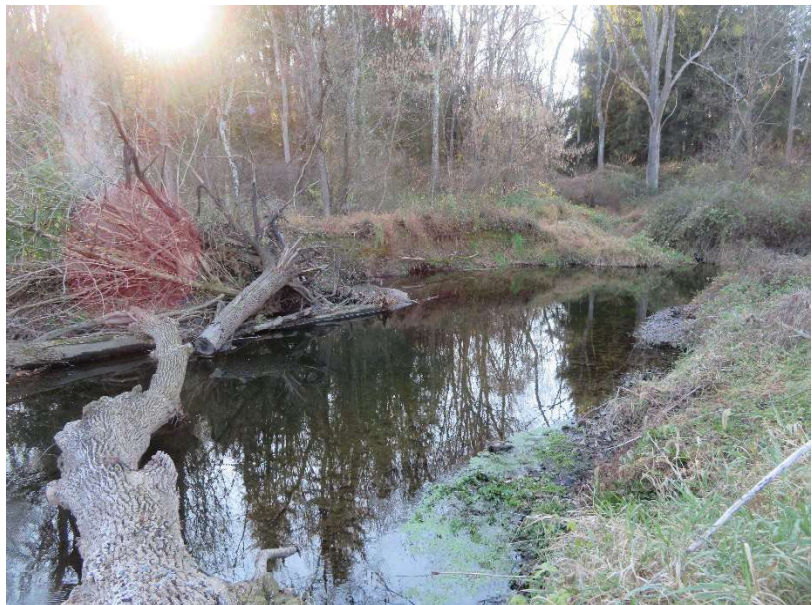
The riparian buffer along this segment of the stream is forested with many dead ash (*Fraxinus* sp.) trees. Ash trees throughout Pennsylvania have been killed in mass by the invasive emerald ash borer (*Agrilus planipennis*). The area is currently dominated by invasive Japanese hops (*Humulus japonicus*) and multiflora rose (*Rosa multiflora*). In the upstream portion of this segment, the streambanks are eroded 3 to 4 feet high. In the downstream portion, the streambanks are eroded 4 to 8 feet high in some areas.

Conservation practices in this area should focus on streambank stabilization and removal of invasive species. Floodplain reconnection would improve water quality and native habitat along the stream. Native trees and shrubs should be planted to aid in the replacement of some of the dying ash trees. Downstream of this segment, the riparian buffer is forested, and the streambanks are stable.

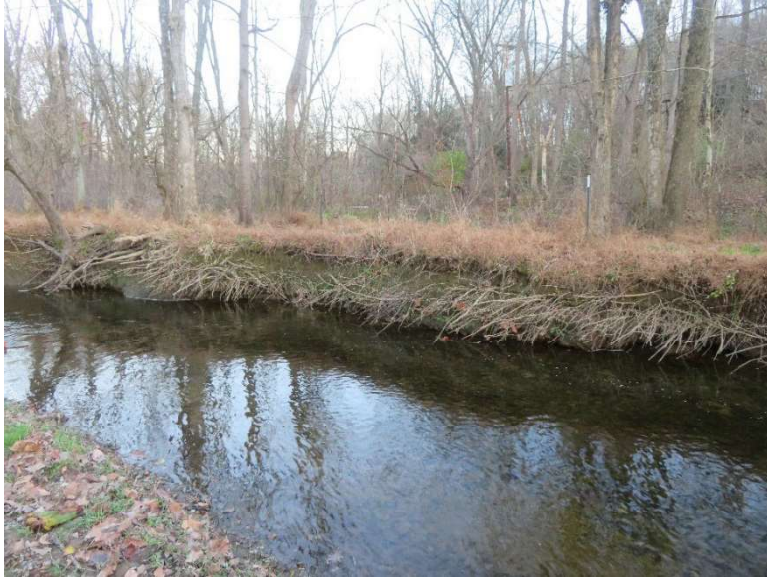
Within this stream segment, the streambanks are actively eroding and are approximately 4 feet high. The stream segment is disconnected from the floodplain. The combination of streambank erosion and floodplain disconnection is likely to have negatively impacted the water quality of the stream.

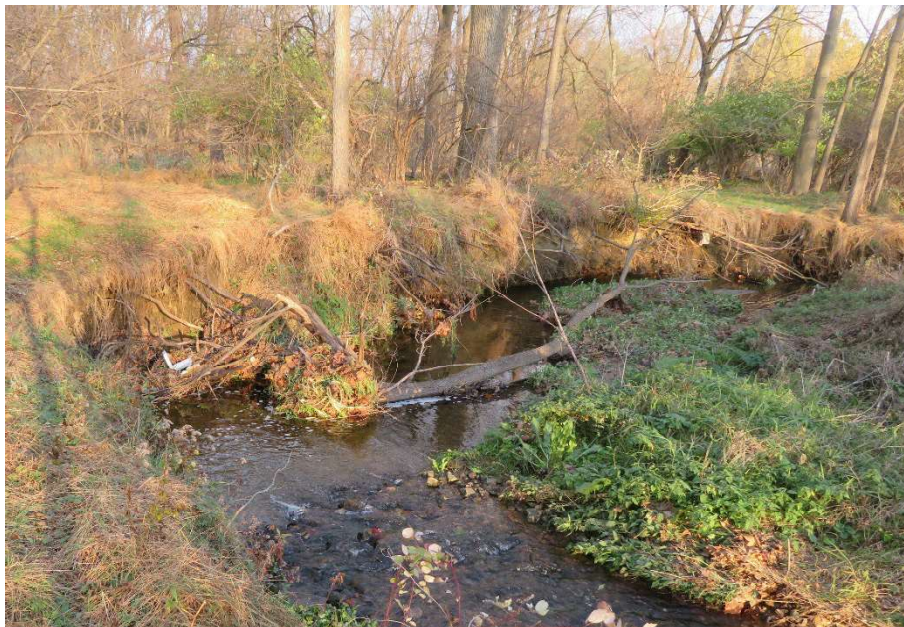
### **Impacted Stream Segment #81-83:**

The streambanks along this stream section are between 3 and 4 feet high and are undergoing active erosion. The stream channel is incised and disconnected from an active floodplain. A portion of the stream segment is mowed to the top of the streambanks. In the un-mowed areas, the riparian zone is dominated by invasive Japanese hops (*Humulus japonicus*).
