Upper East Branch Red Clay Creek Watershed Restoration Plan

East Marlborough and Kennett Townships
Chester County, Pennsylvania

November 2010

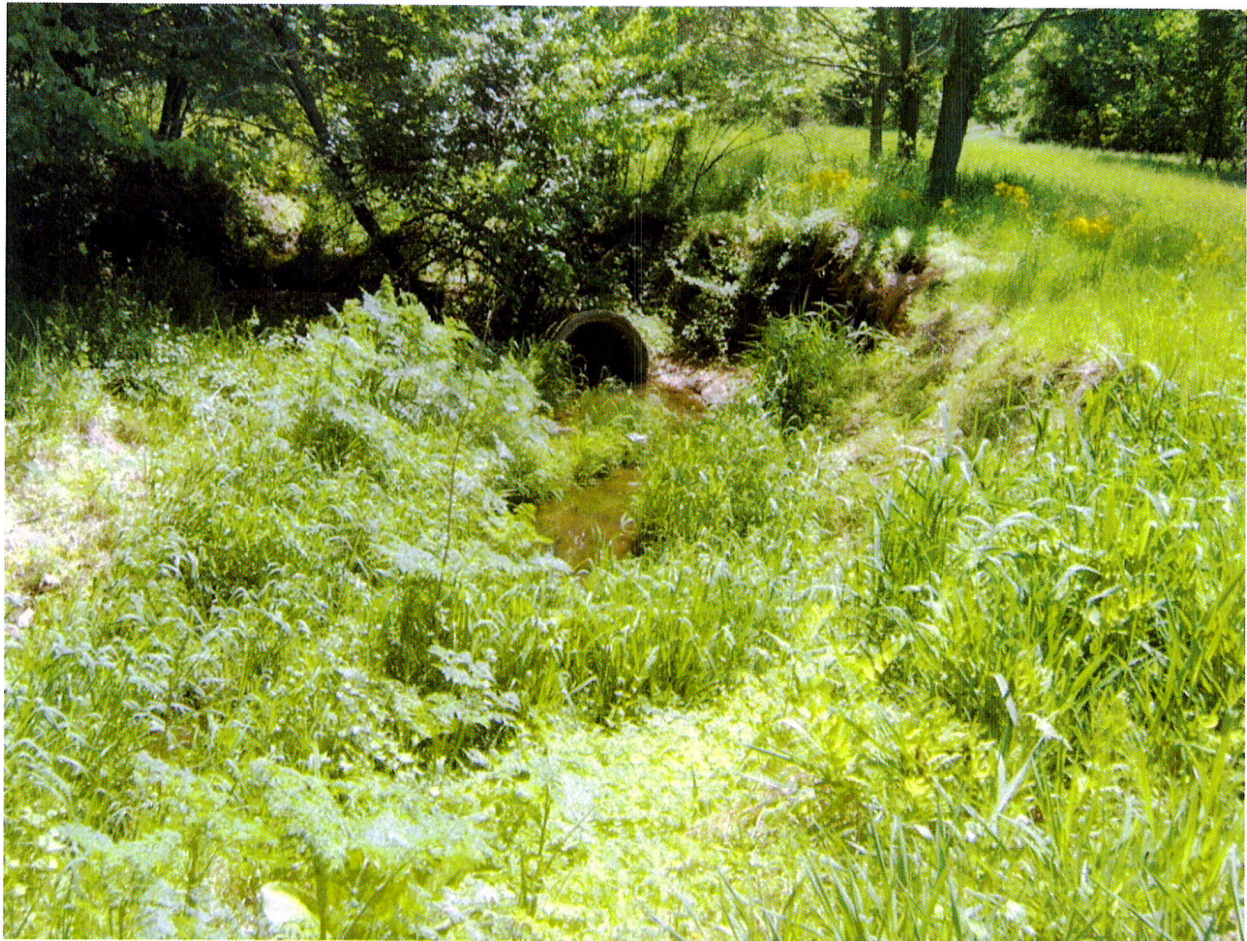
Impacted Stream Segment #1-3:

This stream segment is located in the headwaters of the mainstem of the Upper East Branch Red Clay Creek. Stormwater inputs and past agricultural sedimentation have contributed to a stream channel that is incised approximately 3 to 4 feet. The streambanks are eroding, but in some areas are healed over with herbaceous vegetation.

While streambank stabilization could provide a quick fix in this location, restoration of this area should include reconnecting the stream with its floodplain and installing a forested riparian buffer to the west of the stream. Reconnection of the floodplain in this area should help to reduce the impacts of stormwater within the forested area down slope. As the area immediately adjacent to the stream is currently open space, it may be possible to place soil removed from the floodplain on-site.

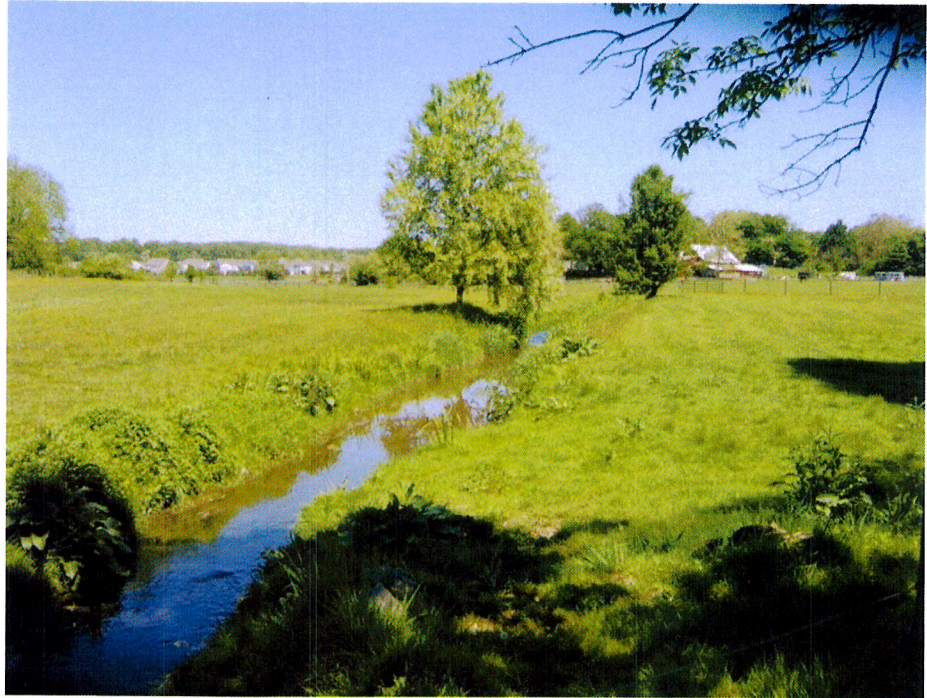
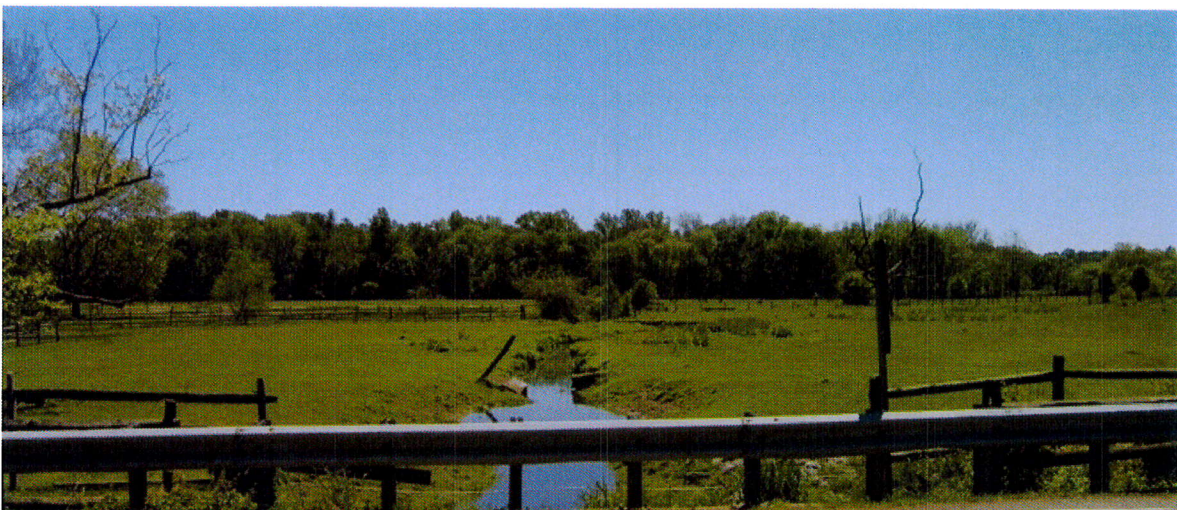
Impacted Stream Segment #8-9:

Within this stream segment, livestock have direct access to the stream. While the streambanks are stable, the stream is exposed to direct sunlight throughout most of this section. The combination of nutrient inputs from livestock within and adjacent to the stream and full sun exposure likely contributes to algal blooms.

Corresponding algal population crashes contribute to the impaired nature of stream assesment site 4 (Clauser and Clauser 2010).

Restoration of this area should primarily focus on getting the livestock out of the stream. Limiting livestock access to the stream will decrease nutrient inputs, sediment discharges, and pathogen levels within the stream. A combination of streambank fencing, stabilized stream crossing areas, and upland watering structures will be required to improve the water quality throughout this reach. Within the fenced buffer areas, native trees and shrubs should be planted to aid in shading the stream and mitigating water temperature fluctuations.

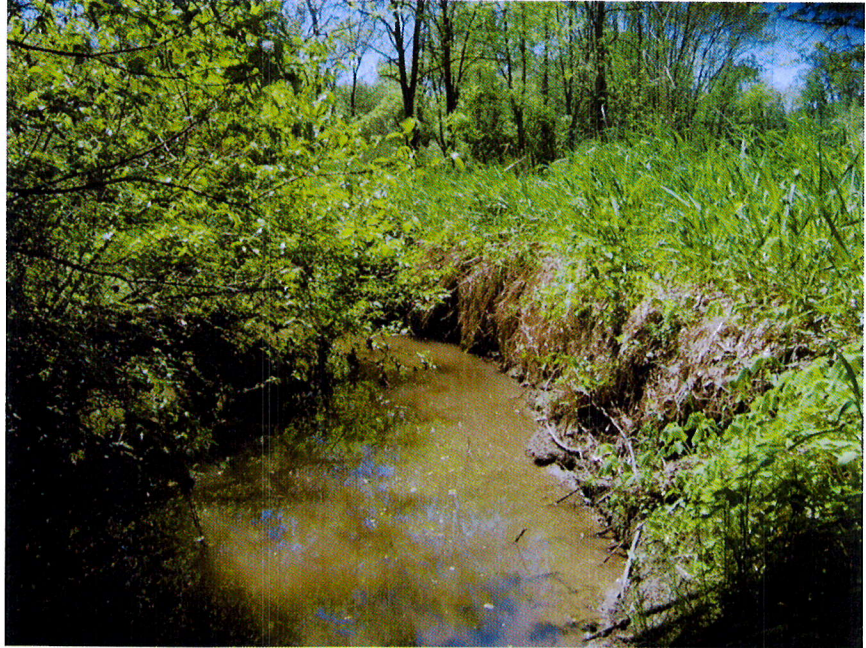
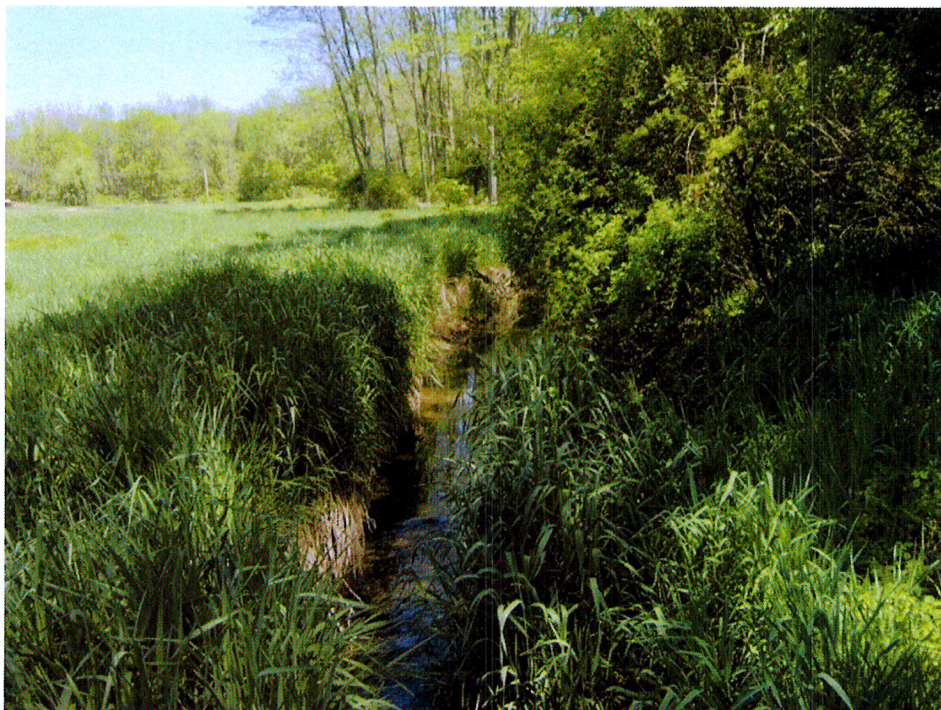
Impacted Stream Segment #23-25:

Legacy sediment is prevalent throughout the floodplain within this stream reach. The streambanks throughout this area are 3 to 4 feet high and actively eroding. The riparian zone to the west of the stream is mowed to the top of the bank. In areas where trees and shrubs are located along the banks, multiflora rose dominates.

Restoration of this area should focus on reconnection of the active floodplain with the stream. The stability of the stream should be considered from a fluvial geomorphology standpoint. As the stream bottom is covered in sediment throughout much of this section, the use of in-stream structures to provide fish habitat should be considered. Reconnection of the floodplain and stabilization of the streambanks throughout this reach should result in measurable water quality benefits downstream.

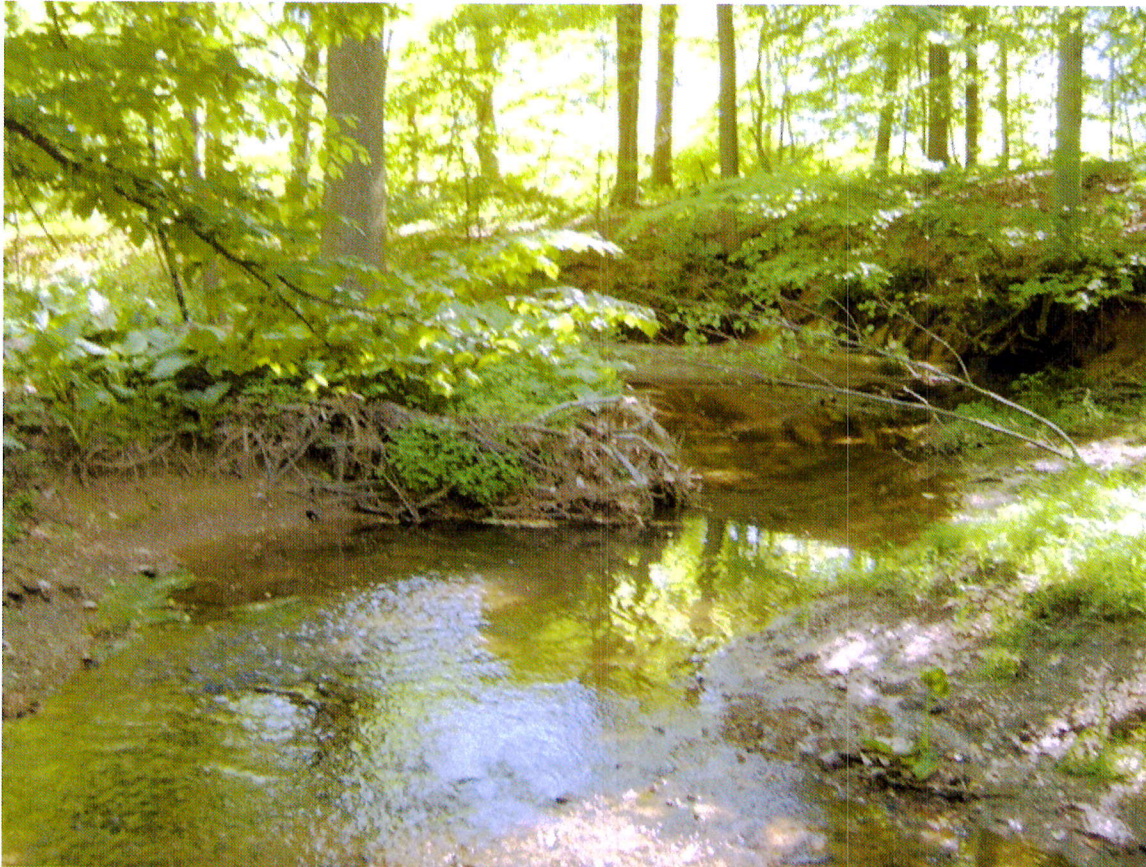
Impacted Stream Segment #35-36:

Throughout this forested area, legacy sediment has accumulated throughout the floodplain. Lateral erosion of the streambanks has left raw banks that are several feet high. Bedrock is visible on the stream bottom near the upstream end of this stream segment and will limit farther down cutting of the stream.

Restoration of this stream segment would require legacy sediment removal and restoration of the floodplain. The riparian forest and wetlands that are located on top of the legacy sediment will need to be impacted and restored at historic elevations in order to achieve the greatest long-term stability in this area. Before restoration of this area is undertaken, permit review staff from the regulatory agencies should be invited to the site to discuss the project objectives and restoration requirements of the project.

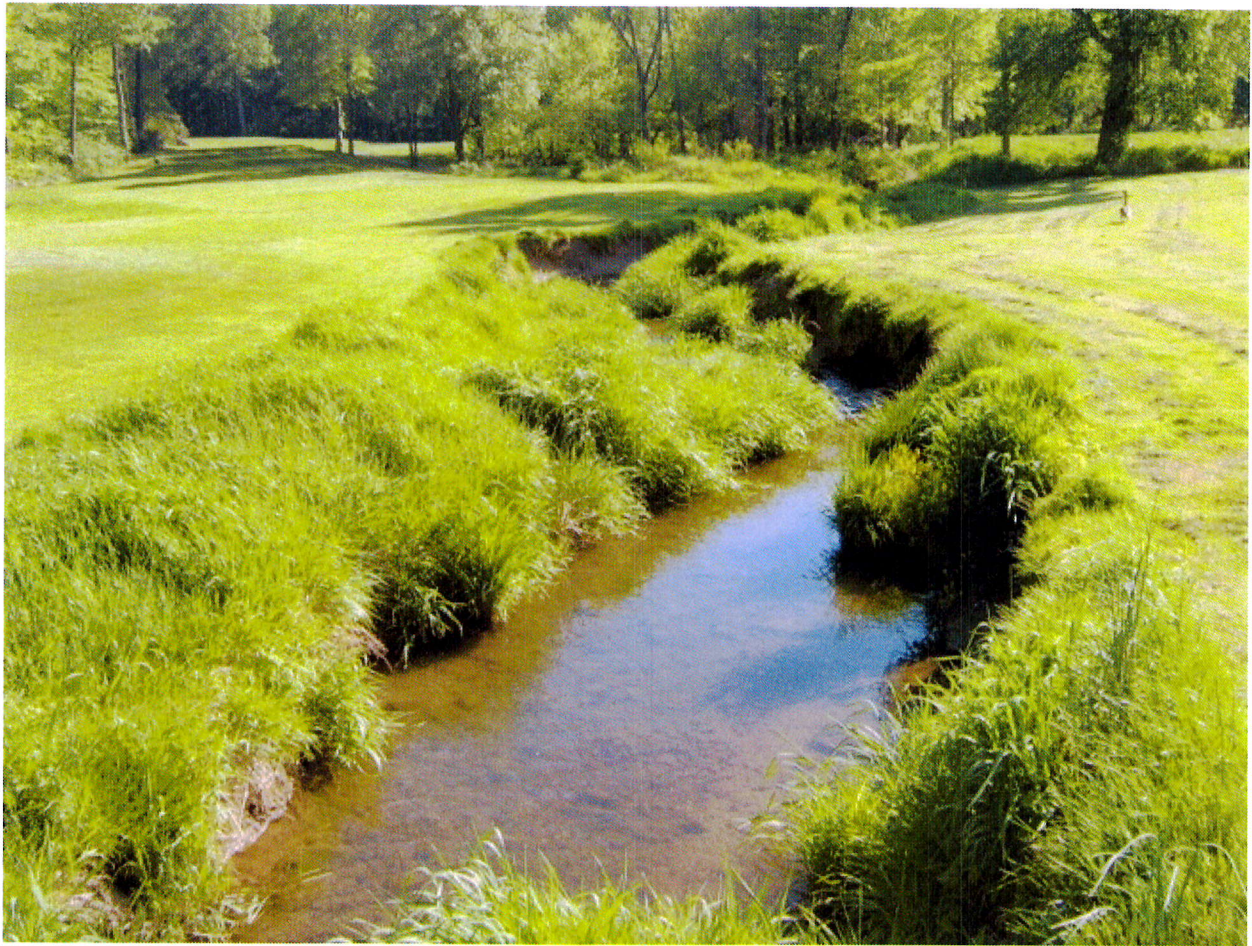
Impacted Stream Segment #36-37:

This stream segment is severely impacted by legacy sediment and has several areas with raw, eroding stream banks. Invasive species dominate the areas along the stream where a riparian buffer exists. The golf course has mowed to the top of streambank throughout much of the reach.

Restoration of this stream segment is ongoing. Funding of this project is provided by a DEP Growing Greener Grant, Kennett Square Golf and Country Club, Chester County Conservation District, Dockstader Foundation, and Red Clay Valley Association. The use of natural stream design, floodplain reconnection, two acres of riparian buffer plantings, bank stabilization and one acre of wetlands improvement should greatly enhance this stream segment. Upon completion, this project will serve as a showcase demonstration project within the watershed that will be a great reference project for attaining landowner support for future projects.

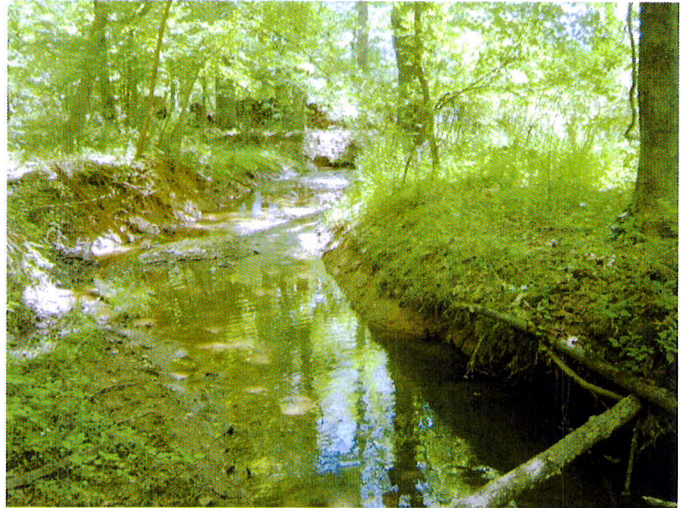
Impacted Stream Segment #3-8:

The streambanks within the forested portion of this reach are eroded and about 3 to 5 feet high. The stream channel appears overly wide and incised. As the stream flows into the open field and lawn area at the bottom of the reach, bank erosion is less of a concern, but the riparian buffer is lacking.

Balancing the impacts of floodplain restoration and streambank stabilization within this forested area will be challenging. A mix of instream structures and minimal bank restoration grading will likely be necessary to stabilize this reach. Downstream of the forested area, a native riparian buffer should be planted.

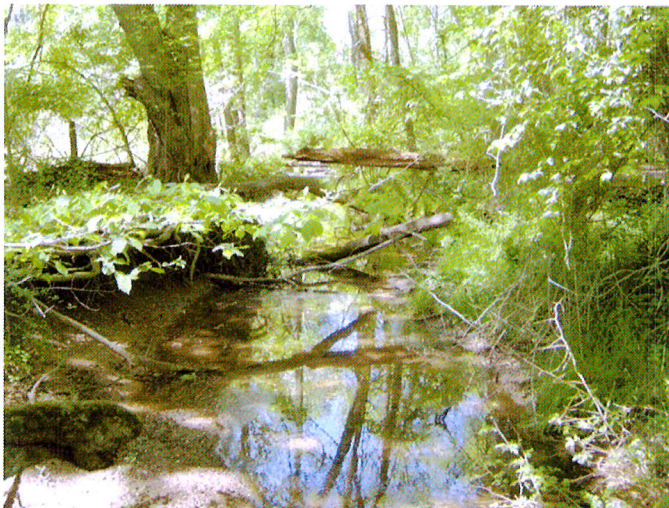
Impacted Stream Segment #20-22:

Within this stream segment, the stream channel is incised 2 to 3 feet with raw, eroded banks on both sides of the stream. Streambank erosion in this area is likely a major contributor to the impairment of stream assessment site 5 (Clauser and Clauser 2010). A mowed lawn extends to the top of the stream bank in the downstream portion of the stream segment.

Restoration of this stream segment should include streambank stabilization with a floodplain restoration component. Restoration of this reach would be challenging. Wetlands and mature forest are perched on top of legacy sediment deposits throughout the forested section. A limited streambank stabilization and buffer planting in the lower section of the reach would require substantially less resources, but would also have less of an impact downstream.

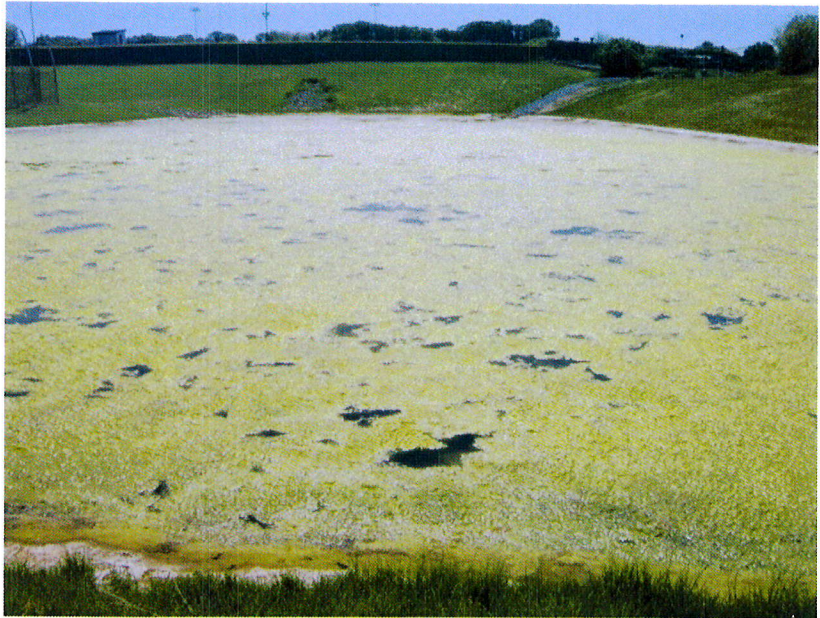
Impacted Stream Segment #26:

A stormwater basin at this location is experiencing an algae bloom. Excessive nutrient inputs likely occur from the upslope playing field and lawn areas.

The landscape crew that is responsible for maintaining the playing field and lawn areas for the Unionville High School should be contacted to discuss implementing a nutrient management plan. Additionally, education and outreach within the watershed should focus on downstream impacts of over-application of lawn fertilizers.

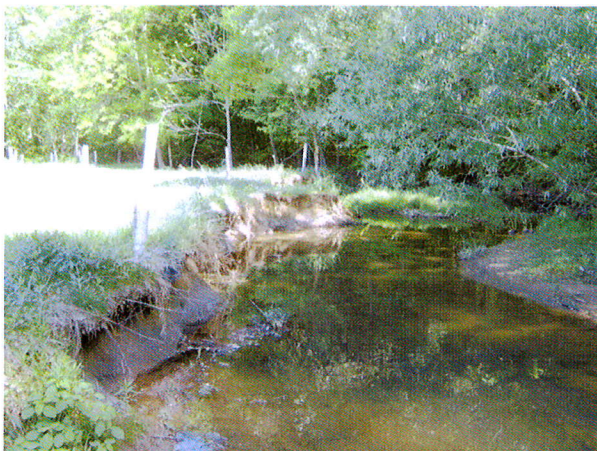
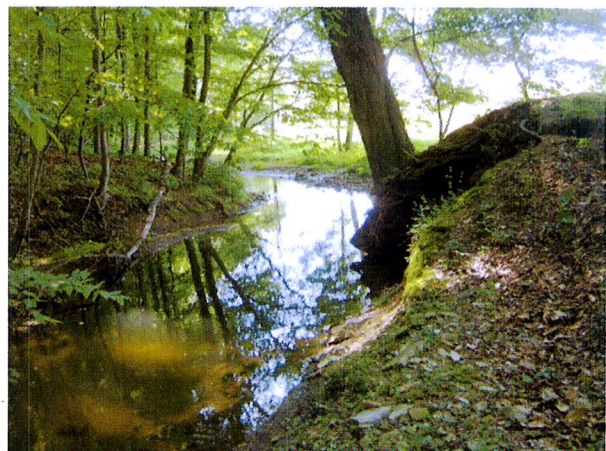
Impacted Stream Segment #33-34

A small earthen dam was breached within this segment. Legacy sediment is evident on the northern streambank. The streambank is several feet high and actively eroding.

Restoration of this area should include a minor streambank stabilization project. The eroding area is just over 200 feet long. Streambank work within this area would likely qualify for general permit coverage. Wetlands do not appear to be an issue. Soils that are removed from the streambank could likely be spread over the upslope crop fields out of the floodplain.
