**Restoration Plan
for
Trib. 414 Watershed
Chester County, Pennsylvania
August 2008**

RETTEW Associates, Inc.
Natural Sciences Group
950 East Main Street, Suite 220
Schuylkill Haven, PA 17972
(570) 385-2270
(570) 385-2217 fax
RETTEW Project No. 07-07957-002

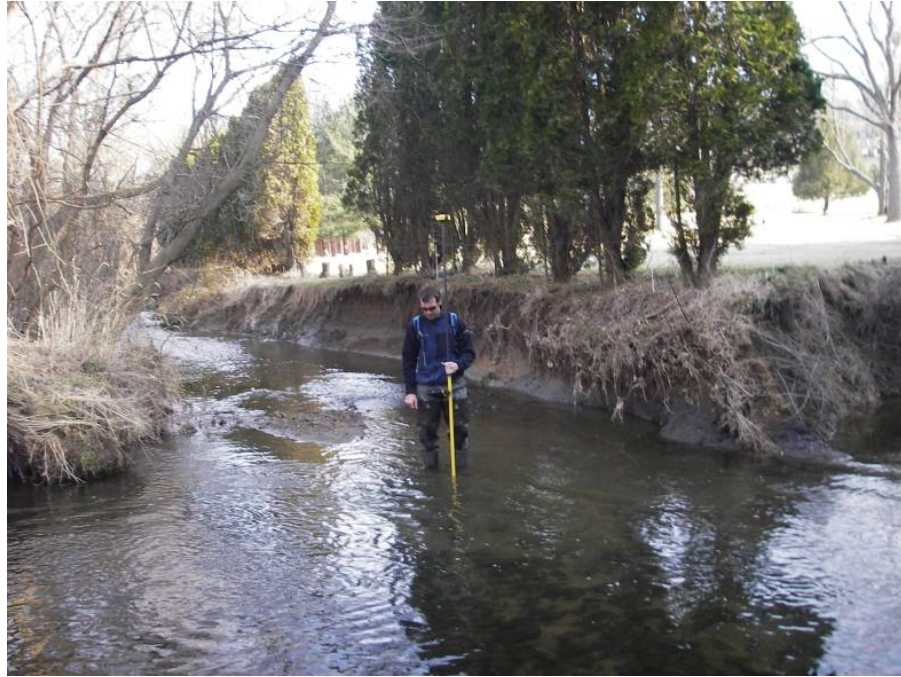
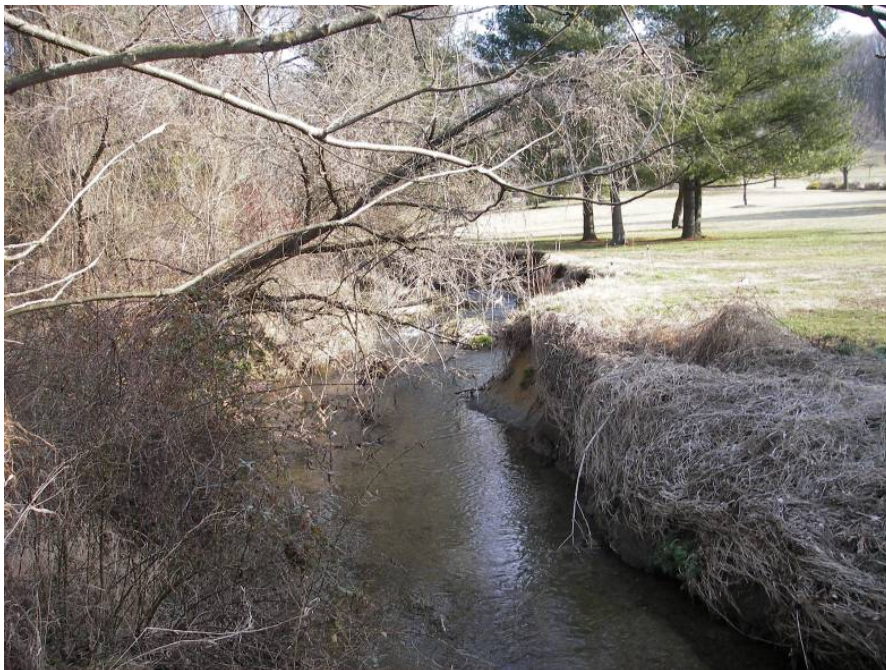
Impacted Stream Segment #1-4:

At the confluence of Trib. 414 and the East Branch of Red Clay Creek looking upstream on Trib. 414, a riparian forested buffer is lacking on the east side of the stream. The lawn area adjacent to the stream is mowed to the top of a 3-5' high eroded bank from points 1 through 4. Approximately 50 feet upstream of point #1, a 50 foot section of streambank was lined with broken concrete rip-rap. The stream has eroded behind the rip-rap area. The west side of the stream has a wide stream buffer. The plant community contains some invasive multi-flora rose.

This section of stream requires streambank stabilization from a fluvial geomorphology (natural stream design) approach. The invasive multi-flora rose should be eradicated before a forested riparian buffer is planted with native tree and shrub species.

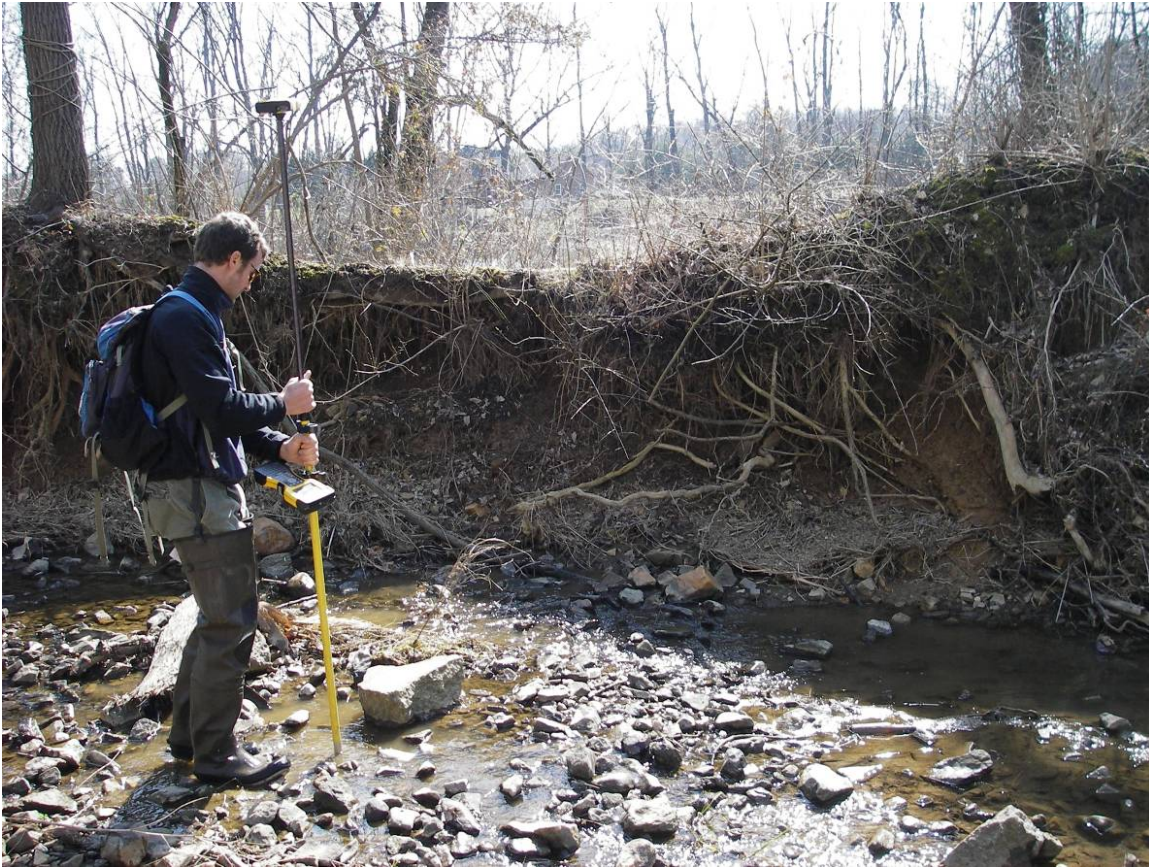
Impacted Stream Segment #15:

This section of Trib. 414 has evidence of the stream being relocated to its present location. It appears that Trib. 414 was diverted around the large off-line dam. At this location, the stream is attempting to reach a stable state and has eroded its streambank and is close to cutting through and spilling into the large off-line pond east of the stream. If the stream is able to cut through the bank at this location, approximately 600 feet of stream will go dry. Upstream of this location, the landowner is clearing the bank of vegetation.

While the long-term stability of this section of the stream would include a major restoration effort to return the stream to its historic location, a much more practical approach is to stabilize the bank in the areas of erosion. Stabilization of this area should be coupled with landowner education, native riparian buffer plantings in the cleared area, and the inclusion of in-stream structures for fish habitat enhancement.

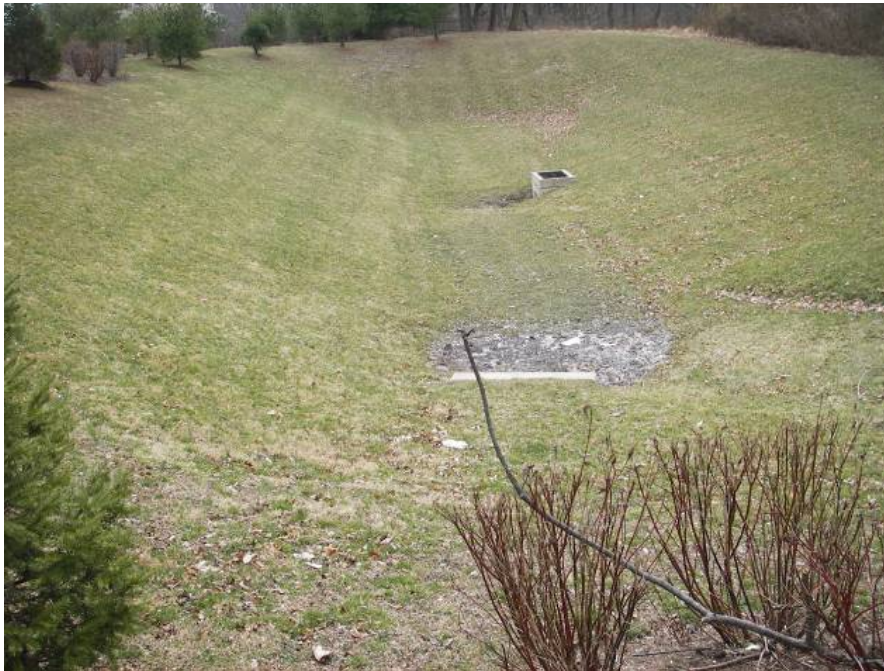
Impacted Stream Segments #39-Headwaters and #73-Headwaters:

The stormwater from the extensive impervious areas upstream of this location are likely the cause of much of the downslope degradation. While the stream is not incised and indicative of an impacted stream from a habitat standpoint, the shallow bedrock is likely playing a role in stabilizing this area. While points 39 and 73 indicate the areas of the watershed where stormwater management retrofits become most necessary, this high priority project is a watershed wide initiative. The field investigation map indicates where good sites for initial stormwater best management practice retrofit projects are located (Appendix A).

Urban stormwater management retrofits that consider volume, rate, and water quality should be included with any work that drains into Trib. 414. While landowner education targeting homeowners will be helpful, an outreach program that targets the commercial areas of the watershed may have the greatest potential for success. Consideration should be given to development of a recognition program

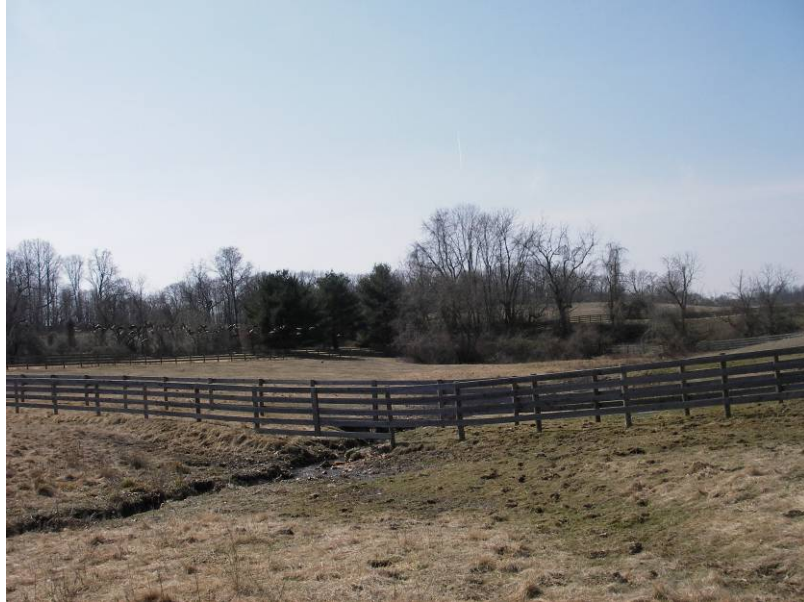
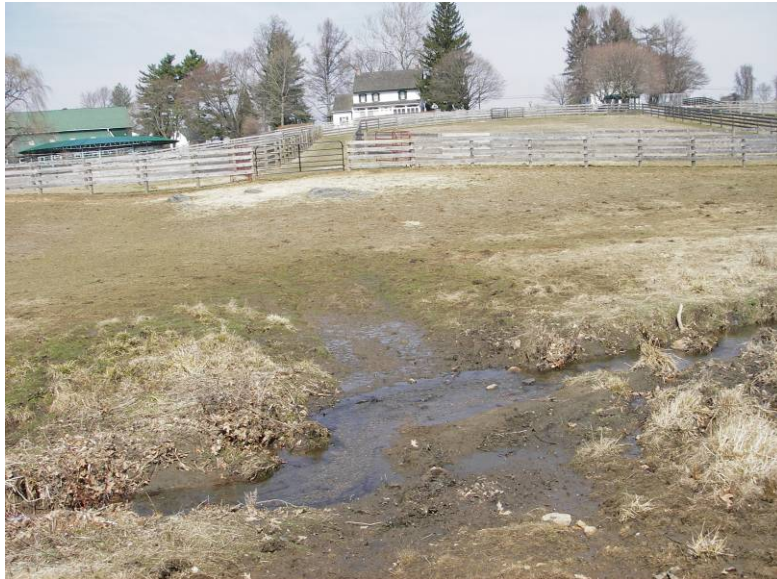
**Impacted Stream Segment
#57-58:**

This section of the stream includes a large well maintained ranch where livestock graze in several large pastures. An unnamed tributary to Trib. 414 flows through the center of the pastures and is freely accessible to livestock in the pastures. The streambanks in the upper section of this area are eroded up to three feet deep on the outside of meander bends.

While a limited amount of streambank stabilization would be beneficial, the primary focus of restoration of this tributary should be on streambank fencing and establishing a riparian buffer. Fencing livestock out of the riparian corridor would allow for a forested riparian buffer to be installed. In areas where livestock need to cross the stream routinely, livestock crossings should be installed.

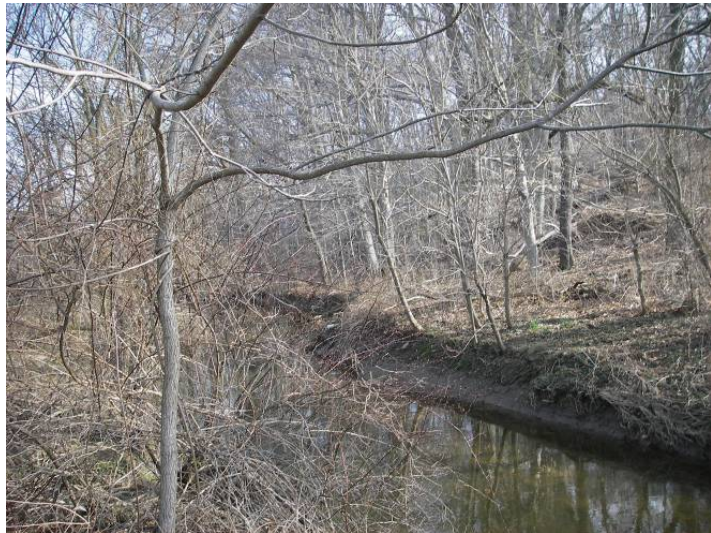
Impacted Stream Segment #4-5:

Upstream of this point, the eastern side of the stream is comprised of mature forest with 2-3 feet high eroded banks. The west side of the stream has 4-5 feet high eroded banks along this entire section. Multiflora rose is common in the open meadow/emergent wetland floodplain plant community located east of the stream.

Streambank stabilization in this area that incorporates traditional streambank stabilization and natural stream design should be considered for this area. The wetlands and mature forest that surround this stream segment will add to the challenge of designing and permitting an effective natural stream design. The invasive multiflora rose should be eradicated from the project area.

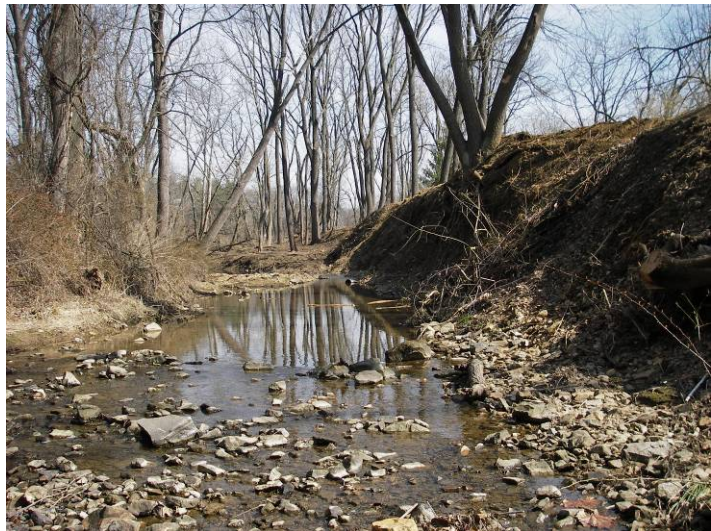
Impacted Stream Segment #17:

The streambank in this area is freshly cleared and grubbed to the stream edge without erosion control best management practices.

Install erosion and sedimentation controls according to Chester County Conservation District recommendations. A riparian buffer enhancement project that includes vegetating the streambank with native trees and shrubs should be considered.

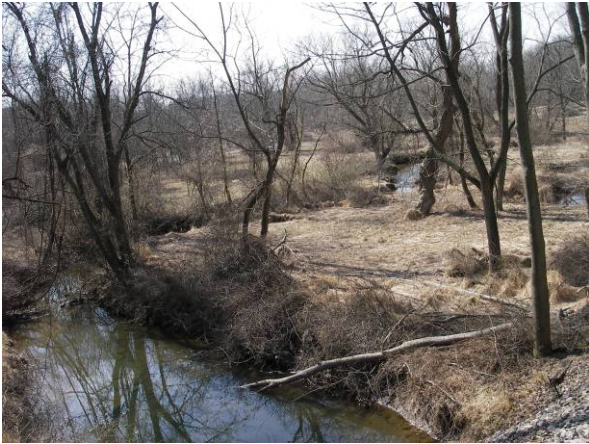
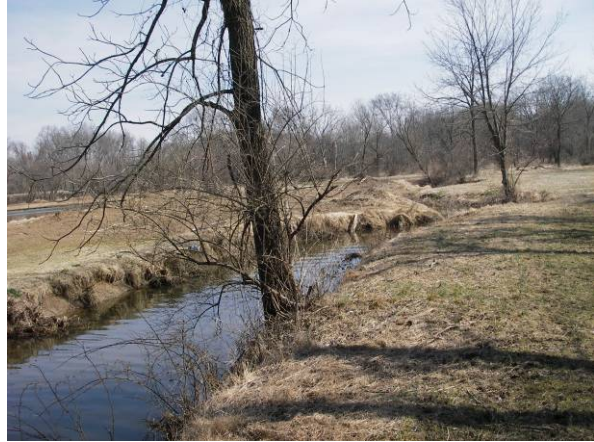
Impacted Stream Segment #19-23:

From points 19 through 23, the riparian zone is mowed to the top of both streambanks.

Riparian buffer enhancements in this area including native tree and shrub plantings to shade the stream would be a great benefit.

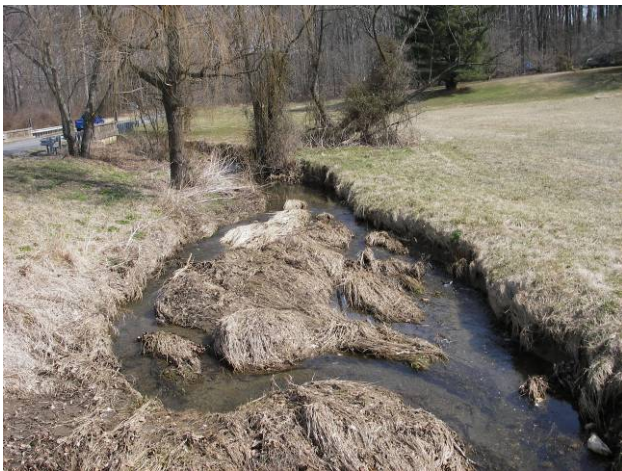
Impacted Stream Segment #25-28:

The streambanks throughout the majority of the stream segment from points 25 through 28 are incised approximately 3-4 feet deep. The upper end of this stream segment flows through a fallow field that is mowed to the top of the streambanks. While the lower section of the stream segment flows through a riparian buffer, invasive multiflora rose is dominant.

Streambank stabilization utilizing traditional and natural stream design techniques. Invasive species removal should be completed throughout the entire stream segment area so that a native forested riparian stream buffer may be established.

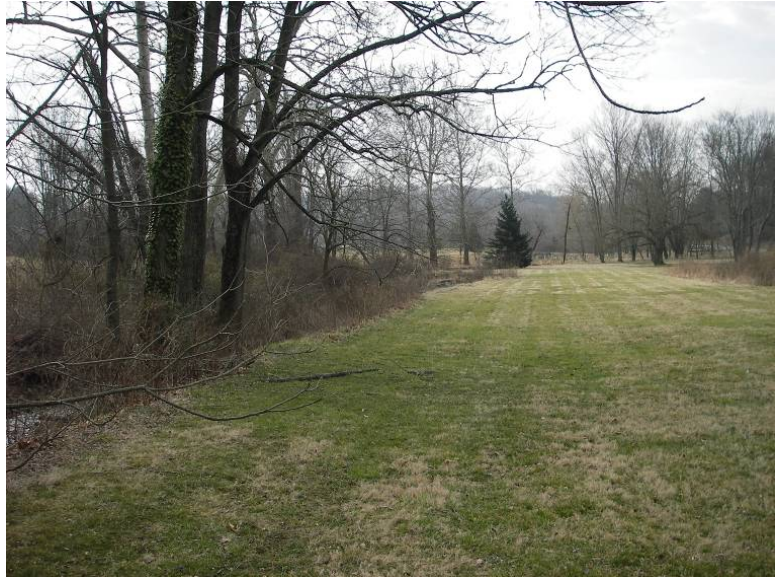
Impacted Stream Segment #34-36:

The stream segment from points 34 through 36 includes a small (approximately 5 feet wide) stream buffer that is bordered by mowed lawn. The lawn area is relatively flat and just slightly above the grade of the stream. A depression east of the stream may be the remnants of a historic off-line ice dam. A small area of erosion around tile drains is present with approximately 2 feet high eroded streambanks in the downstream end of the stream segment. Further downstream is an area that recently has been planted with trees to create a forested riparian buffer.

This section of stream may be an excellent location for the installation of a large floodplain bench wetland area that would help attenuate the effects of upstream stormwater discharges. Another less costly option to improve this stream section would be to install a forested riparian buffer throughout this section. Streambank stabilization in this area would be limited to traditional bank stabilization in the downstream section of the stream segment.

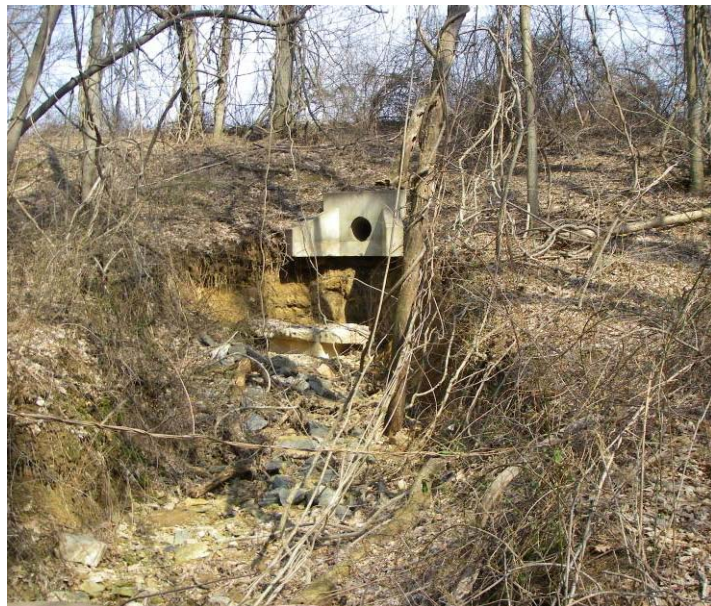
Impacted Stream Segment #75:

A stormwater outfall at this location is severely eroded from scour under the endwall.

Maintain outfall by installing an energy dissipating device (likely rip-rap) and designing a stable channel (likely a step pool design). This area should be assessed for the installation of stormwater management retrofits.
