West Branch Brandywine Ag-1 Watershed Restoration Plan

Honey Brook Township and Honey Brook Borough, Chester County
Caernarvon Township, Lancaster County
Brandywine Creek Watershed, Pennsylvania

August 2010

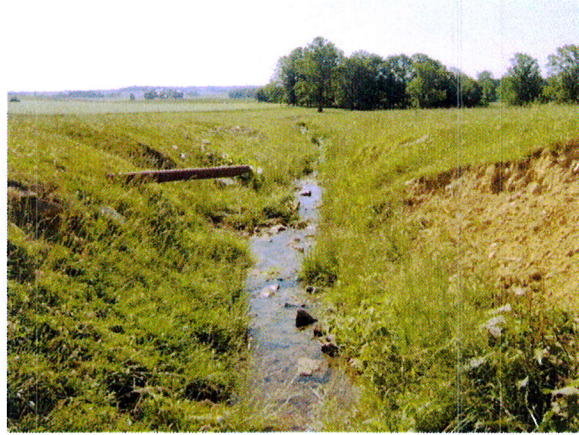
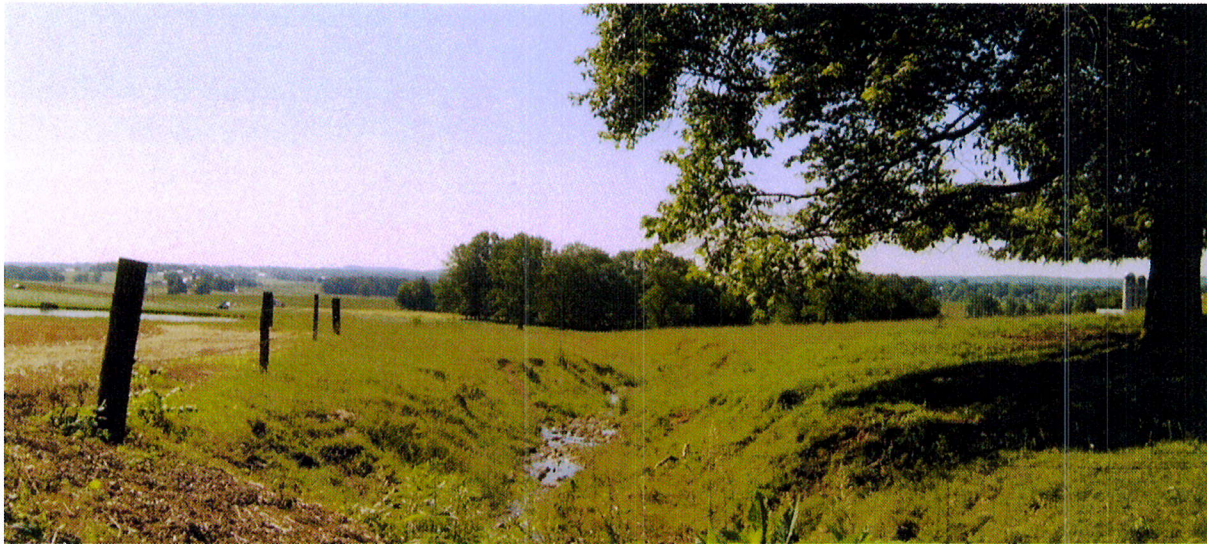
Impacted Stream Segment #2-5:

Within this stream segment, cattle have direct access to the stream that flows through the center of an open pasture. Several iron pipes discharge to the stream from an off-line pond and a watering trough. Within the stream segment, approximately 200 feet of 3 feet high, raw, eroding streambanks are present. A small spring seep is located to the west of the stream and originates within the pasture area. Cattle have direct access to the spring.

The restoration of this stream segment should focus on minimizing the direct access of livestock to the stream and spring. Streambank fencing should be installed on both sides of the stream and around the spring area. The installation of stabilized stream crossings would allow livestock to cross the stream without causing additional bank erosion. In the areas where the streambank is raw and actively eroding, streambank stabilization should be considered. The streambanks could be graded to a more stable angle that is no greater than 3:1 (horizontal:vertical). The watering trough should be maintained to encourage cattle to drink from that area rather than loafing in the stream. Native vegetation should be planted within the riparian zone to aid in filtering runoff, stabilize the banks, and eventually provide a forest canopy over the stream. The installation of a biofiltration area around the headwater spring should be considered to minimize the impact of contaminated runoff on the spring.

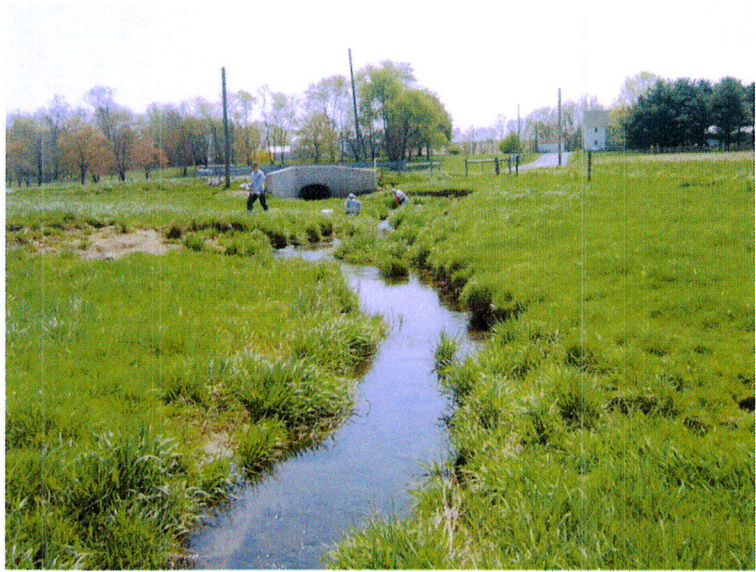
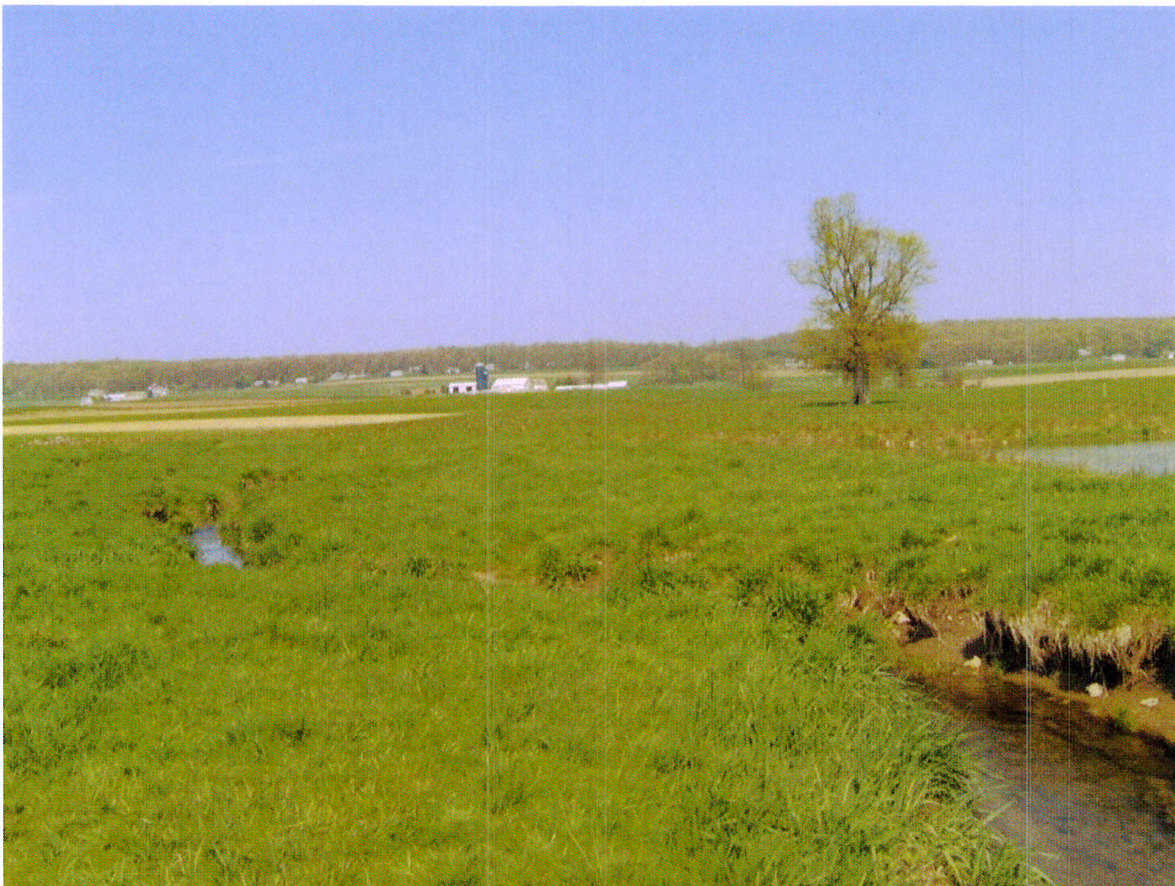
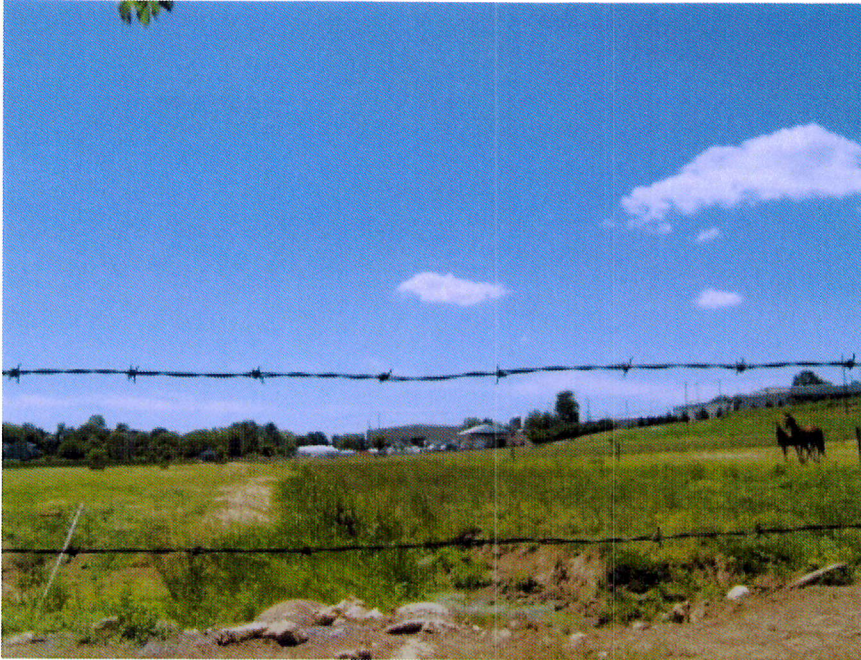
Impacted Stream Segment

This stream segment includes a large area of pasture on several parcels. The stream flows through an open area and is not shaded. Livestock have direct access to the stream. In addition to the mainstem of the West Branch Brandywine Creek, six ponds and several small tributary streams are located within this stream segment.

Restoration of this stream segment should focus on reducing nutrient, sediment, and pathogen discharges to the stream by installing streambank fencing and riparian buffers. As the pastures extend to both sides of the streams, the installation of stabilized stream crossings will be necessary. Throughout the area, watering troughs should be installed to encourage livestock to drink and loaf in upland areas. Within the riparian zone, native vegetation should be planted that will eventually develop a forested canopy over the stream.

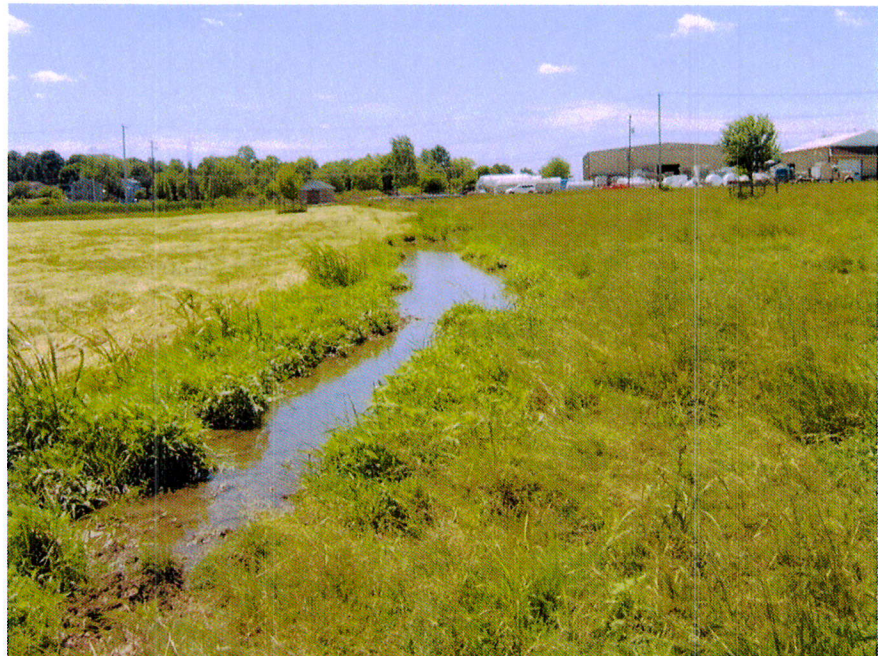
**Impacted Stream
Segment #18-19:**

Within this stream segment, livestock have direct access to the stream. This pasture is rotationally grazed by both horses and cattle. The streambanks are stable and vegetated, but the stream is not shaded.

Restoration of this area should focus on streambank fencing and riparian buffer enhancement. Several culvert pipes are located within this reach and should be considered for use as stabilized crossing areas to minimize the amount of time livestock spend within the stream. Native trees and shrubs should be planted within the riparian zone to help the buffer become established. Restoration of the stream within this segment should aid in improving the water quality at Sample Site 5 as identified in the West Branch Ag-1 Assessment Report.

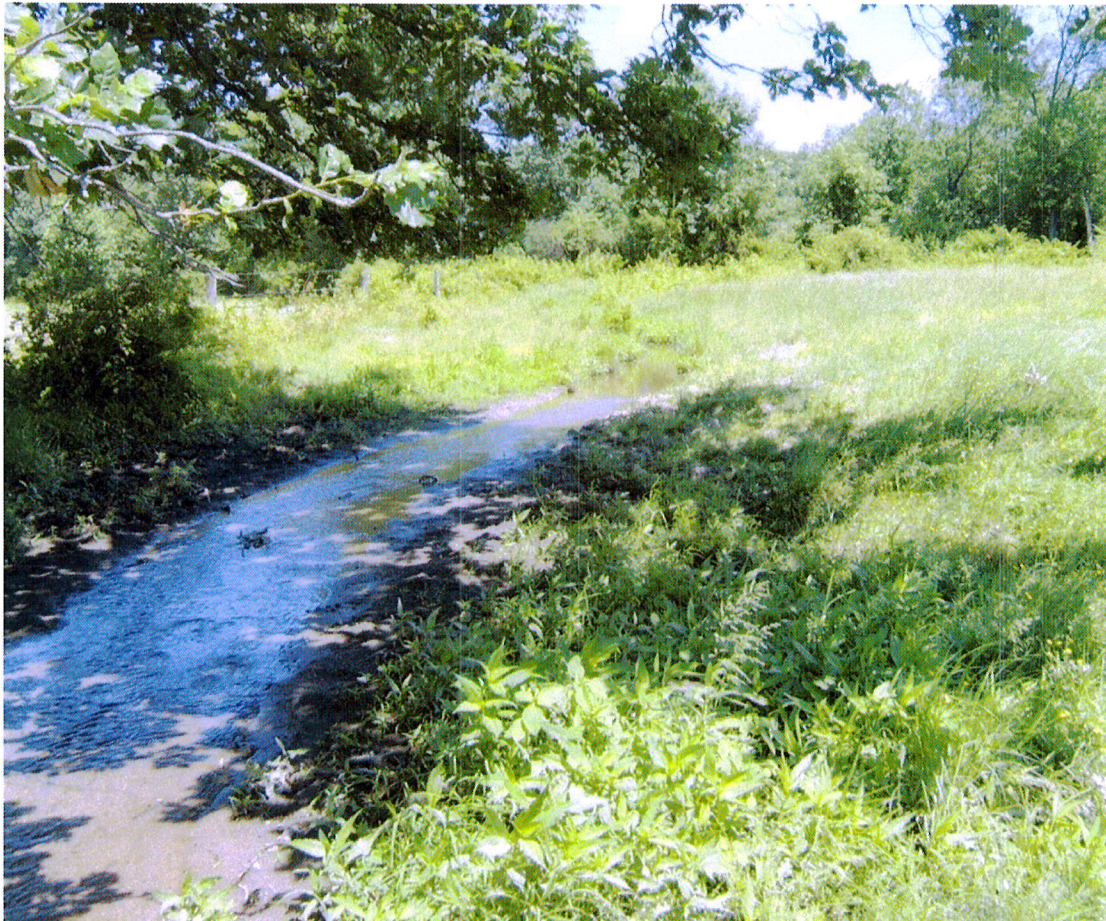
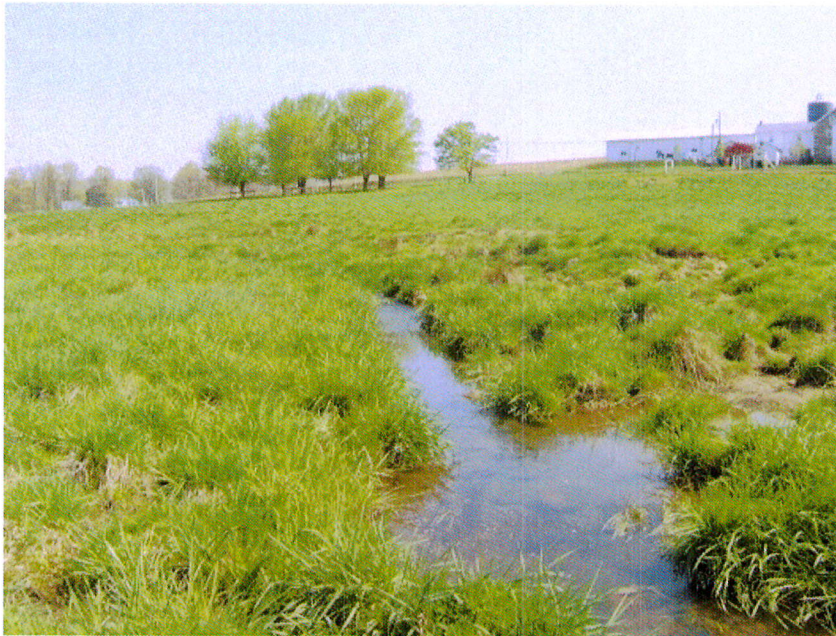
Impacted Stream Segment #21-23:

This high priority stream segment includes a pasture where livestock have direct access to two unnamed tributaries. The majority of the pasture is open without an established riparian buffer. While the streambanks are primarily stable throughout this reach, in the areas where livestock routinely cross the stream the banks are raw and eroding. Within the stream segment, two unnamed tributaries meet. The western tributary drains from a forested parcel that is under a conservation easement. The eastern tributary drains through a wetland area identified as stream segment 20-21. Downstream of this segment, riparian buffers have been established within a stream corridor that has streambank fencing.

Restoration of this stream segment should include installation of streambank fencing and riparian buffers. Stabilized stream crossings and upland watering troughs are also important to minimize the impact that this pasture area has on water quality. To jump start the establishment of a native riparian buffer, trees and shrubs should be planted along the stream. The restoration of this segment is essential to improving the water quality of this unnamed tributary. Water quality improvements made by this project should benefit the biology of the restored area immediately downstream. Long-term monitoring before and after restoration of this segment should be completed. Data collected within this tributary could then be utilized to guide BMP selection, leverage funding, and generate support for work in other sections of the watershed.

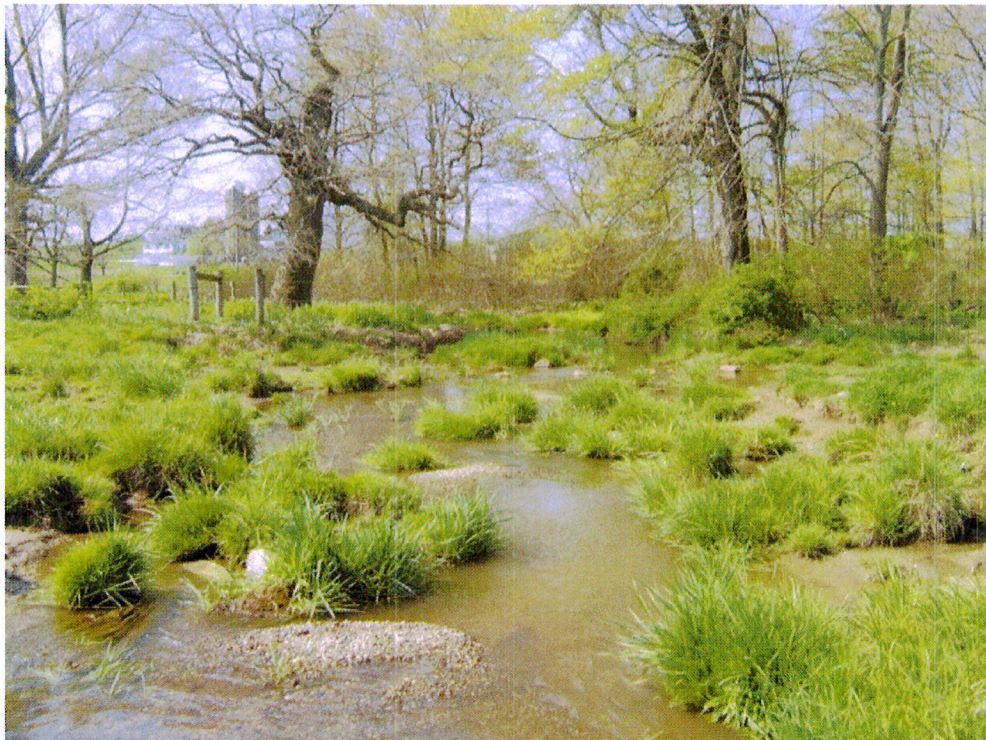
Impacted Stream Segment #25-26:

This stream segment flows through an open pasture where livestock have direct access to the stream. The streambanks are stable throughout the majority of this segment. The pastures immediately upstream and downstream of this pasture have streambank fencing and established riparian buffers.

Restoration of this stream segment should include installation of streambank fencing on both sides of the stream. As the pasture includes substantial areas on both sides of the valley, stabilized crossing areas should be established. Upland watering troughs should be installed to encourage livestock to drink and loaf away from the stream corridor. Native riparian buffer plantings should be installed to create a wildlife corridor that connects the downstream and upstream buffer areas, shade the stream, and filter runoff.

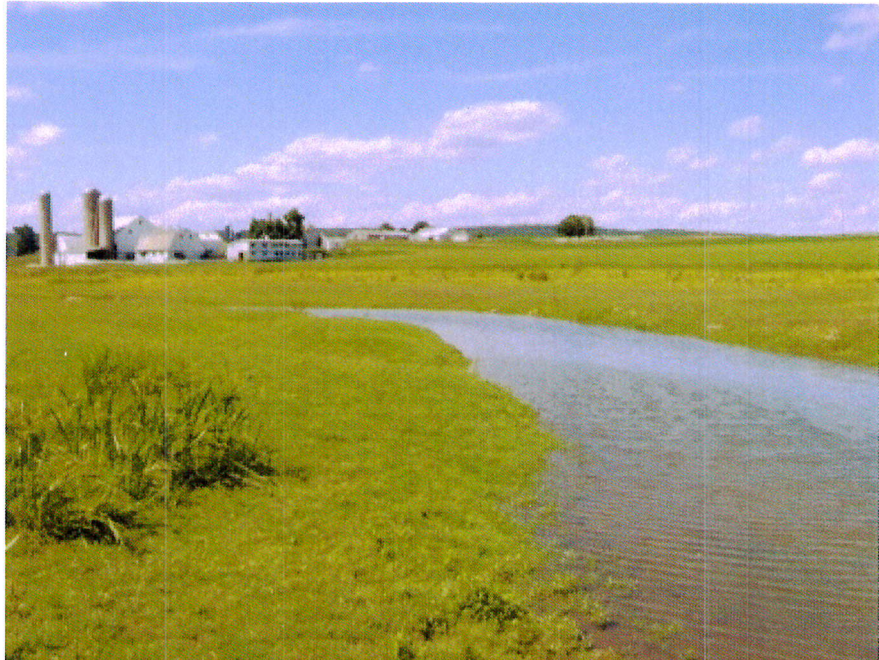
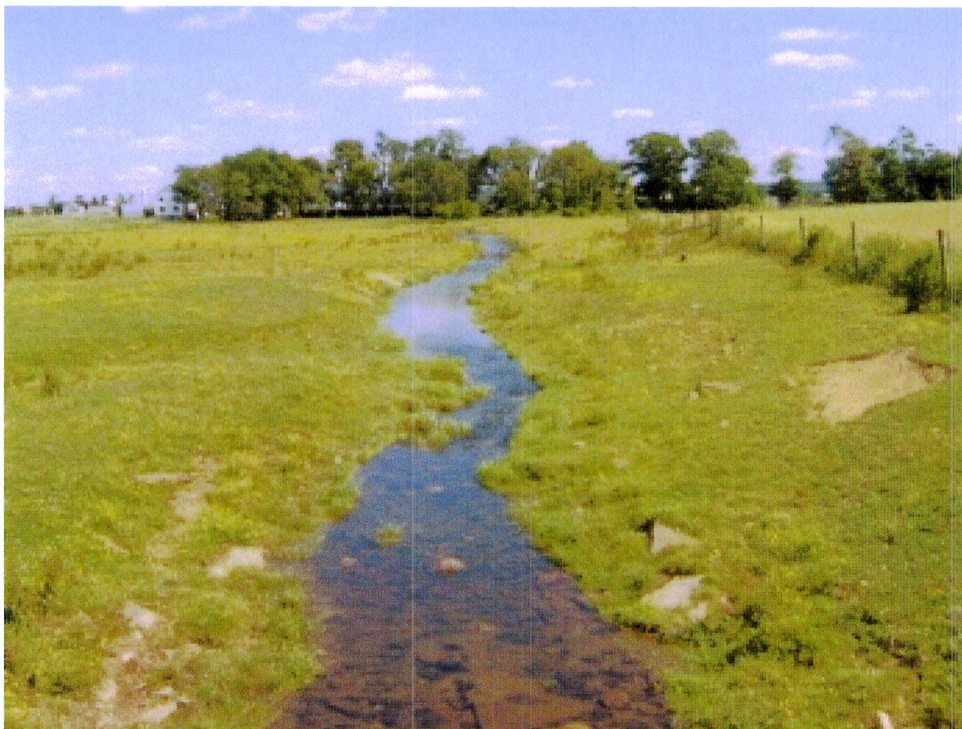
Impacted Stream Segment #28-29:

Within this stream segment on the mainstem of the West Branch Brandywine Creek, livestock have direct access to the stream. While the streambanks are stable, the vegetation is grazed so that it is only several inches tall. The lack of a stream buffer allows agricultural pathogens, nutrients, and sediment to discharge directly to the stream without control. The

lack of a forested canopy over the stream allows for excessive algal growth, warming of the stream, and impacts the foodchain dynamics of the stream.

Restoration of this area should include the installation of streambank fencing along with stabilized stream crossings and upland watering troughs. The riparian zone should be planted in native vegetation so that a canopy becomes established over the stream.

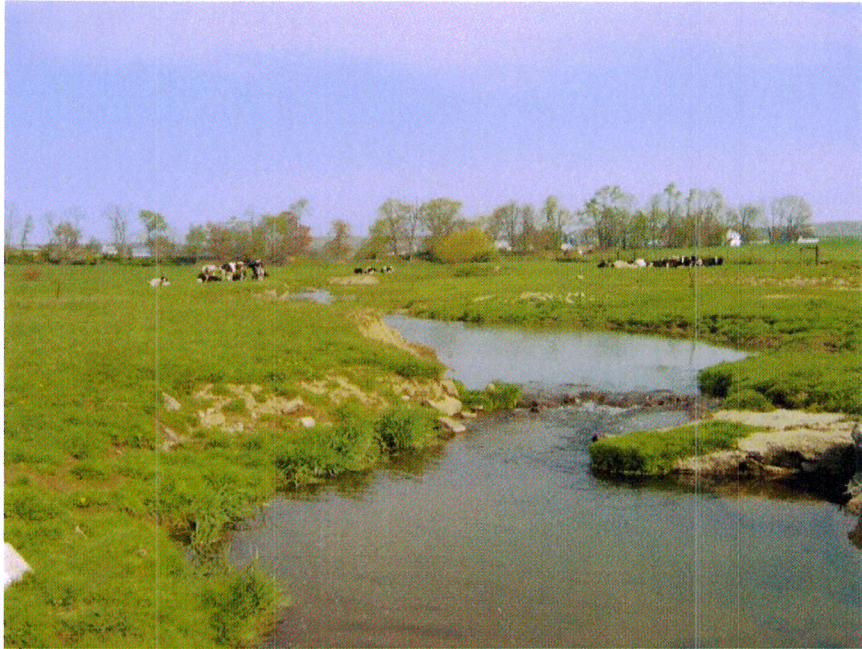
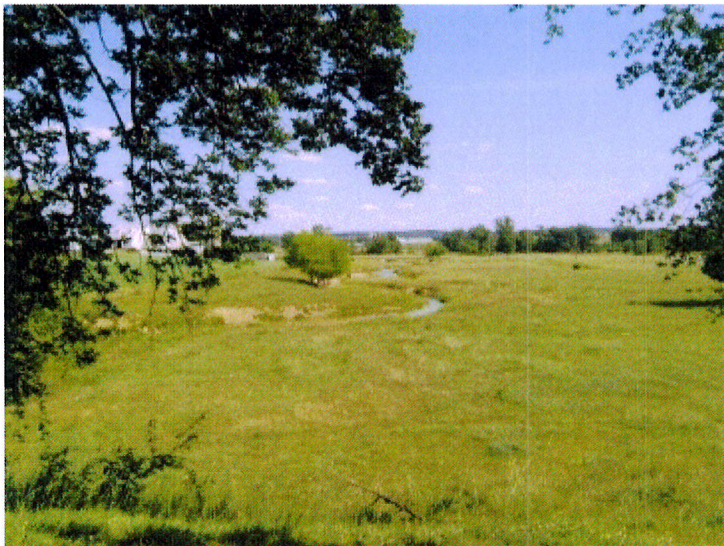
Impacted Stream Segment #31-34:

This stream segment includes several pastures on adjacent properties where livestock have direct access to the stream. Throughout the segment, pastures extend to both sides of the stream and cattle often loaf within the riparian zone. The streambanks within this area range from stable with short, cropped vegetation to raw and

steeply eroded. The majority of the eroded stream banks are located along the mainstem of the West Branch Brandywine Creek. In the section of the stream segment that is upstream of Suplee Road, several areas are eroded with streambanks that are 4-6 feet high. Within the downstream portion of the stream segment, some areas have streambanks that are eroded with banks that are 3-4 feet high. The farm at the downstream portion of the site and the farm just upstream of Suplee Rd. have feedlots that drain in the direction of the stream.

Restoration of this stream segment should focus on bank stabilization along the mainstem and streambank fencing throughout the segment. The pastures within this area extend to both sides of the stream so that the installation of stabilized stream crossings will be required. Native riparian buffers should be installed throughout the

length of the segment. During the conceptual design stage, fluvial geomorphological techniques should be considered to determine if the stream is overly wide in portions of this area and to ensure that the most appropriate best management practices are selected to stabilize the stream. The feedlots within this segment should be investigated to determine if an improved manure management system could be developed to minimize manure draining to the stream.

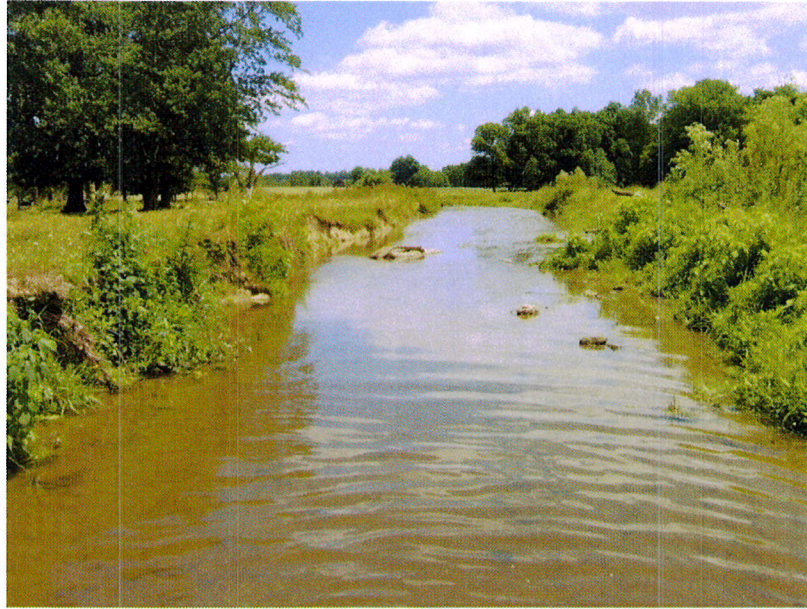
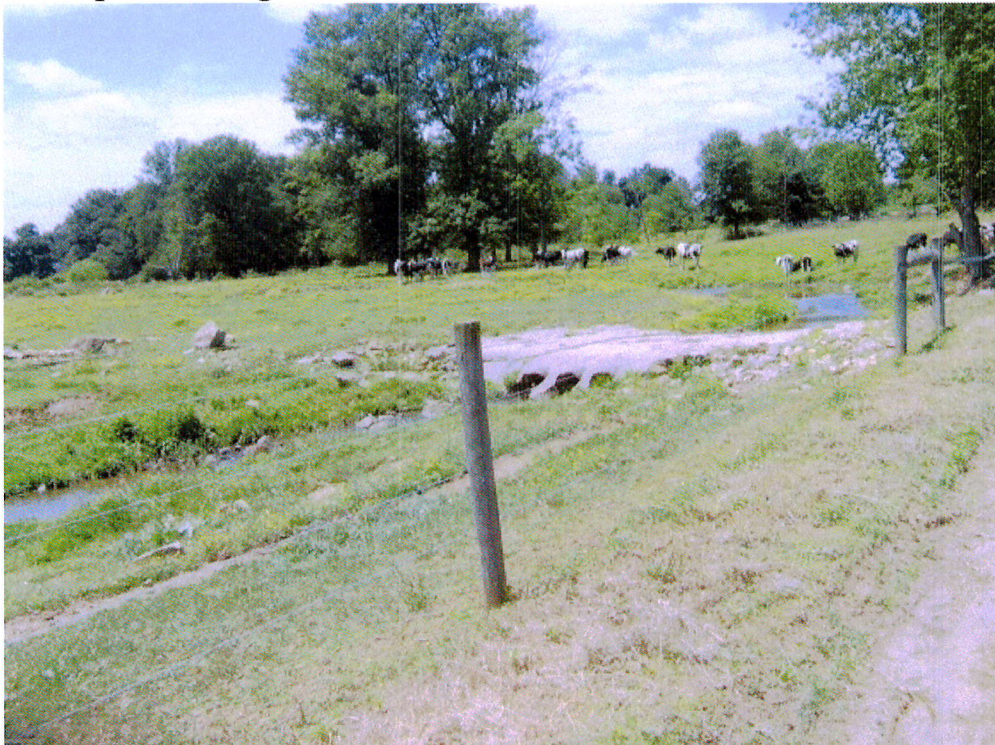
Impacted Stream Segment #37-38:

Within this stream segment, livestock have direct access to the stream and have grazed the vegetation so that it has very limited value as a buffer along the stream. Within the upstream portion of this segment, the streambanks are eroded approximately 2 to 3 feet high. The stream channel is incised and has become overly wide and shallow.

In order to minimize the impacts of agriculture on this stream segment, streambank fencing and bank stabilization should be considered. The overly wide channel and eroding banks should be evaluated for restoration with a fluvial geomorphological approach. The use of in-stream structures such as deflectors, cross-vanes, and J-hooks should be considered during the design phase of the project. As this pasture extends to both sides of the stream, the use of stabilized stream crossings will be necessary. After the streambank fencing is installed, native trees and shrubs should be planted to shade the stream and provide long-term stabilization of the streambanks.

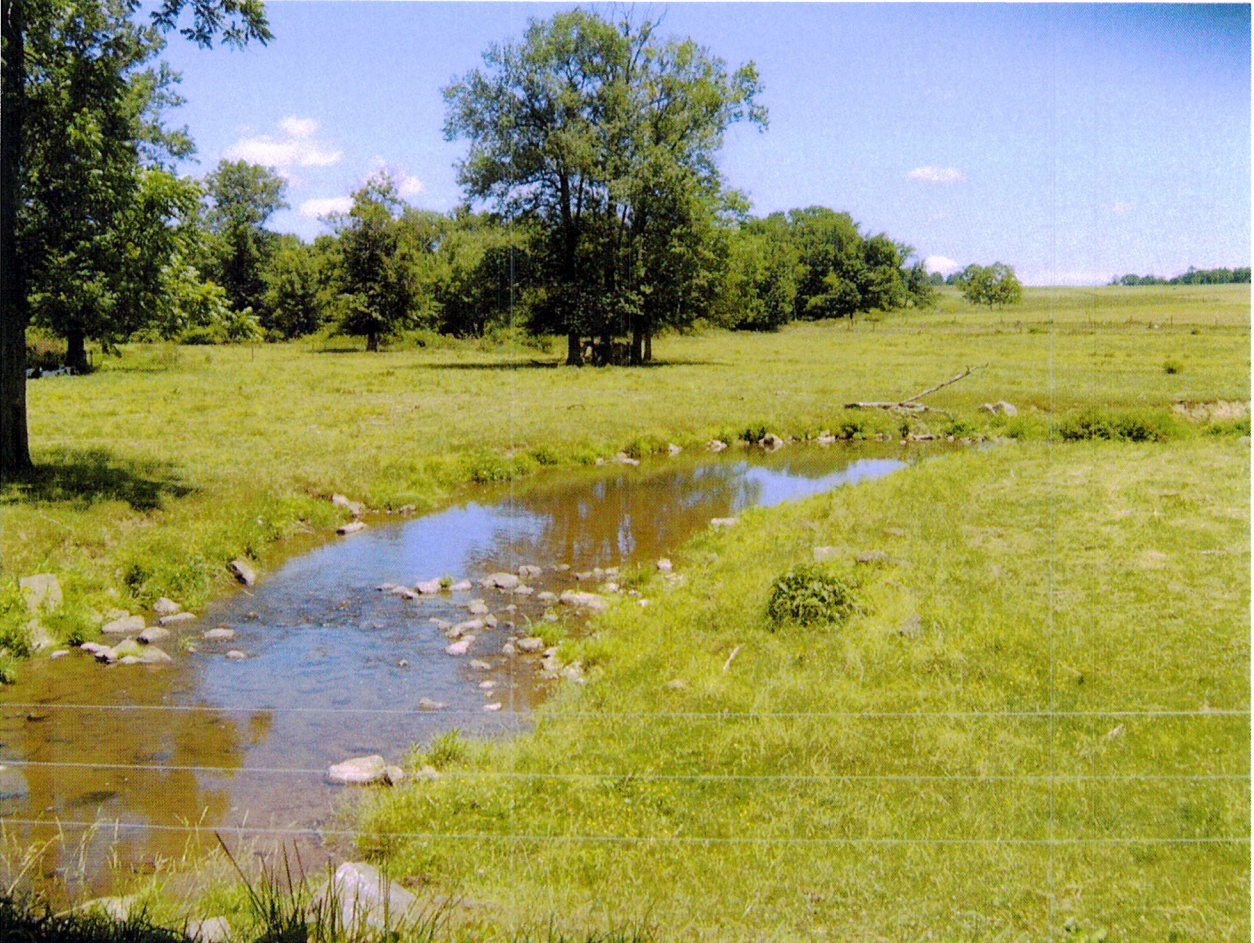
Impacted Stream Segment #49-50:

Livestock within this stream segment have direct access to the stream. The streambanks range from stable to several feet high and actively eroding throughout this reach. The stream corridor lacks riparian vegetation and is heavily grazed to the stream edge.

Streambank fencing should be installed throughout the length of this segment to minimize the impacts of livestock on the stream. The channel should be evaluated to determine if it is overly wide and appropriately stabilized where the banks are eroding. The installation of stabilized stream crossings will be required as the pasture extends to both sides of the stream. The stream corridor should be planted with native trees and shrubs to establish an effective buffer.

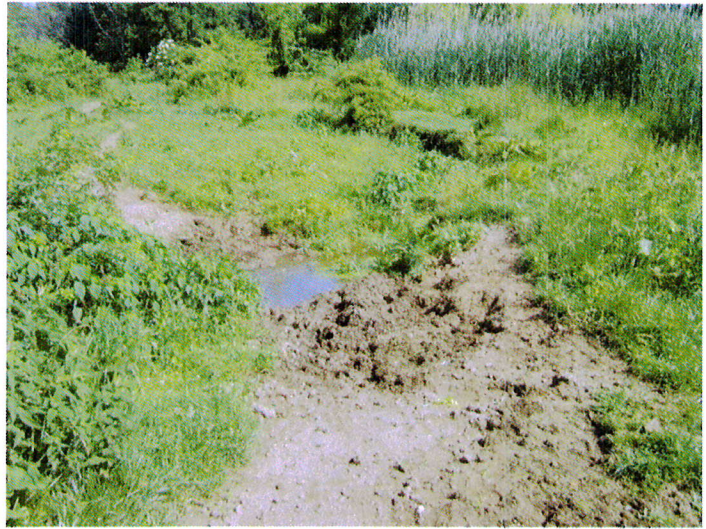
Impacted Stream Segment #5-8:

Livestock have direct access to the stream within this forested area. In several areas, the streambanks are unstable from repeated livestock crossings within those areas. Within one portion of this segment, streambank fencing has not been maintained.

Install and maintain streambank fencing. Where livestock cross the stream, stable crossings should be installed. The forested nature of this area should allow a riparian buffer to quickly become established.

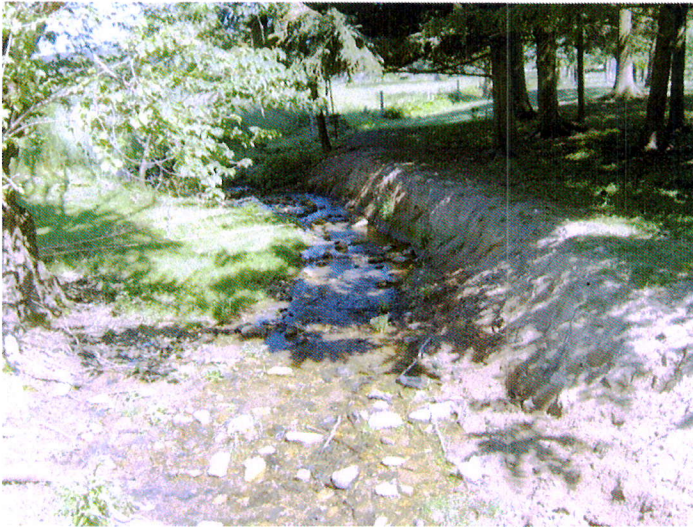
Impacted Stream Segment #9-10:

Within this small stream segment, livestock have direct access to a stream that cuts through the corner of a pasture. The animals are trampling the streambank and contributing to its instability.

Restoration of this stream segment should include fencing the livestock out of the corner of the pasture where the stream crosses. An upland watering trough may be required. The area adjacent to the stream should be allowed to grow into a riparian buffer to filter stormwater discharges to the stream from the upslope pasture area.

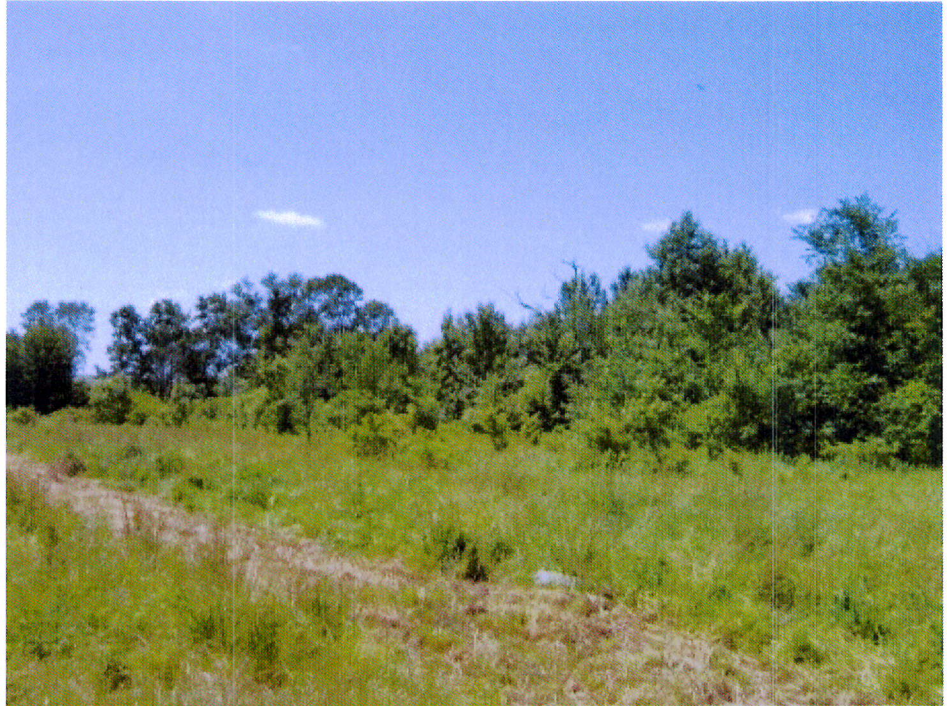
Impacted Stream Segment #20-21:

A small unnamed tributary that flows through this stream segment flows through a wetland area that is intermittently grazed. While the livestock appear to minimize their use of the wetland portion of the pasture, they have direct access to it.

Restoration of this area should include streambank fencing to keep the livestock out of this headwater wetland area. The wetland should quickly develop into a suitable stream buffer when grazing pressure is removed.

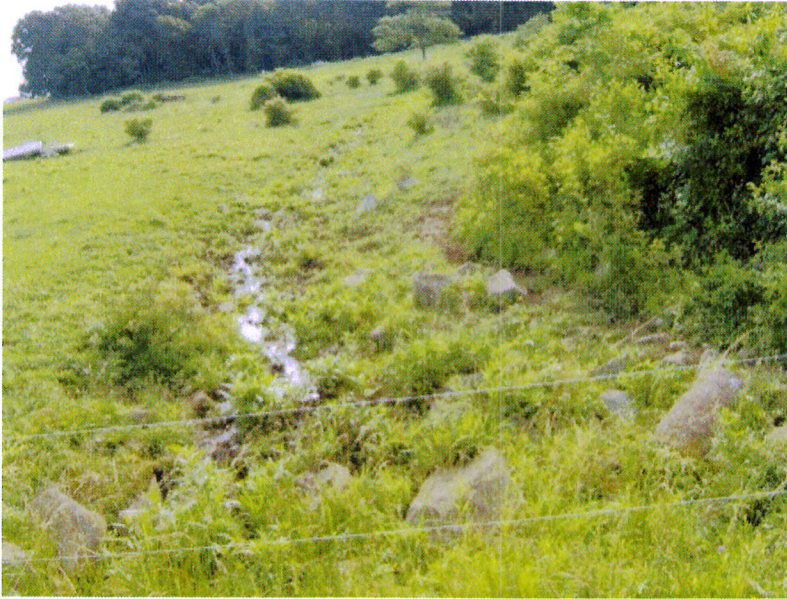
Impacted Stream Segment #39-40:

Within this segment, large shade trees provide canopy over much of the stream. The understory area is a pasture where livestock have direct access to the stream. The streambanks are stable. Of primary concern within this segment is the nutrient and pathogen inputs from the livestock being discharged directly into the stream.

Restoration of this area should include streambank fencing with stabilized stream crossings. The existing large trees should be maintained to continue shading the stream. After the fencing is installed, the riparian zone should be allowed to grow into a more effective stream buffer.

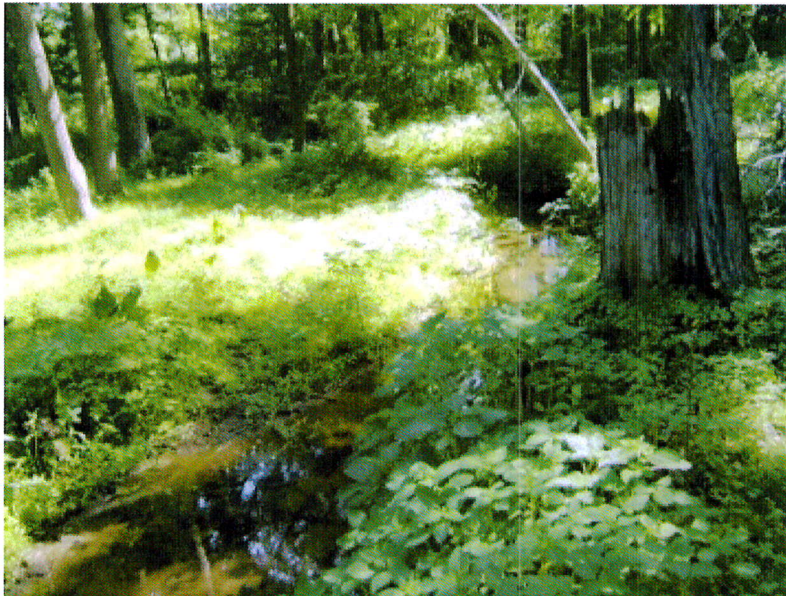
Impacted Stream Segment #43-44:

Within this forested area, livestock have direct access to the stream. The stream within this area includes several fringe wetlands and has stable banks.

Conservation practices within this area should focus on installation of streambank fencing to keep livestock out of the stream and wetland areas. The landowner has indicated that he intends to install streambank fencing within the next year and is actively working with the Brandywine Conservancy.

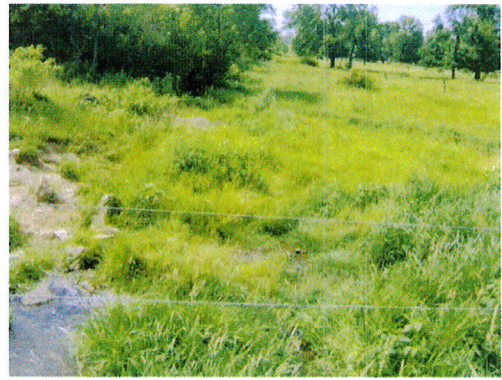
Impacted Stream Segment # 46-49:

Within this stream segment, livestock have direct access to the stream as it flows through a meadow area. Livestock stocking density and corresponding grazing appear to be light within this area and the streambanks are stable. A pond located along the western streambank was green with an algal bloom on the day of the streamwalk. Excessive nutrient and pathogen inputs likely impact the stream and pond in this area.

Streambank fencing and installation of effective buffer areas around the stream and pond should be the top priority of restoration in this area. After the livestock are removed from the riparian zone and the immediate vicinity of the pond, ongoing monitoring should be conducted to determine if additional nutrient reductions will be necessary to improve the biology of the stream and pond.

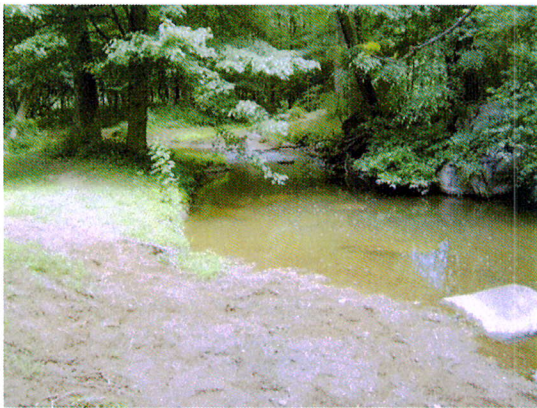
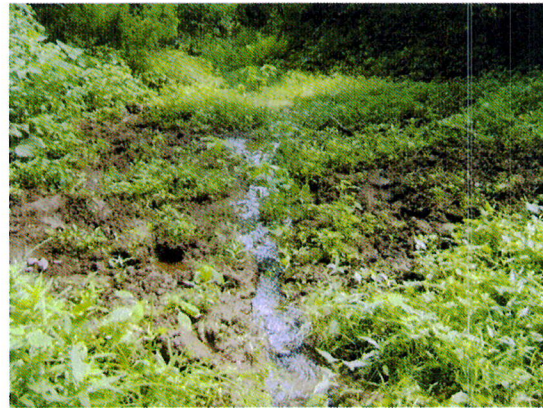
Impacted Stream Segment #50-54:

Livestock within this stream segment have direct access to the stream. The riparian zone is forested within the upstream portion of the segment. The downstream portion of the segment is partly shaded by a small buffer where livestock are fenced out of the stream by fencing located at the top of the streambank. Livestock cross the stream and a small unnamed tributary in several areas and have made the streambanks unstable in those locations.

Restoration of this area should include installing streambank fencing throughout the upper portion of the segment and widening the downstream fencing to include a vegetated filter strip to help filter runoff discharging to the stream. In the locations where livestock cross the stream and have contributed to the instability of the banks, stabilization and installation of livestock crossing structures should occur. Within the downstream segment, the streambank fencing should be extended to include several wetland areas located to the east of the stream.
