Upper West Branch Brandywine Stream Restoration Project 2015 to 2016

This project restored 1,300 feet of stream on the upper west branch Brandywine Creek in Honey Brook Township. The work involved stream bank stabilization, in-stream structures such as cross vanes, J-hooks and toe rip-rap. In addition, three livestock crossings were installed for access to pastures as well as fencing the entire length of the stream. A tree-and-shrub buffer was planted to complete the project. Construction was in fall 2014 and the buffer planting was in April 2015.

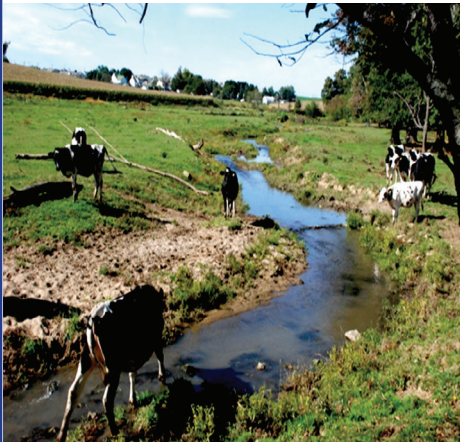
Stream before restoration

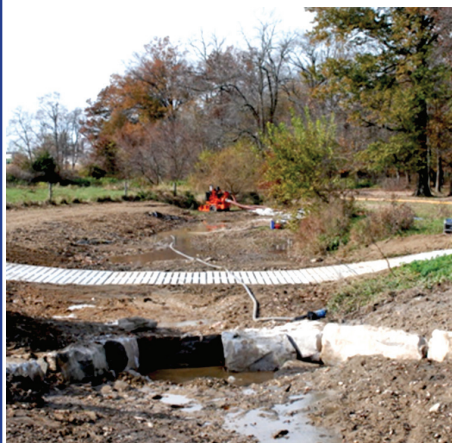
Cross vane and livestock crossing installation

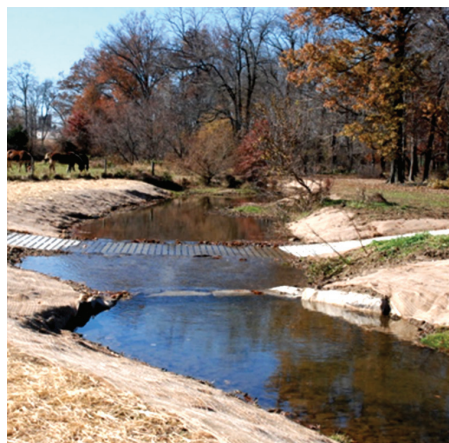
Stream livestock crossing

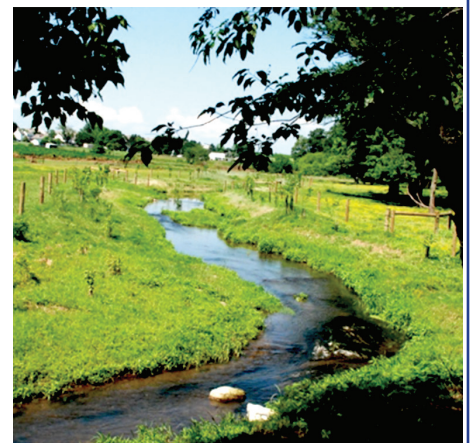
Stream after restoration
