Pocopson Creek and Browning Barn Tributary Watershed Assessment Report

**Pocopson Township, East Marlborough Township, Newlin Township,
Pennsbury Township, and Kennett Township,
Chester County, Pennsylvania**

September 9, 2025

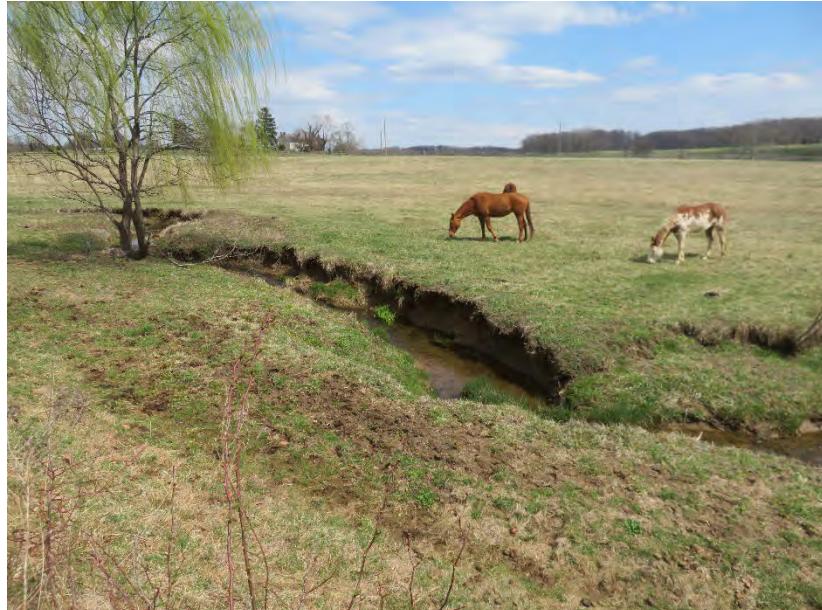
Within the Pocopson Creek and Browning Barn Tributary Watersheds, the stream corridor contains substantial sediment deposits that have accumulated during decades of farming within the watershed. These accumulated “legacy” sediments continue to impact the stream system as the streambanks erode. The accelerated erosion and siltation of the streambanks may be minimized through streambank stabilization and floodplain restoration projects. While soil loss from upland areas has decreased with a decrease in farming within the watershed and from the implementation of conservation farming techniques, siltation from the uplands still reaches the stream corridor, and more opportunities for conservation exist. In this assessment, siltation levels within the stream are analyzed as part of the habitat assessment.

Livestock graze along Pocopson Creek

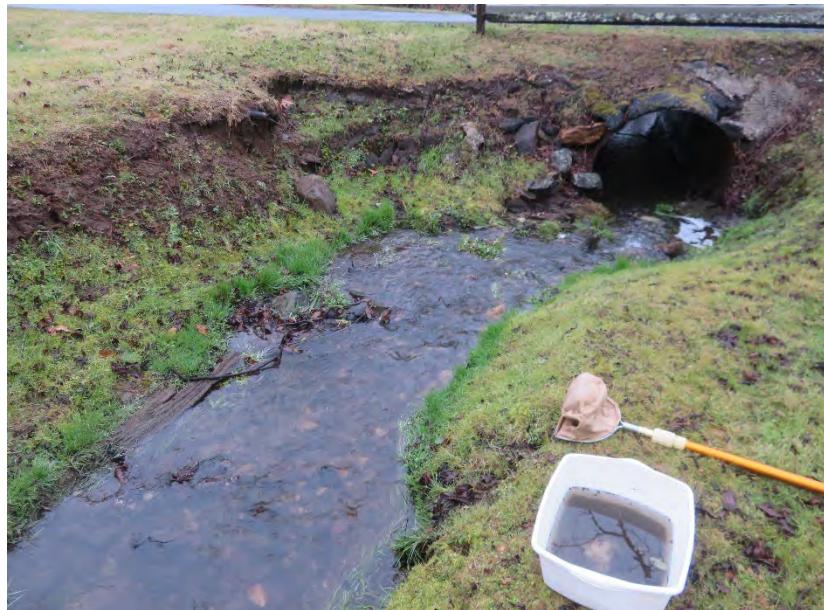
The Pennsylvania Department of Environmental Protection (PA DEP) Wadeable Riffle-Run Stream Macroinvertebrate Data Collection Protocol (PA DEP, 2023(a)) was utilized to collect benthic macroinvertebrates at each of the sample locations. Field sampling occurred on December 17, 2024. The 6 D-frame method of sample collection was utilized in accordance with the PA DEP Standardized Biological Field Collection and Laboratory Methods (PA DEP, 2006; PA DEP, 2023(a)). Samples were processed, sub-sampled, and identified in the lab by Clauser Environmental, LLC following PA DEP protocols (PA DEP, 2015). Identification of collected organisms was conducted with the aid of established taxonomic keys (Merrit and Cummins, 1996; Pekarsky et al., 1990).

Macroinvertebrate sampling along the Browning Barn Tributary

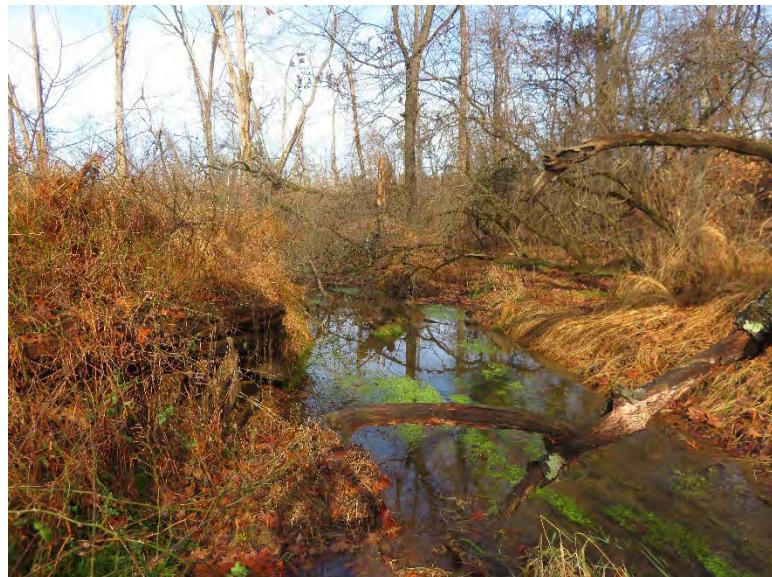
Sub-Watershed A is at the top of the Pocopson Creek Watershed and includes the first unnamed tributary (UNT) to Pocopson Creek. The UNT flows through residential developments before being picked up by Pocopson Creek. Sub-Watershed A is the least forested sub-watershed, being only 28.43% forested. The water quality of the first UNT to Pocopson Creek was assessed at Sample Site 1. Sample Site 1 was impacted by sedimentation and has the lowest IBI value of 28.4, indicating it had the most impaired macroinvertebrate

community in the watershed. During 2024, there was a significant drought within the watershed that may have reduced flow levels within the stream to a point where it may have potentially impacted the macroinvertebrate community at Sample Site 1. Nitrogen concentrations exceeded impairment thresholds, but phosphorus levels were within the range for unimpaired streams. The high nitrogen and sedimentation impairments are likely the result of increased stormwater from development in the watershed depositing legacy sediment from historic agricultural operations into the stream. A review of historic aerial photographs shows a significant increase in housing developments in the last 50 years (Appendix B). Increased stormwater runoff from housing developments surrounding the tributary coupled with nutrient and pesticide discharges from lawn care are exacerbating preexisting agricultural impacts to the upstream watershed. Appropriate best management practices for water quality improvement in this sub-watershed should focus on stormwater quality and volume management controls, wetland creation, and stabilizing streambanks. Additionally, the application of lawn fertilizers and chemicals should be managed to reduce future impacts on water quality.

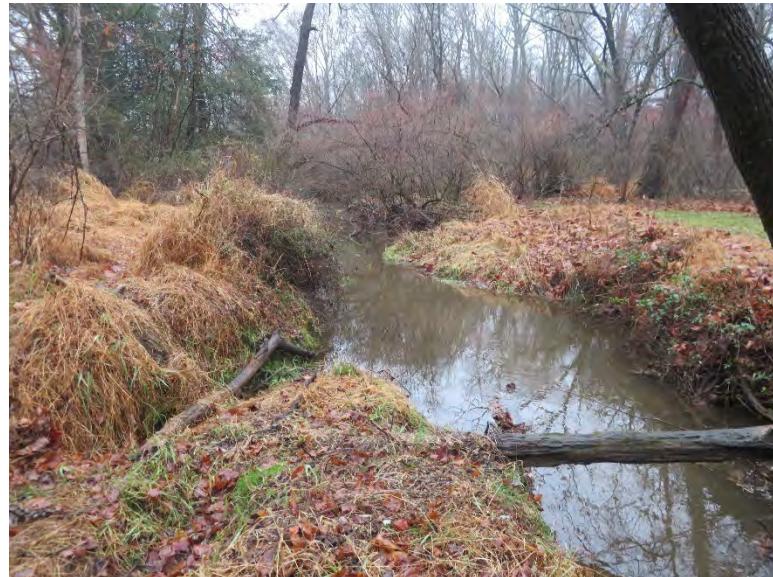
Sub-Watershed B captures the stretch of Pocopson Creek from its origin to its confluence with an UNT south of Marlborough Road. This sub-watershed is dominated by agricultural operations, leaving only 0.3% of its area to urban development, and 32.96% forested. The water quality of Sub-Watershed C is captured at Sample Site 2. Despite an unimpaired total habitat score, habitat is impaired due to impaired riffle/run habitats and the condition of streambanks. Total phosphorus and nitrogen concentrations for Sample Site 2

exceed the thresholds for impairment. The sedimentation observed during the habitat assessment (Appendix G) and the high nutrient concentrations (Tables 6 and 7) are primarily the result of legacy sediments with nutrients bound to them being eroded into the stream channel. The macroinvertebrate community is impaired with an IBI value of 40.7. Poor instream cover, sediment loading, and increased nutrients likely all contribute to the macroinvertebrate community impairment. Upstream of Sample Site 2, long sections of Pocopson Creek flow through agricultural areas with little or no riparian buffer where the streambanks are eroding sediment into the stream (Appendix A). These areas hold substantial potential to restore the floodplain and create wetlands to aid in filtering nutrients, sediment, and other pollutants from upstream. Riparian buffer plantings, streambank stabilization, floodplain reconnection, and wetland creation should be considered to aid in restoring this sub-watershed.

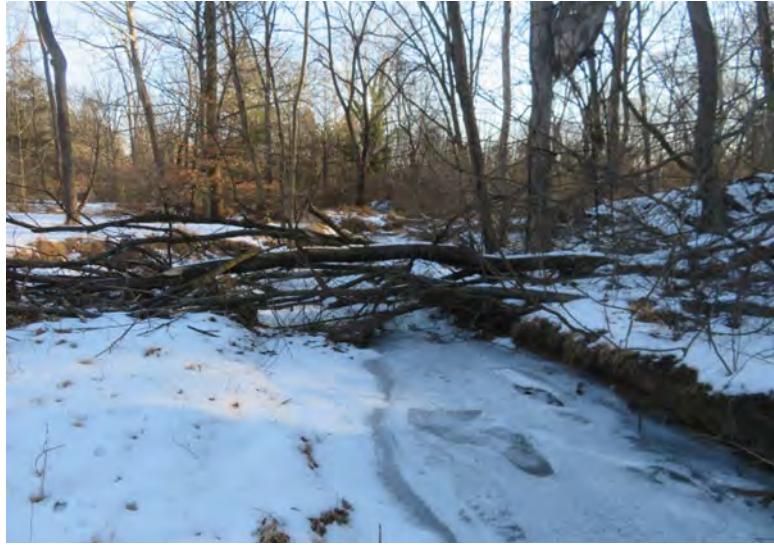
Sub-Watershed C captures an UNT that discharges into Pocopson Creek just south of the Marlborough Road and Red Lion Road intersection. This sub-watershed is approximately 0.04% developed area and 42.68% forested area. The water quality of the UNT and Sub-Watershed C is captured by Sample Site 3. This sample site has an unimpaired macroinvertebrate community, with an IBI score of 66.4. Sample Site 3 is unimpaired for total habitat score, but impaired for both riffle/run habitat and condition of banks. These impaired scores are due to ongoing erosion and sedimentation. Sample Point 3 has the highest concentrations of nitrogen in this study, but phosphorus

concentrations are below the established thresholds for impairment. The UNT primarily runs through forested areas and open meadows. A review of the historic aerial photography indicates that the entire sub-watershed was primarily agricultural fields through at least 1971 (Appendix B). The legacy impacts of agriculture in this area, coupled with the stormwater from upslope development, is likely the main cause of impairment. Within this sub-watershed, appropriate best management practices for water quality improvement should focus on habitat improvements, streambank stabilization, and stormwater quality and volume management controls.

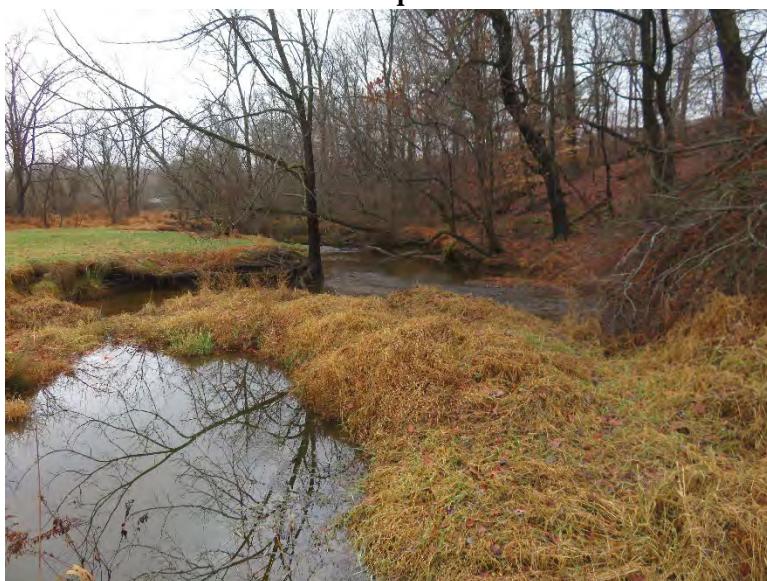
Sample Site 4

Sub-Watershed D stretches from Pocopson Creek's confluence with an UNT south of Marlborough Road and Red Lion Road to just above where Pocopson Creek joins its largest UNT. Sub-Watershed D has a similar profile to other sub-watersheds, with only 0.5% urban development and 44.40% forested area. The water quality of this section of Pocopson Creek and Sub-watershed D is captured by Sample Site 4. The water quality in this sub-watershed is impaired for nutrients with both measured nitrogen concentrations and one measured phosphorus concentration surpassing the threshold for impairment. This stream section is unimpaired for macroinvertebrate IBI (57.6) and for total habitat.

However, the riffle/run and bank condition scores were impaired, making the site impaired for habitat. Long stretches of Pocopson Creek within Sub-Watershed D are mowed to the edge of the stream, leaving the streambanks exposed and vulnerable to erosion. Sediment deposition within the channel from the eroding streambanks within Sub-Watershed D is likely impacting the macroinvertebrate community, as the IBI score is unimpaired but still suboptimal (Appendix

G). Riparian buffer plantings, stormwater retrofits to decrease discharges to the stream, streambank stabilization, floodplain reconnection, and wetland creation should be considered to restore this sub-watershed. There is significant potential for restoration work in this watershed because the stream runs through fields and mowed areas that offer ample space for work to be completed.

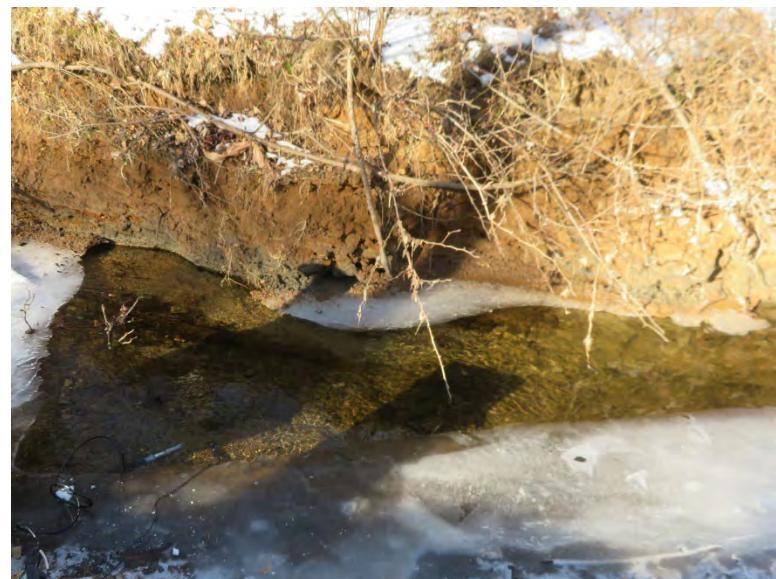
Sub-Watershed E includes the area that drains to the longest UNT to Pocopson Creek, which flows from the south and originates on Longwood Gardens property. This sub-watershed consists of residential subdivisions and agricultural areas that are not immediately adjacent to the mainstem. Sub-Watershed E is 47.19% forested and 4.93% urban development. The water quality of Sub-Watershed E is captured by Sample Sites 5, 6, and 7. Sample Site 5 is the only sample site in this study with an IBI score (53.1) above the attainment threshold to still be considered impaired for macroinvertebrates. This is because the sample meets the criteria for impairment where the Beck's Index standardized score is <33.3 and the percent sensitive individuals score <25.0 . Sample Site 5 was unimpaired for total habitat but

had impaired scores of 22 for both the condition of banks and riffle/run habitat. Upstream of Sample Site 5, the tributary runs through residential areas, and sections of wetlands and forests. This site is unimpaired for phosphorus but has nitrogen concentrations that surpass the thresholds for impairment. Sample Site 6 was the only sample site to be unimpaired across all metrics. Sample Site 6 has an IBI score of 61.9 and unimpaired habitat scores. Most of the UNT upstream of Site 6 has a forested buffer on both sides of the stream. This buffer helps to capture pollutants from surrounding residences and agricultural fields and strengthens the banks, preventing erosion. Site 6 has noticeably more small litter than the other sample sites, due to its proximity to the busy Lenape Road (Route 52). Sample Site 7 is located just upstream of where the UNT discharges into Pocopson Creek. Sample Site 7 has an unimpaired macroinvertebrate community with an IBI score of 55.3. The total habitat score for Sample Site 7 is unimpaired (162), but it has the lowest riffle run score (17) and second lowest condition of banks score (16). These habitat scores are low due to erosion and sedimentation within the stream channel (Sample Site 7 photo). Site 7 is unimpaired for phosphorus but is impaired for nitrogen. A significant portion of the UNT to Pocopson Creek runs through areas with minimal riparian vegetation. The impacts of sediment deposition, erosion, and elevated nutrient

concentrations throughout the sub-watershed are likely due to increased stormwater flows from recent development. Based on a review of historical and current aerial imagery, much of the watershed has been converted from agricultural to residential uses in the last 50 years (Appendices A and B). Targeted best management practices for this sub-watershed include litter cleanups, riparian buffer plantings, streambank stabilization and floodplain reconnection. Where possible, floodplain wetlands should be created to aid in absorbing flooding flows and address sedimentation and erosion concerns.

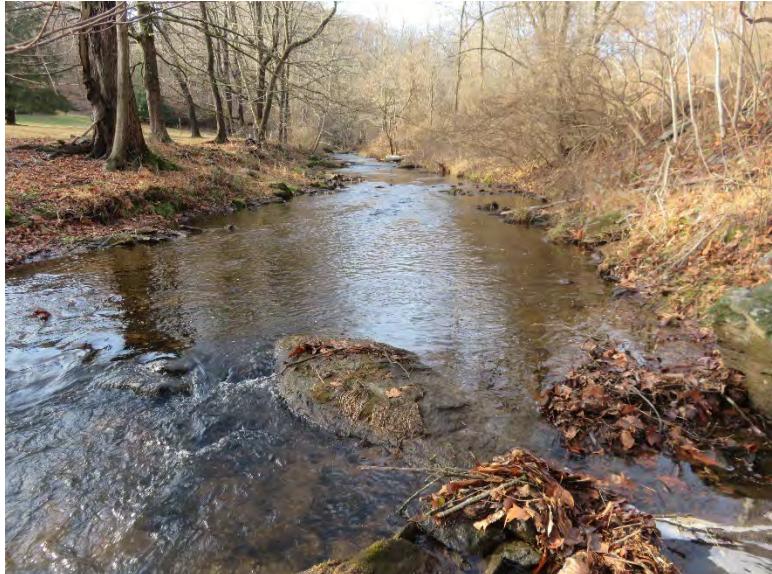
Sub-Watershed F captures Pocopson Creek and its tributaries from just downstream of where it picks up the largest UNT to where Pocopson Creek meets its confluence with Brandywine Creek. As the Sub-Watershed at the bottom of the overall watershed, Sub-Watershed F is impacted by the water quality of Sub-Watersheds A-E. Sub-Watershed F is significantly more developed than all of the other sub-watersheds, with 15.36% urban development. Despite this, it is still a relatively well-forested area with 42.10% forest. Sample Sites 8 and 9, both located on Pocopson Creek, capture watershed F. These sites have the healthiest macroinvertebrate communities of the entire watershed, with IBI scores of 68.50 and 73.32 respectively. Sample Site 8 has one of the highest total habitat scores, however, the riffle/run habitat is impaired due to sediment deposition (Appendix G). Sample Site 8 has the highest condition of banks score of all the sites, and erosion is not a significant concern at this site. Sample Site 8 is impaired for nutrients, with both phosphorus and nitrogen concentrations exceeding impairment thresholds. Sample Site 9, which captures the downstream end of the Pocopson Creek Watershed,

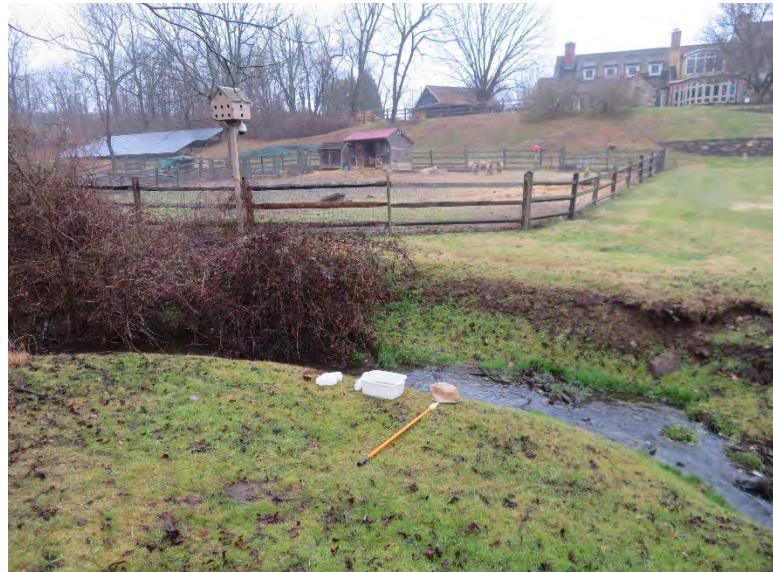
The Browning Barn Tributary Watershed, identified as **Sub-Watershed G** in this study, is approximately 53.49% forested and only 0.06% urban. This watershed is less developed than the Pocopson Creek Watershed. Sample Site 10 is located near the mouth of the Browning Barn Tributary and is unimpaired for macroinvertebrate life, total habitat, and riffle/run habitat, but impaired for condition of banks (Table 3). The sample site is impaired for nitrogen concentrations, but not phosphorus concentrations. Approximately half of the total length of the tributary is located on property owned and managed by BRC. A review of the historic aerial photography indicates that between 1937 and 1971 this and neighboring parcels were in active agriculture (Appendix B). In 1981, when BRC took possession of the parcel as part of the Myrick Conservation Center, the organization prioritized restoration work on the property. BRC planted trees within the riparian zone of the stream, constructed a bioswale to minimize erosion into the stream, and converted the remaining agricultural fields to no-till contour farming. These efforts, paired with the expanding forested area within the riparian zone have likely helped stabilize streambanks and improve habitat for macroinvertebrates and other life throughout the stream. Legacy sediment is likely a major factor in stream bank impairment and conditions within the stream channel are likely still improving. Although meeting attainment thresholds for multiple criteria, the habitat and diversity of the stream bank could still be improved. Installing additional riparian buffer enhancements where opportunities exist and streambank stabilization could directly relate to improved water quality within this sub-watershed.

Improving the water quality and habitat within the Pocopson Creek and Browning Barn Tributary Watersheds should lead to biological improvements within the stream community. The primary focus of restoration within the watersheds should be on addressing the current and legacy impacts of agriculture as well as increasing stormwater concerns from suburban sprawl. To make substantial improvements within the watershed, best management practices such as floodplain restoration, wetland creation, streambank stabilization, stormwater management retrofits, litter cleanups, native riparian buffer installations, and invasive species removals should be considered.
