Pocopson Creek and Browning Barn Tributary Watersheds Restoration Plan

**Pocopson Township, East Marlborough Township, Newlin Township,
Pennsbury Township, and Kennett Township,
Chester County, Pennsylvania**

September 18, 2025

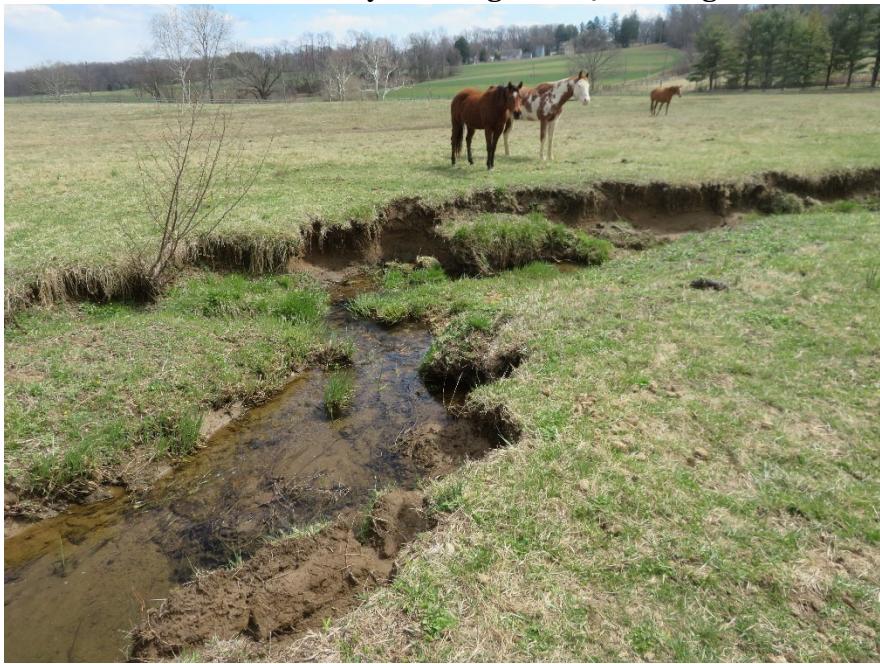
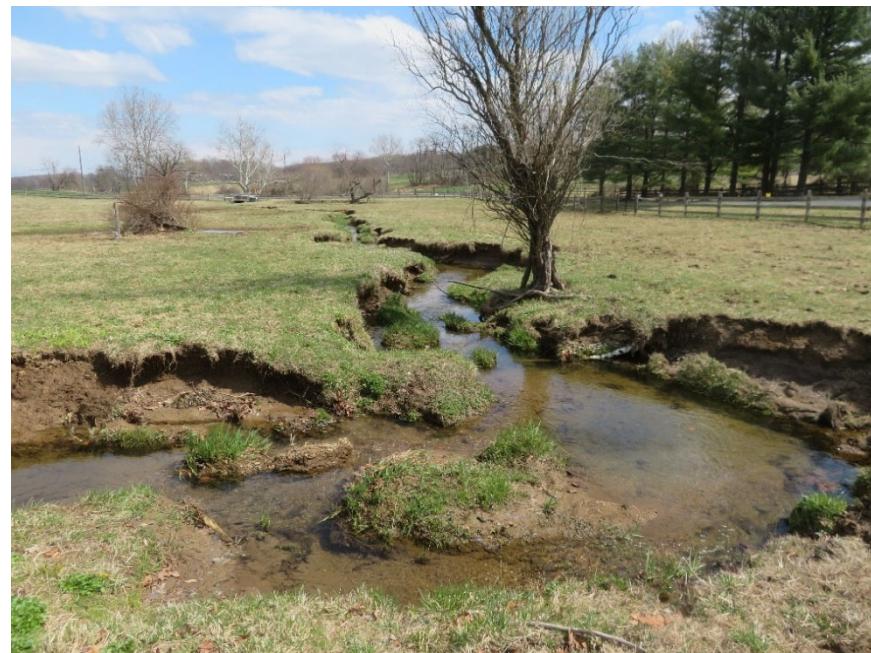
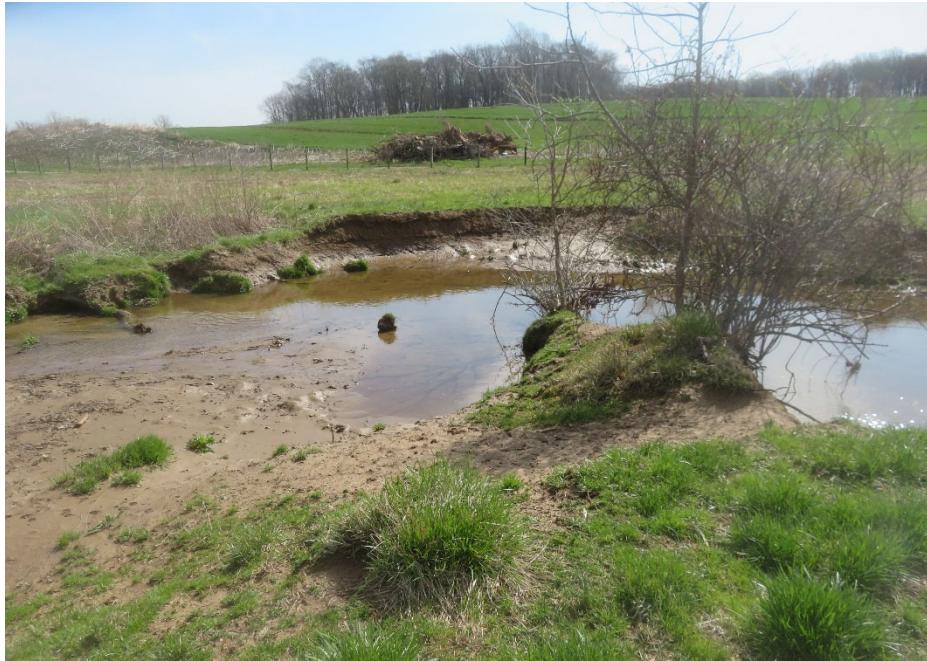
Along this stretch, there is an equine pasture with direct access to the stream. Throughout this stretch, streambanks are undercut and actively eroding 2 to 4 feet high. Nutrients from horse manure are carried downstream with the eroded sediment. The entire stretch lacks a riparian buffer, with the few remaining trees threatened by the ongoing erosion. The lack of a riparian buffer to shade the stream results in the warming of the water as it flows through the pasture, further impairing water quality and benthic habitats.

The most effective way to restore this area is to address the eroding streambanks while reducing future impacts. Fencing the horses out of the stream and installing equine crossings will ensure livestock safety and prevent further bank degradation. Grading the streambanks to a stable slope would minimize additional erosion. Instream structures

such as log vanes and root wads should be installed to create fish habitat and reduce near-bank friction during vegetation establishment. Planting native riparian buffers within the fenced stream corridor will help stabilize the banks, provide shade to cool the water, enhance biodiversity, and create valuable wildlife habitat. As the landowner for this stream section expressed interest in partnering with BRC to complete restoration work within

the pasture during the site visit, it is recommended that this high priority project be one of the first to be pursued.

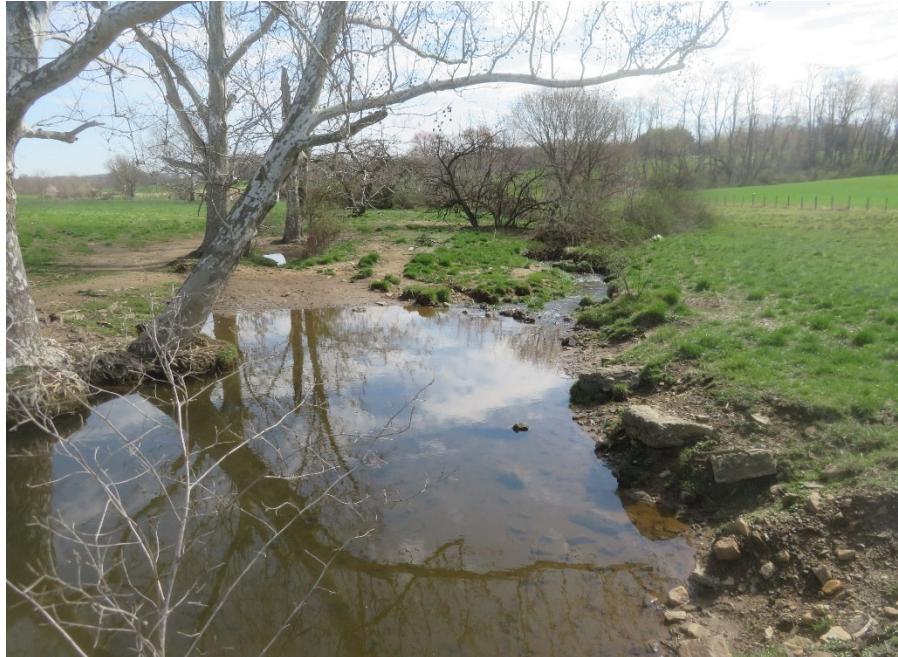
Impacted Stream Segment #10-11:

degrading the aquatic habitat and water quality on the site and downstream. There is little to no riparian buffer, and some of the few large trees along the stream are threatened by the active erosion.

This stream section requires a holistic approach to stream restoration. Fencing cattle out of the stream and installing stable livestock crossings will help reduce the input of harmful nutrients entering the stream and streambank degradation. The streambanks should be graded to a stable slope of 4:1 or flatter and planted with native vegetation within the fenced area. The use of instream structures such as rock and log structures will increase the diversity of microhabitats in the stream and protect the restored streambanks as the vegetation becomes established.

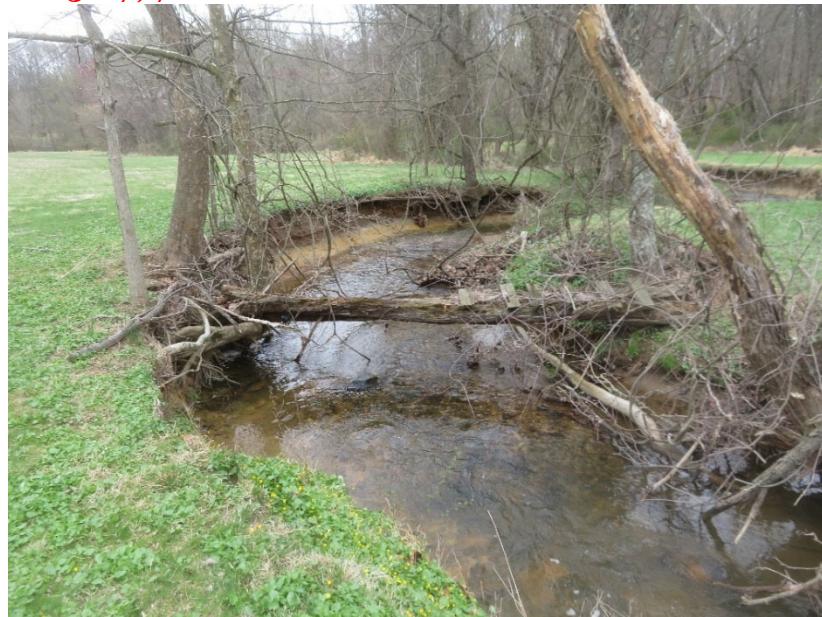
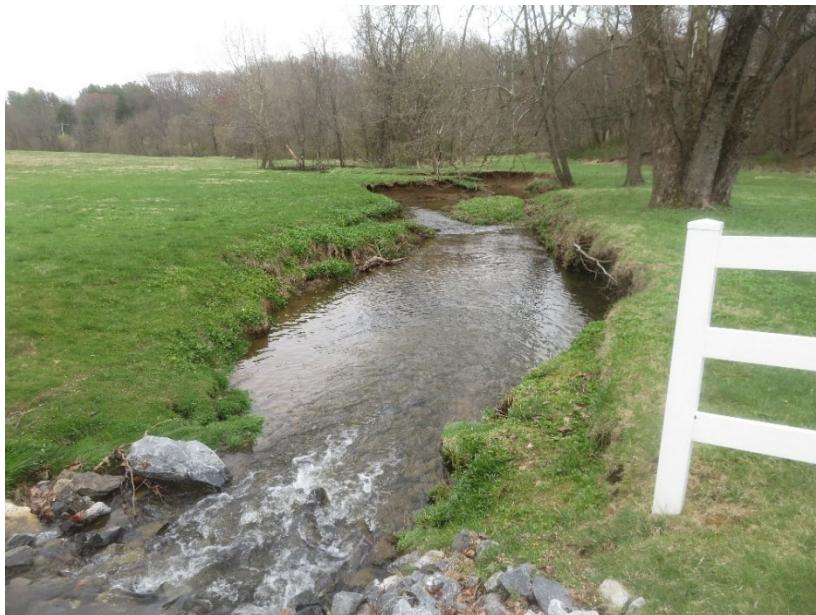
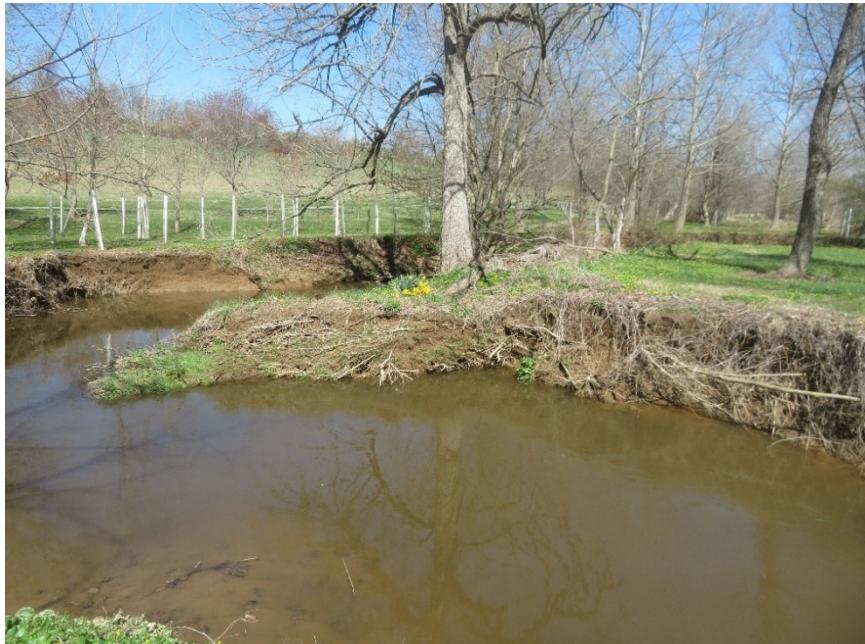
Impacted Stream Segment #25-27, 78:

The Haines Grist and Saw Mill dam was located within this stream segment and has left a legacy of sediment deposited in the dam's backwater. The stream cut through the sediment and currently has actively eroding 4 to 5 feet high streambanks. The erosion is exacerbated by mowing to the top of the banks that limits the establishment of stabilizing vegetation. The ongoing erosion is adding sediment to the stream bed, which negatively impacts the aquatic habitat and water quality both at this site and downstream. The riparian buffer is limited along this stretch of the stream, reducing the available habitat within the corridor.

channel improvements that include natural restoration design elements would help to mitigate future flooding, improve water quality, create better aquatic habitat, and protect the stream channel from future erosion. The creation of upland pollinator meadows in these mowed fields would help to increase biodiversity, create habitat, and improve the natural filtration of contaminants, sediment, and nutrients from the water entering the stream.

This stream reach would benefit from a legacy sediment removal project where the post colonial sediment is removed and the stream is reconnected to a floodplain at its historic elevation. Floodplain wetlands, a forested riparian zone, and upland meadow's should be integrated into the design if permitted by the landowner. The creation of wetlands, floodplain reconnection, tree and shrub plantings, and stream

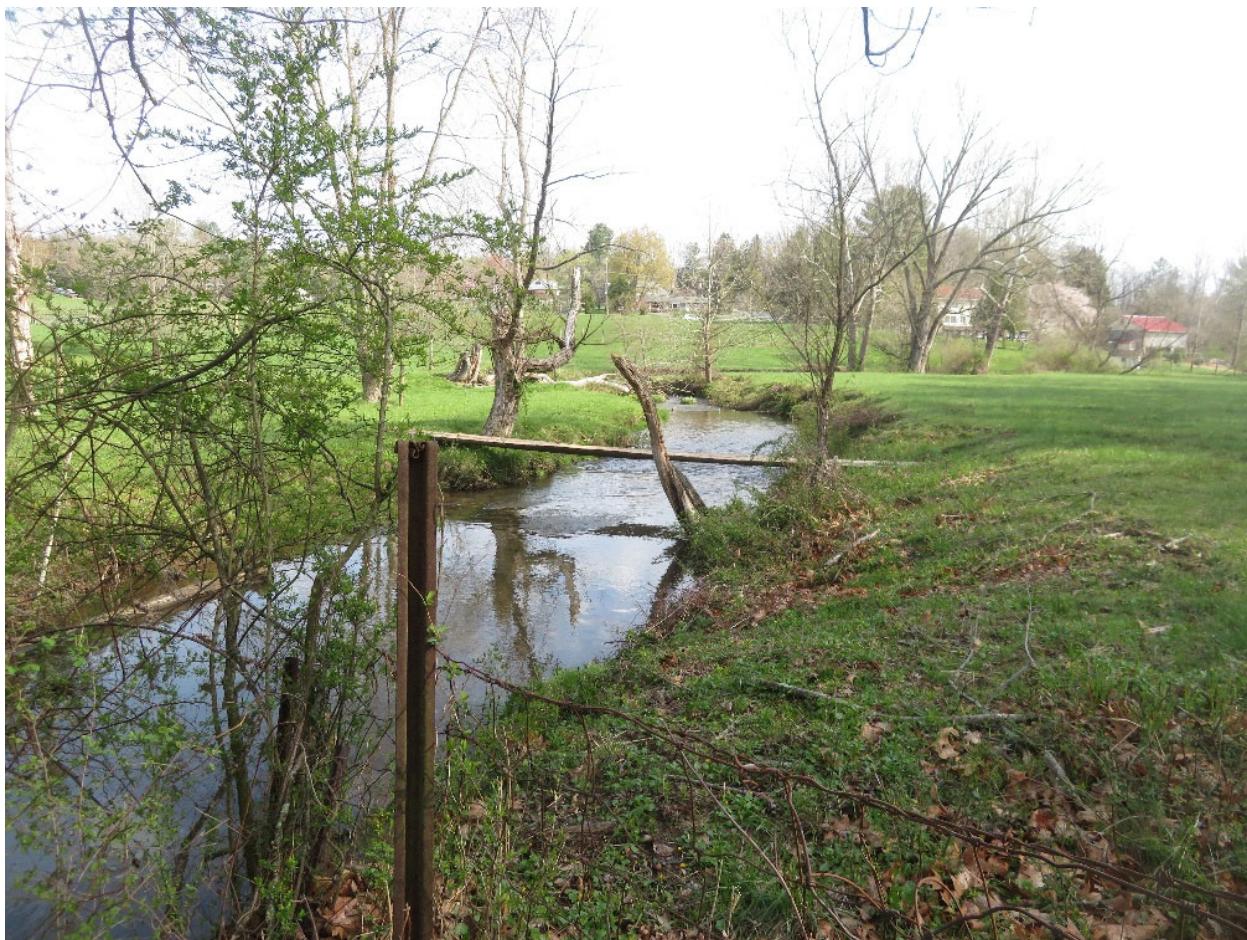
Impacted Stream Segment #39-40:

This stretch is within an active livestock pasture where animals have direct access to the stream. The pasture is mowed to the top of the 2-3' high eroding streambanks. The eroding streambanks discharge nutrients and sediment to the stream channel, which, in addition to nutrients from livestock waste, impacts water quality on the site and downstream. A breached dam breast is evident in the stream segment. The backwater from the dam likely contributed to the legacy sediment that is currently eroding on this site.

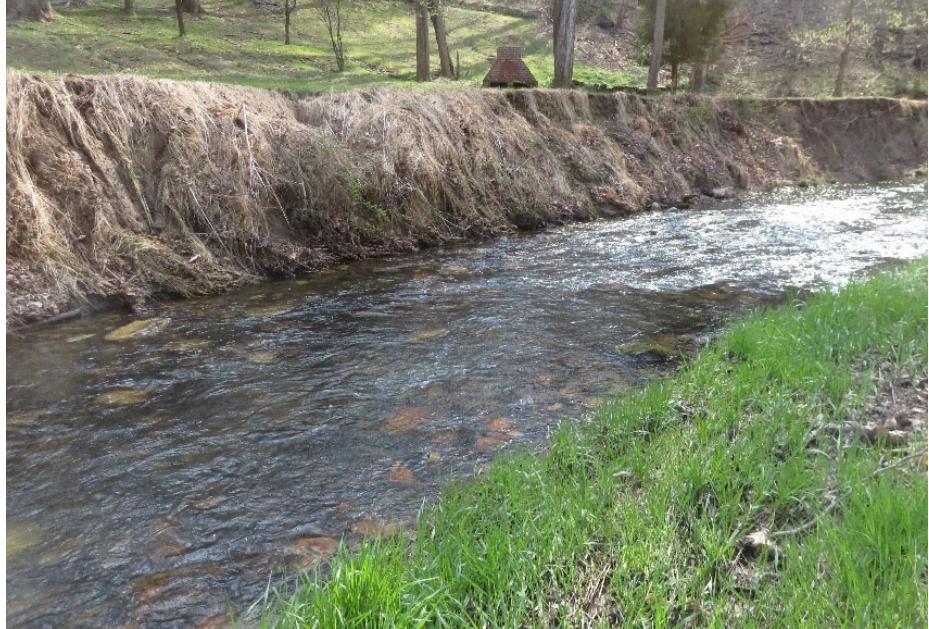
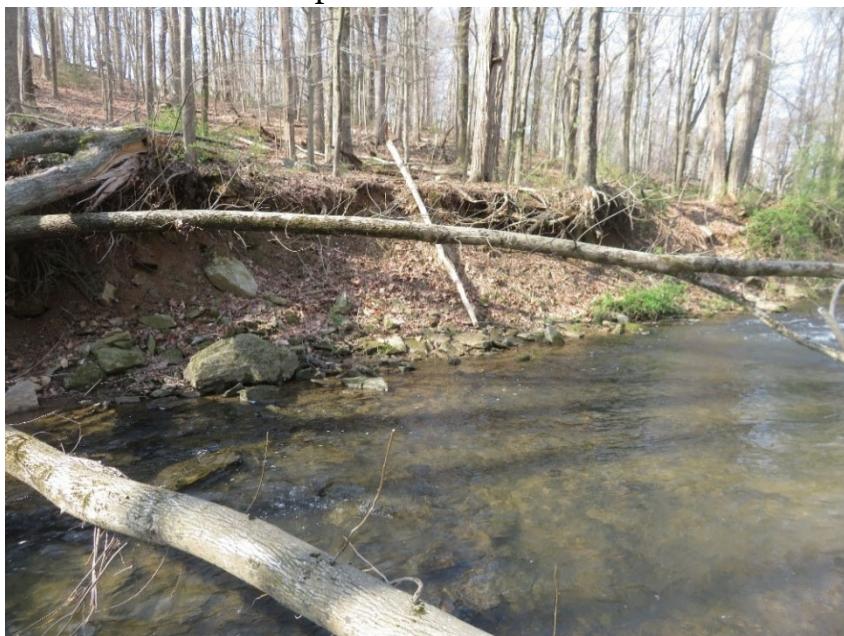
In this stretch, the streambanks are incised 5 to 8 feet and are actively eroding in many areas. In some parts of the segment, the riparian zone is mowed to the top of the streambank. The high banks in this stretch are likely due to the accumulation of legacy sediment upstream of the historic Denton's Mill dam, which was located directly downstream of this reach for over 200 years before being breached in 1935. Over time, legacy sediment deposited

in the dam's backwater area upstream of the dam. After the dam was breached, the stream downcut through the sediment, creating the 5-8 feet high eroded banks that are present today. These high banks have left the stream disconnected from its floodplain, contributing to a larger volume of water moving down the channel during storm events.

Restoration of this stream segment should focus on removing legacy sediment to reconnect the floodplain, stabilizing the stream channel, and establishing native trees and shrubs within the riparian zone. The combination of floodplain reconnection and

streambank stabilization will help to manage storm flows and improve water quality by providing a place for sediment and contaminants to settle out, where they can be broken down by the sun and ecological processes. The implementation of structures such as mudsills and rock vanes will help improve the aquatic habitat for fish, including the trout that are stocked in this area.

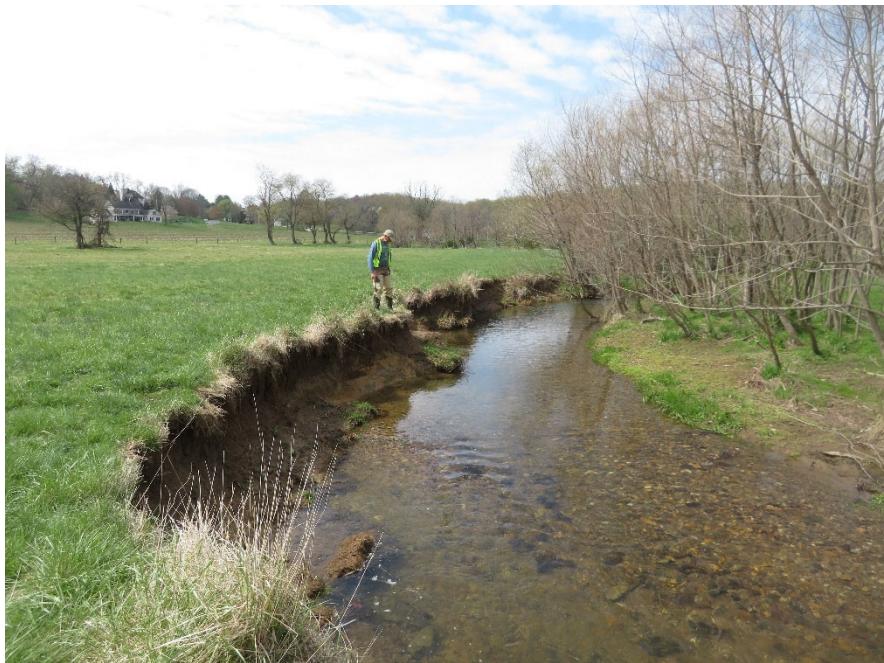
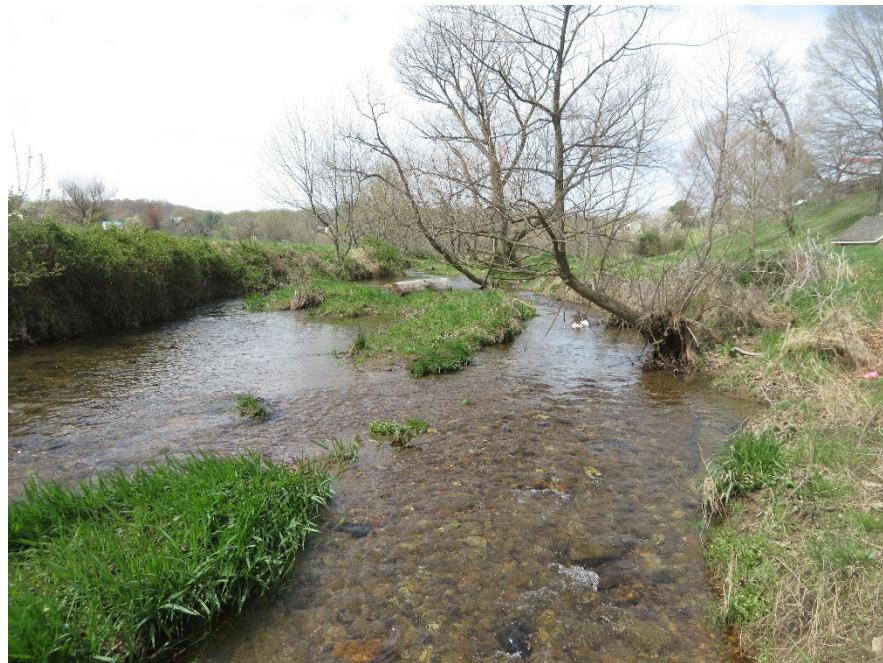
Impacted Stream Segment #49-51:

while ongoing streambank erosion washes legacy sediment into the stream.

stream segment. Streambank fencing can be used to keep cows out of the stream. A healthy riparian buffer will help to capture nutrients before they enter the stream and provide sediment and contaminants a place to settle out where they can be broken down by the sun and ecological processes. Streambank stabilization structures, including rock deflectors, root wads, and log vanes, would

help to create fish habitat and protect the streambanks while vegetation within the fenced area becomes established.

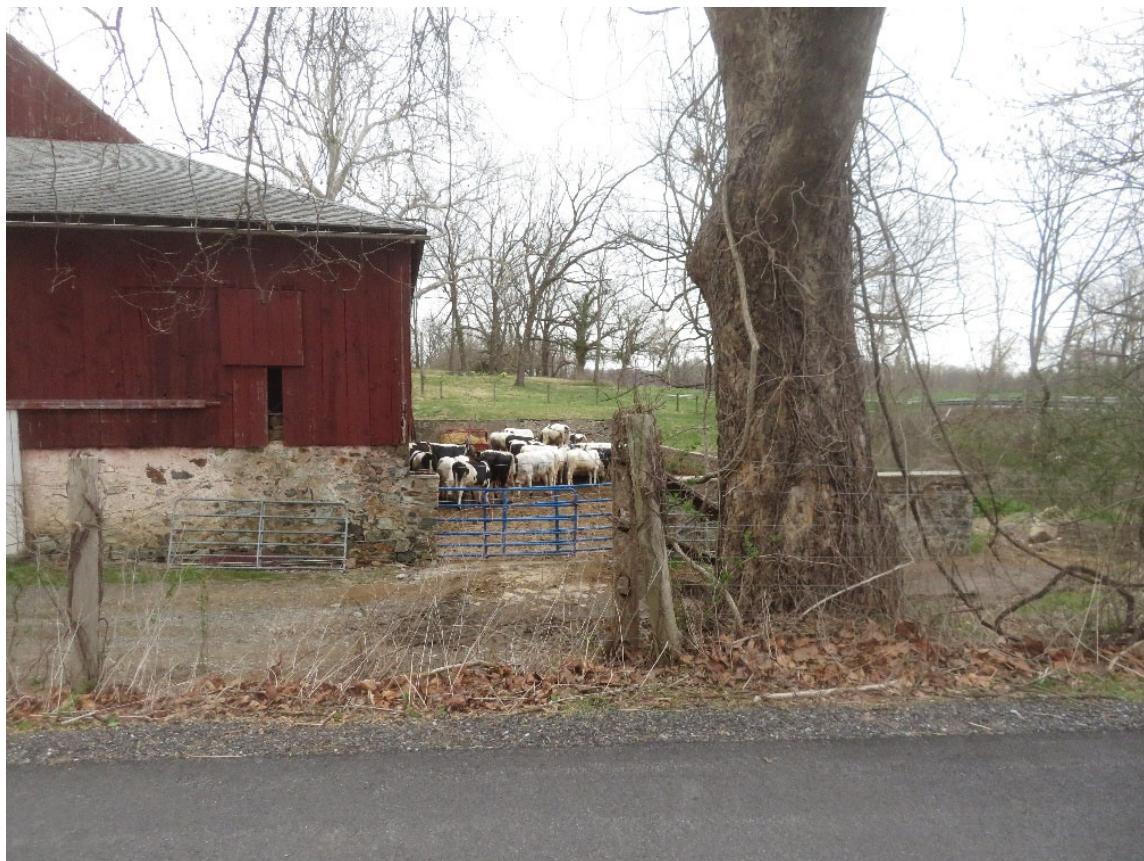
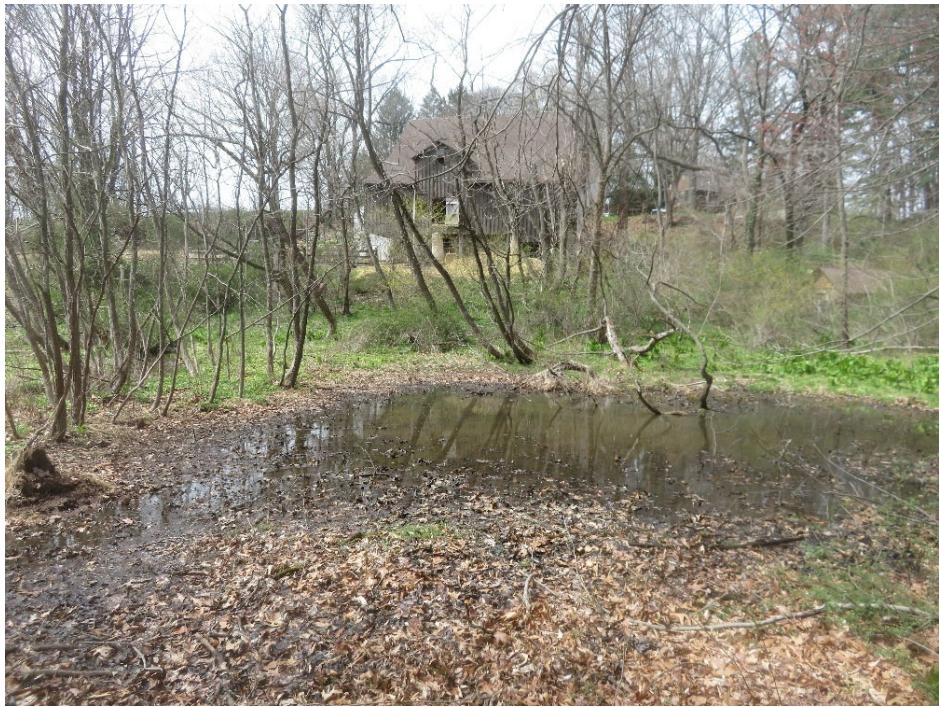
This point identifies a barnyard where many cattle are fed. Rainwater flows through the barnyard, washing nutrients and bacteria from the cattle into a swale that carries it under Unionville Wawaset Road and into an unnamed tributary to Pocopson Creek. This runoff can degrade water quality, contribute to algal blooms, and harm the already impaired aquatic life.

Barnyard enhancements could be added to protect downstream water quality. Rerouting the rainwater coming off of the barn roof to bypass the cattle enclosure would prevent the nutrients and bacteria from the manure from being carried into the stream. Barnyard surface enhancements, such as adding gravel to high-traffic areas, planting vegetated buffers to capture and filter runoff, grading swales to manage the flow path of runoff, and covering the barnyard with a roof, could all be explored as possible improvements to this site.

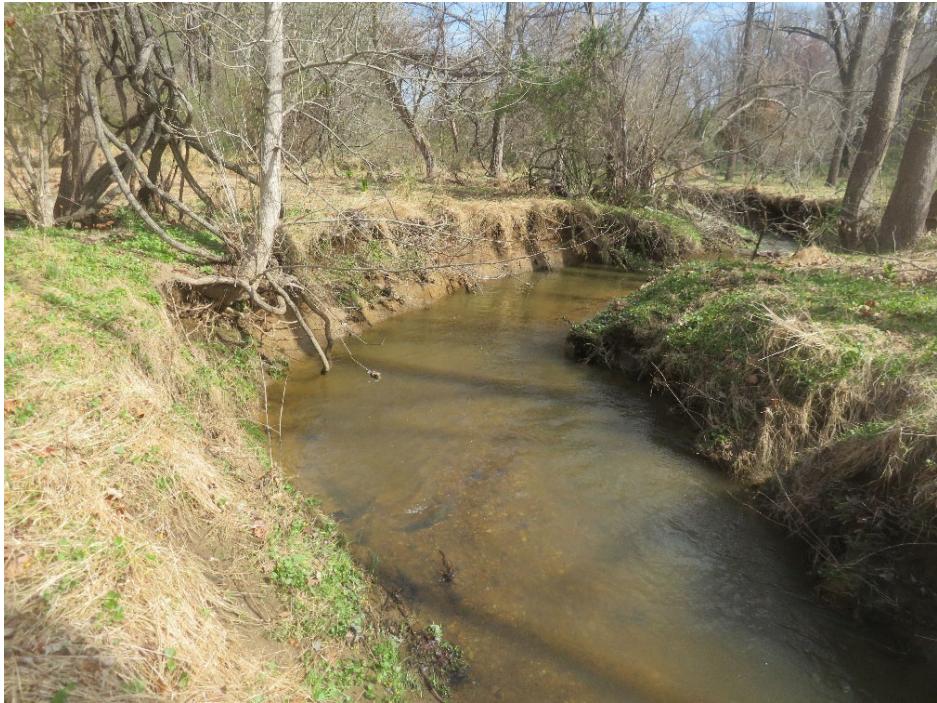
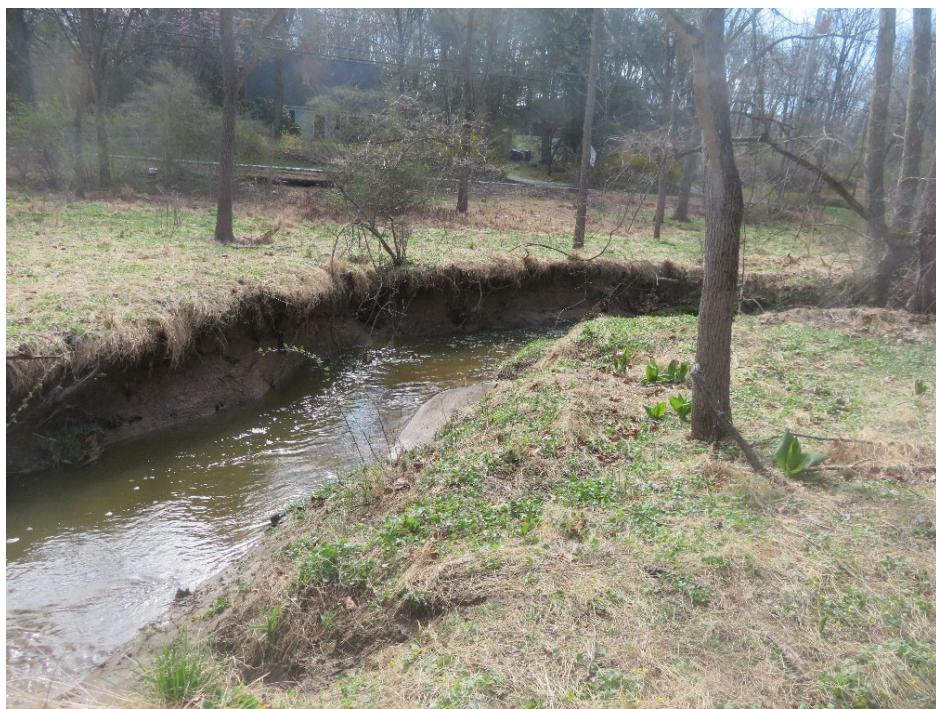
Within this stream segment, both banks of the stream are eroded. From point 100 to point 102, approximately 75% of the reach has actively eroded legacy sediment on the 2 to 4 feet high streambanks. In addition to the problem of erosion, invasive species, including Japanese stilt grass (*Microstegium vimineum*) and multiflora rose (*Rosa multiflora*), dominate the riparian zone in the areas that are not mown to the top of the bank.

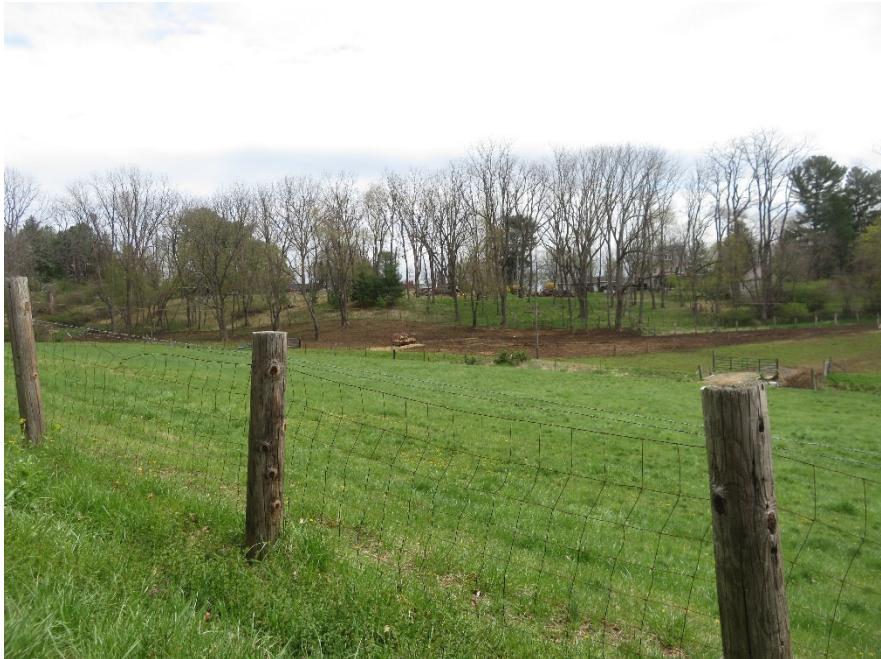
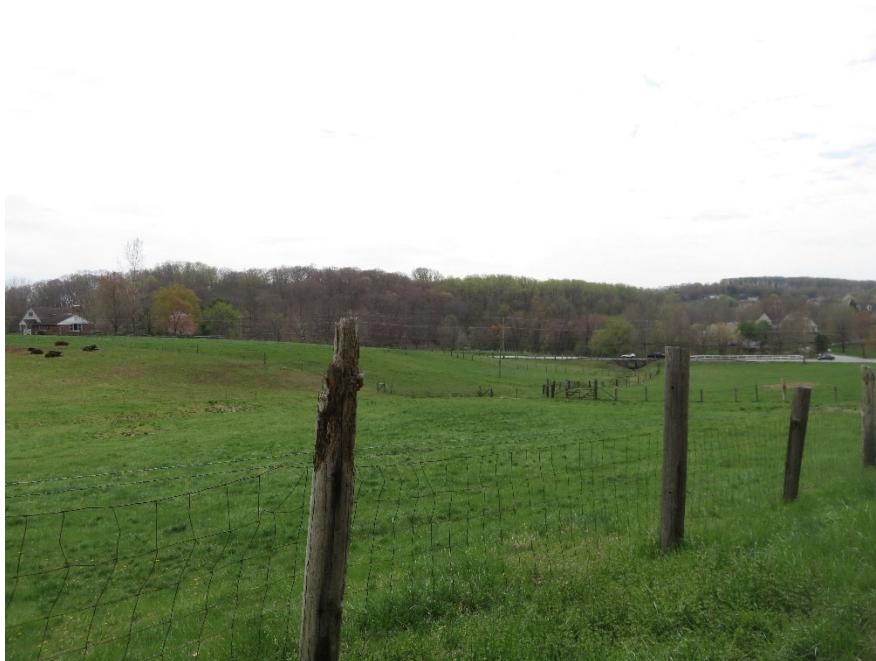
This stream section includes a small unnamed tributary that flows through an active cattle pasture. Cattle have direct access to the channel, contributing nutrients and sediment to it. The stream channel is grazed to the stream edge, and the stream is exposed to direct sunlight for over 900 feet before crossing under Lenape Road.

Restoration of this stream section should begin with collaborating with the landowner to install streambank fencing within the pasture to keep the cows out of the stream and allow for the establishment of a riparian buffer. The riparian buffer should be planted with native vegetation, including trees and shrubs, to shade the stream and create habitat. Stable cattle crossings should be installed to allow cattle to safely cross the tributary without degrading the stream.

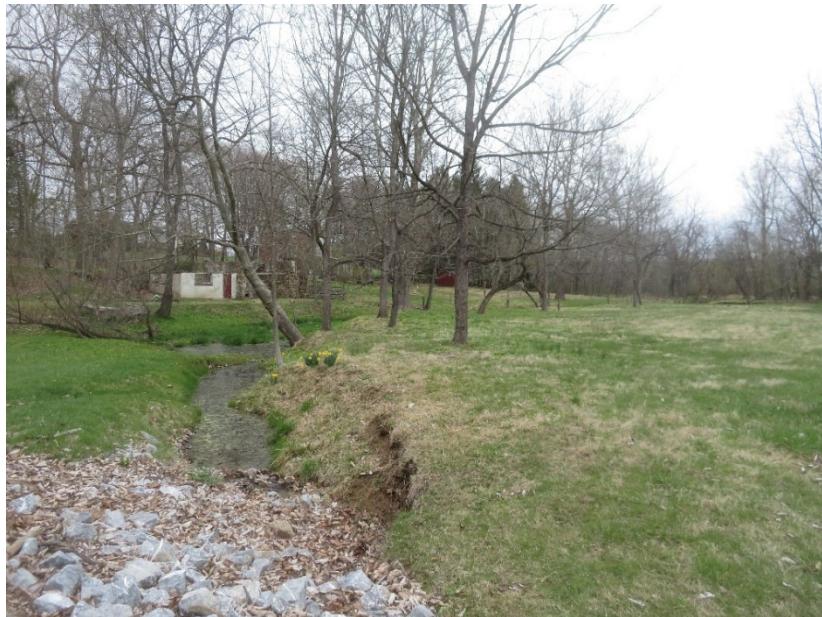
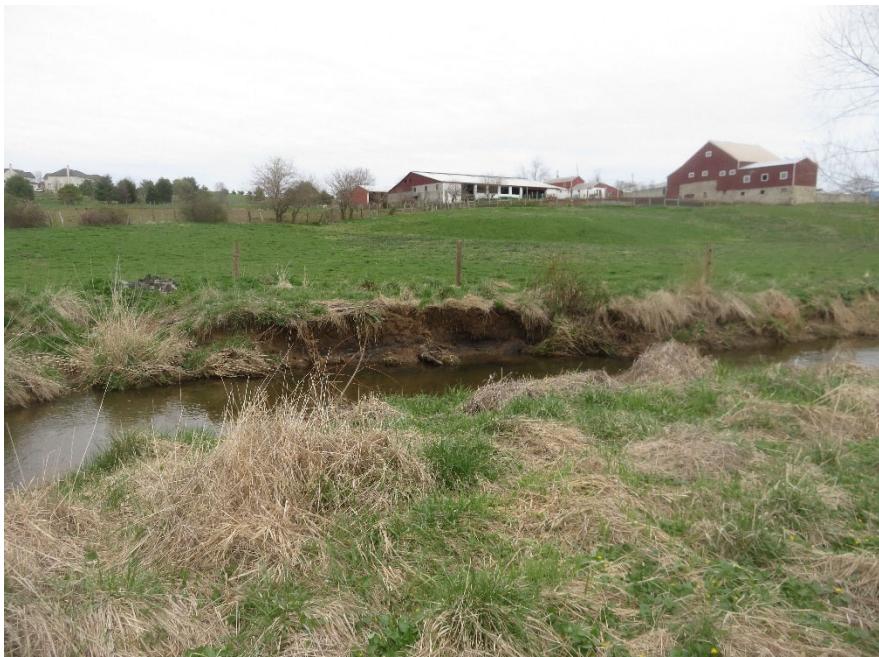
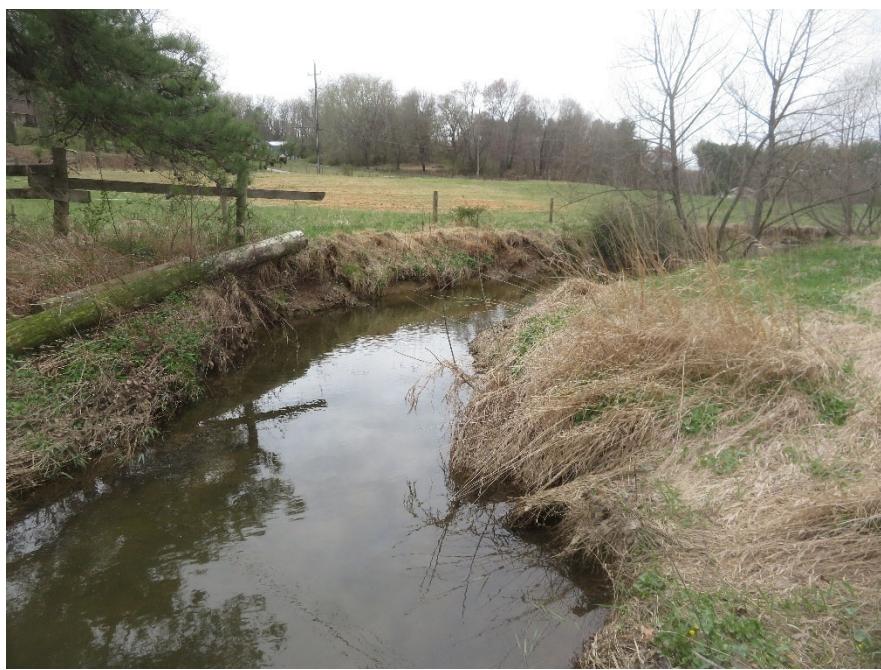
This stream reach includes the former location of Haines Grist and Sawmill. While the dam for the mill was in place, legacy sediment from upstream agriculture accumulated in the backwater of the mill dam. Upon breaching, excessive sedimentation to this stream reach began. Today, the streambanks are actively eroding and are 1 to 3 feet high and the sediment has reduced the available habitat within the stream channel. The north side of the stream lacks a riparian buffer and is mowed to the edge of the channel.

grading them to a stable slope, installing natural stream design structures to create fish habitat and protect the streambanks during the establishment of native vegetation, and reconnecting the stream to its floodplain will help to restore this section. After grading is completed, additional riparian buffer plantings would help to shade the stream and improve the biodiversity and ecological function of the riparian zone.

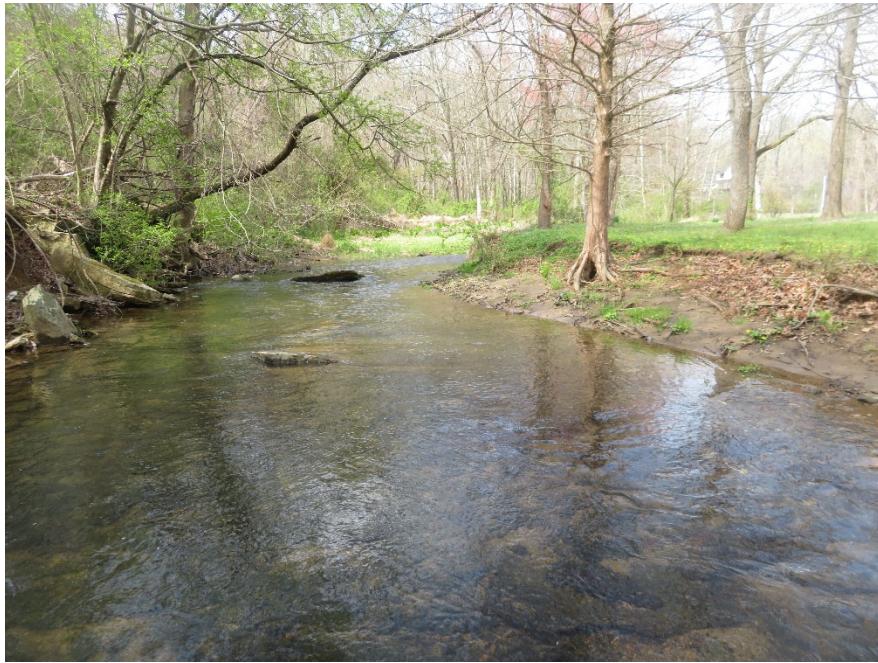
Impacted Stream Segment #44-45:

the north side of the stream. The northern streambanks are eroded 2 to 3 feet high.

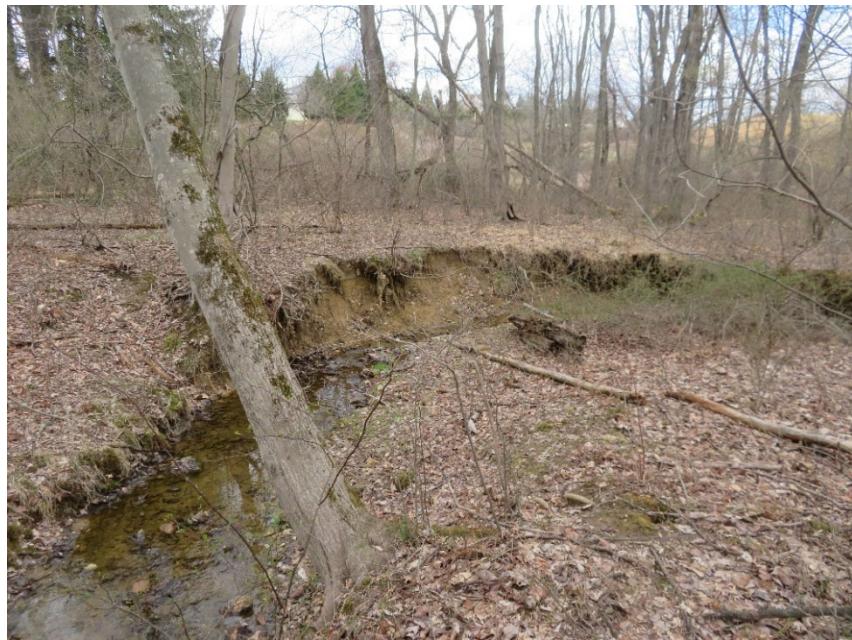
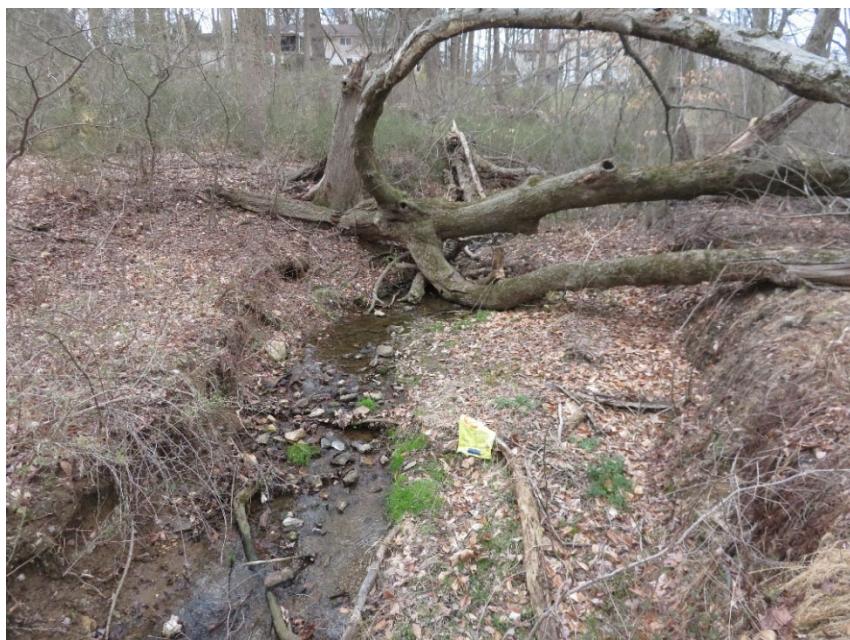
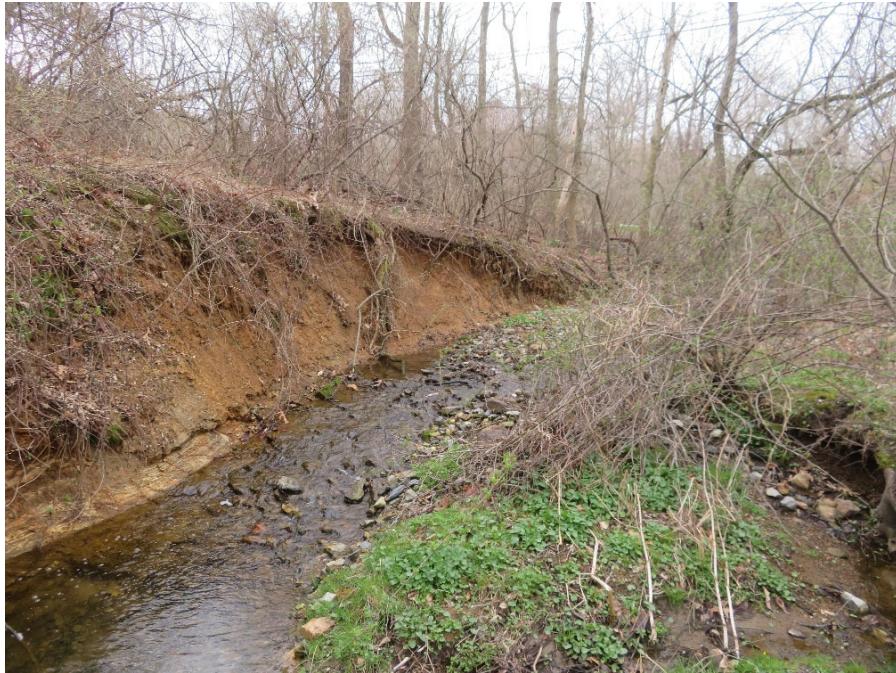
Within this stream segment, the streambanks are actively eroding and are approximately 3 to 4 feet high. The stream segment is disconnected from the floodplain. The combination of streambank erosion and floodplain disconnection in this headwaters section of the watershed has likely negatively impacted the water quality of the stream both in this stretch and downstream.

water will infiltrate into the groundwater while some of the stormwater slowly seeps out of the sand and compost mixture into the channel over an extended time. When established, the regenerative stormwater channel will improve water quality, decrease flood flows, and aid in recharging the groundwater.

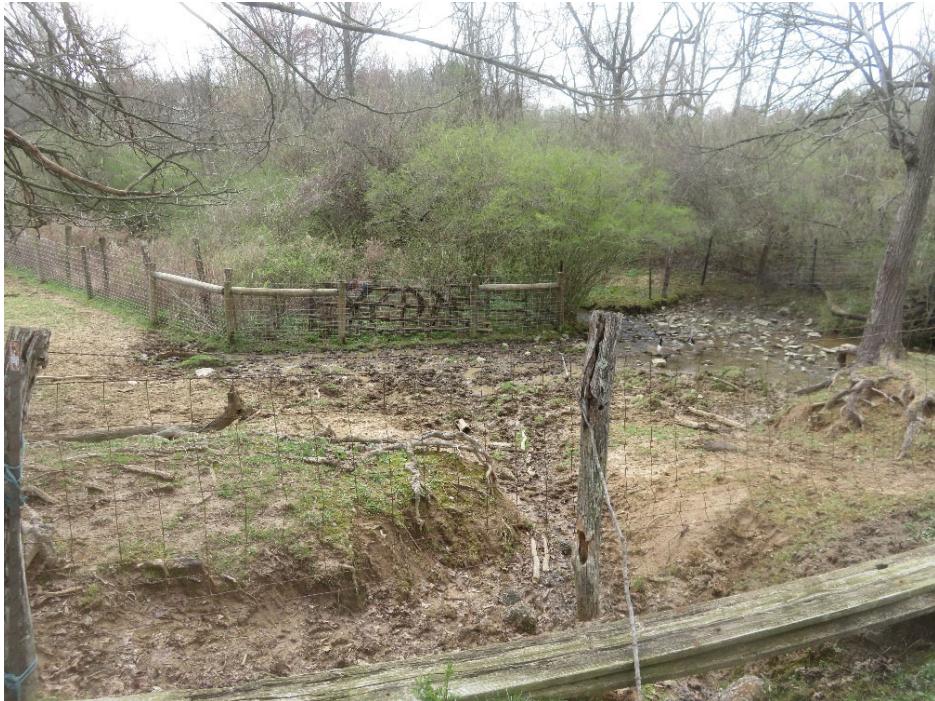
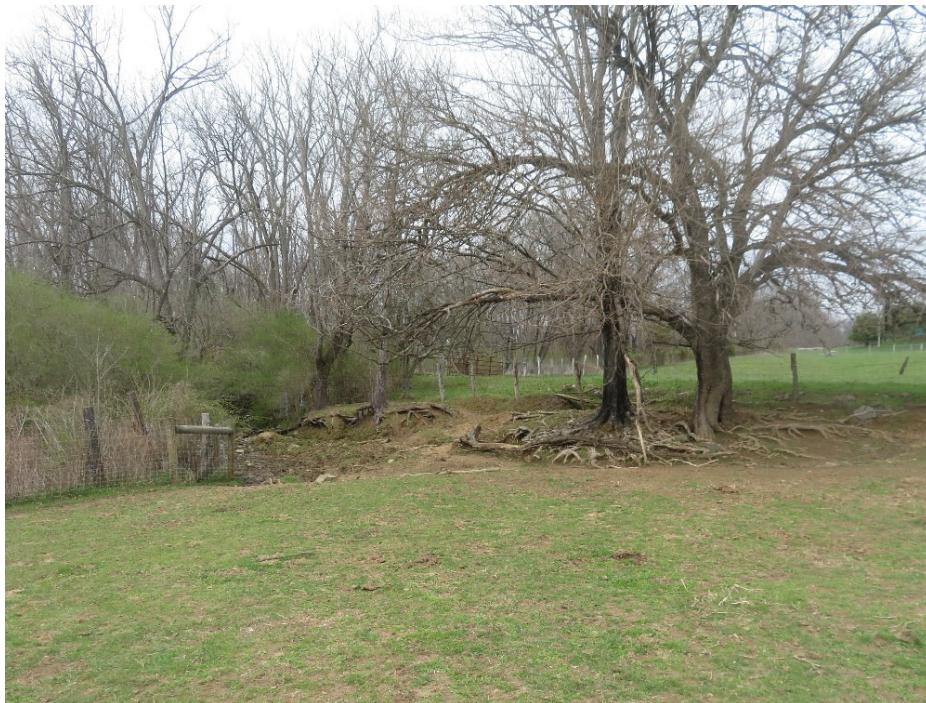
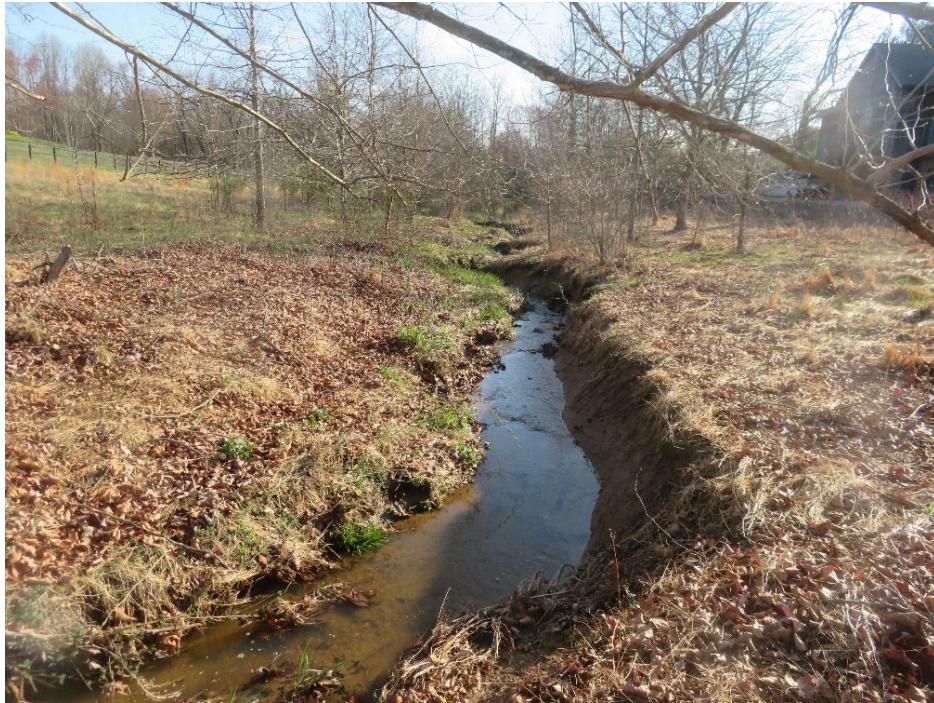
Impacted Stream Segment #82:

At this point on the tributary, cattle have access to the stream. Runoff from the barnyard area has eroded out a small channel, creating a muddy ditch from under the pasture fence to the stream. Multiple large trees in this area are at risk of dying if erosion continues. Downstream of this point, streambank fencing and livestock crossings have been installed to keep cattle out of the stream and allow plantings in the riparian zone to grow.

Stabilizing this area and providing a safe water access point for the cows will enhance water quality and promote livestock safety. Grading the area to create a stable drainage pathway for the barnyard runoff will help to prevent additional erosion in this area and protect the trees.

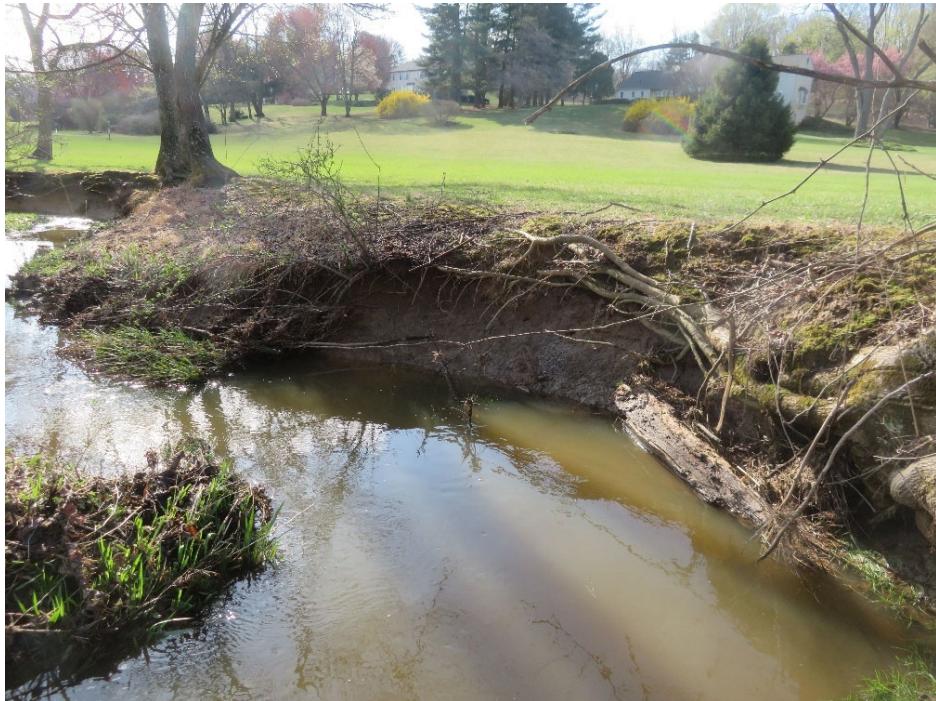
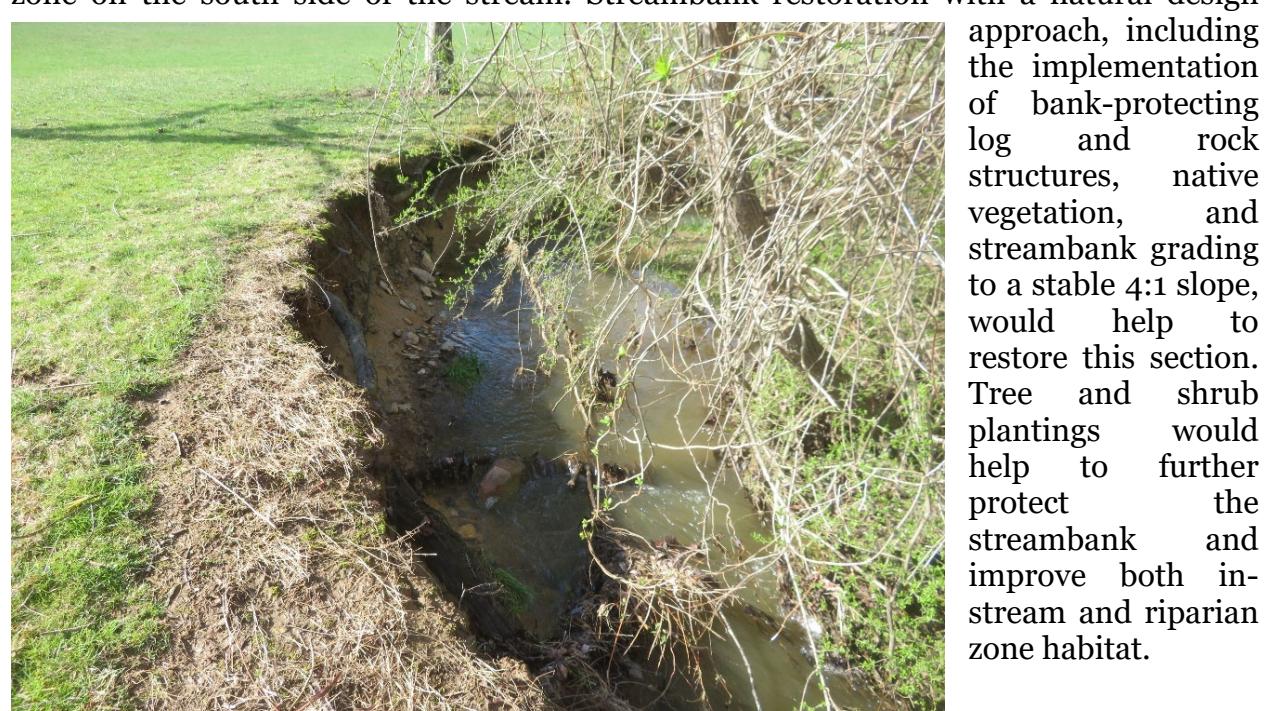
Impacted Stream Segment #94-95:

In this stretch of the stream, the south side is mown to the top of the bank. Approximately 30% of the south bank is eroded 2 to 3 feet high. The north side of the stream is forested with wetlands in the riparian zone.

This area would benefit from the cessation of mowing within the riparian zone on the south side of the stream. Streambank restoration with a natural design approach, including the implementation of bank-protecting log and rock structures, native vegetation, and streambank grading to a stable 4:1 slope, would help to restore this section.

Tree and shrub plantings would help to further protect the streambank and improve both instream and riparian zone habitat.
