Pocopson Creek and Browning Barn Tributary Watersheds Restoration Plan

**Pocopson Township, East Marlborough Township, Newlin Township,
Pennsbury Township, and Kennett Township,
Chester County, Pennsylvania**

September 18, 2025

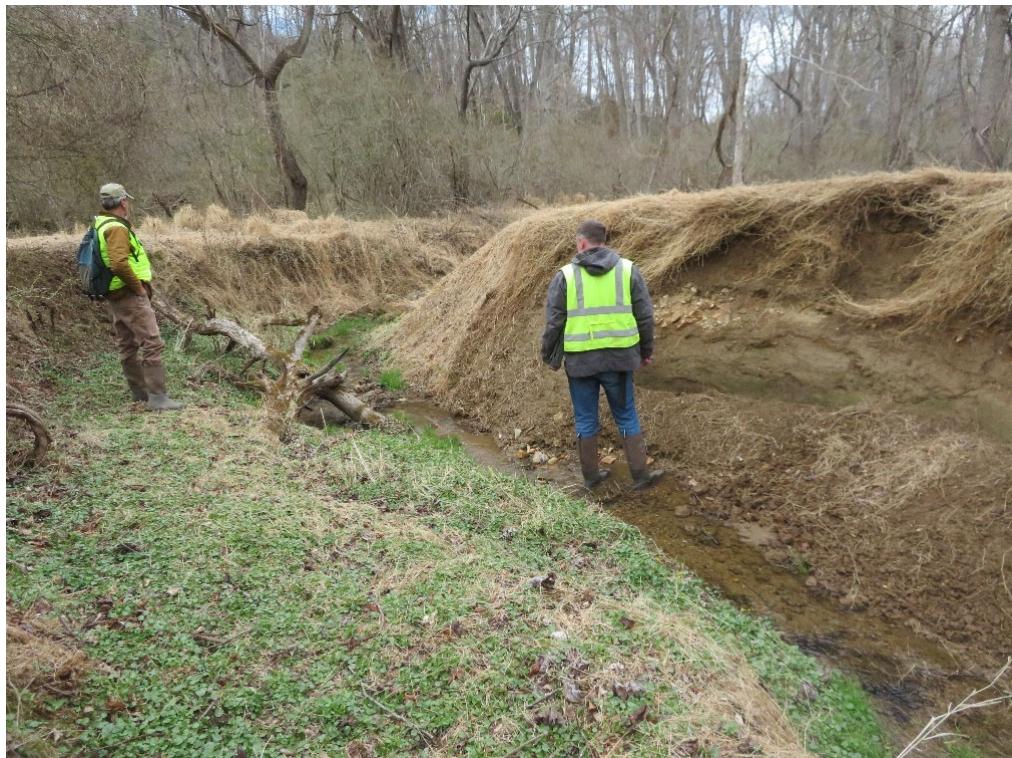
Along this stretch of the stream, significant legacy sediment has accumulated since colonial times, causing the stream to become disconnected from the floodplain. The streambanks in this section are between 1 and 7 feet high and are actively eroding. Throughout this section of the stream, a thick mat of Japanese stilt grass (*Microstegium vimineum*) has suppressed the growth of native vegetation within the riparian zone.

The most effective approach to restoring this section of the stream would likely involve reconnecting the floodplain through removing legacy sediment to create an active floodplain bench. Within the reconnected floodplain, wetland pockets could be established to help retain floodwaters and filter pollutants. Grading the streambanks to a stable slope will reduce further erosion and provide a foundation for planting native vegetation to stabilize the banks. Instream structures, such as log vanes and root wads, should be installed to provide fish habitat and reduce near-bank friction while vegetation is being established. Enhancing the riparian buffer through native plantings, and invasive species removal along the stream will strengthen the streambanks and boost biodiversity in the surrounding area.

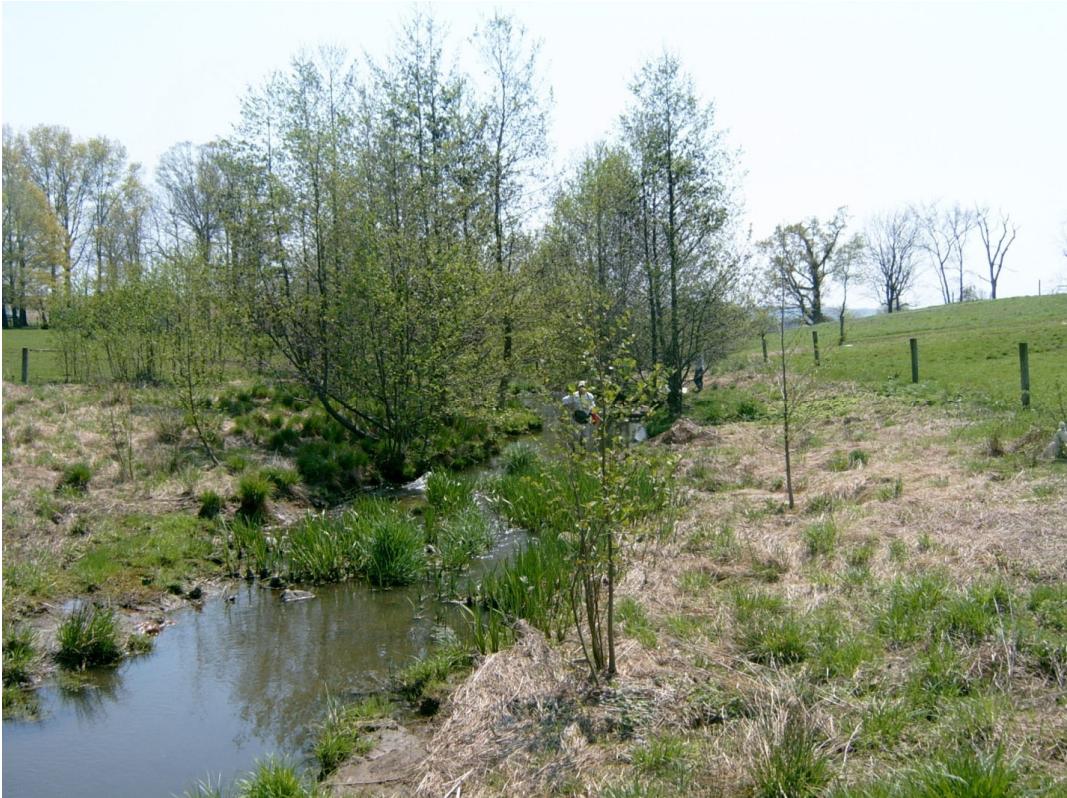
Riparian Buffer Enhancement

Mowing and grazing stream corridors to the stream edge impacts water quality and the community of creatures that live within the stream. Streams lacking a healthy riparian buffer are exposed to high levels of sunlight and lack a filter to minimize sediment and nutrients from discharging into the stream. As sunlight warms the water, it cannot hold as much dissolved oxygen, which is essential for a healthy stream community.

Riparian buffers provide shade, helping moderate daily stream temperature changes during both winter and summer months. Pollutants can be successfully filtered and trapped by the physical structure of the vegetation itself and be taken up through the root systems and stored in the tree and shrub's wood. In addition, healthy riparian buffers provide a home for a diversity of wildlife and function as a corridor to allow wildlife to move from one pocket of habitat to another. Funding is often available to implement riparian buffer plantings.

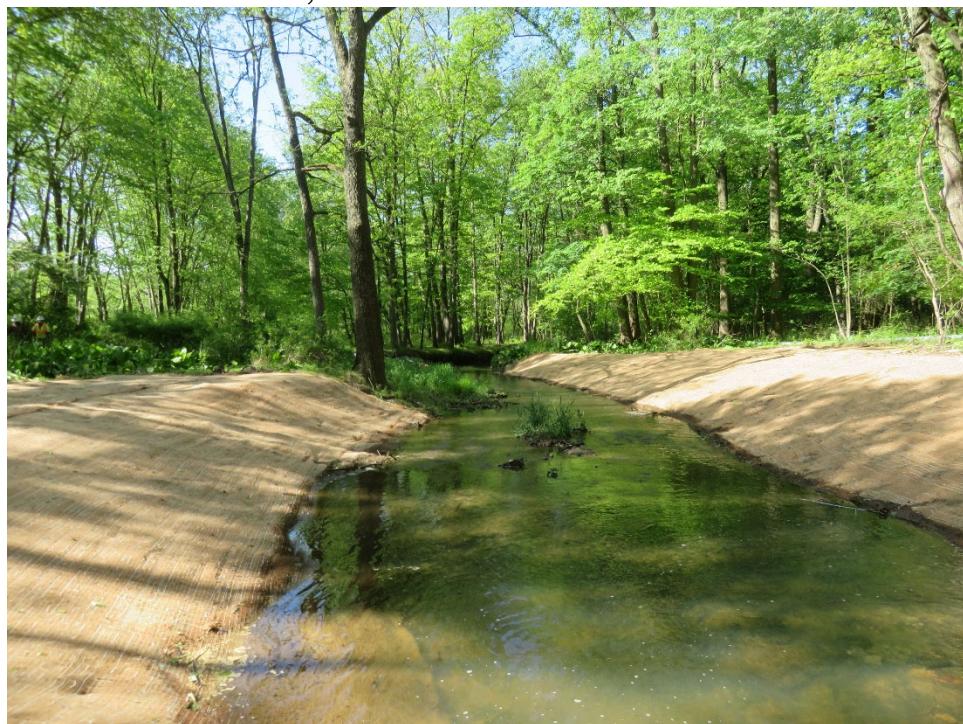
Stream restoration within the watershed should focus on the long-term stability of the stream by looking at the stream's pattern, profile, and dimension. Where streambanks are actively eroding, stabilization that focuses on establishing

native vegetation is often the best long-term option. As the vegetation becomes established, a combination of rip-rap and instream structures are often implemented to provide stabilization. The use of well-positioned in-stream deflectors, cross-vanes, j-hooks, and straight vanes can help to hold the streambanks in place as the vegetation becomes established. These structures, when utilized effectively, minimize streambank erosion by reducing the force of water that is scouring the bank surface and provide habitat for many types of aquatic life.

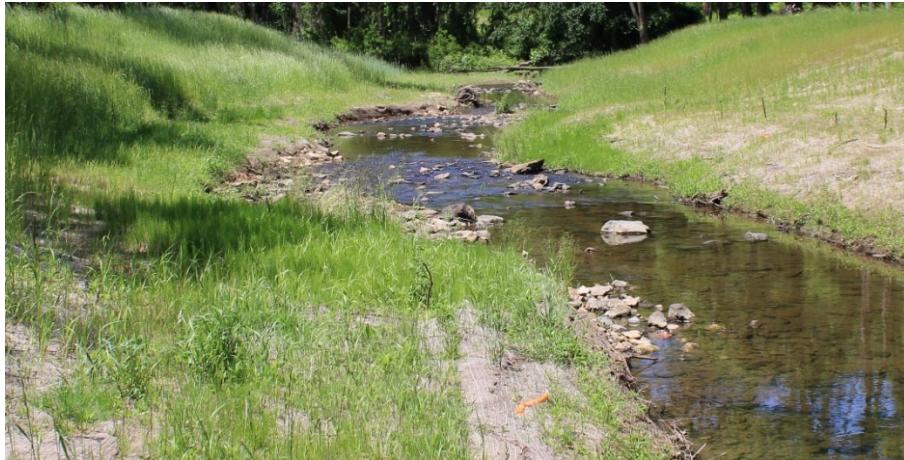
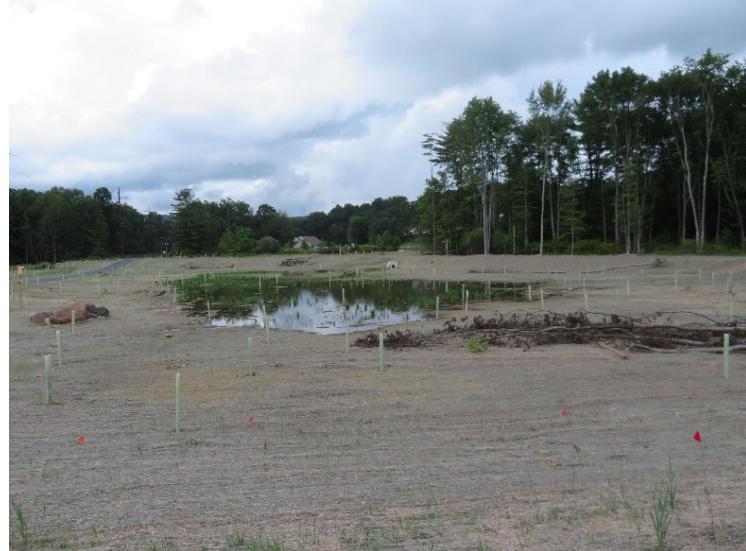
Floodplain Restoration

In many areas of the Pocopson Creek and Browning Barn Tributary Watersheds, past human activities have placed fill in or caused extensive sedimentation within the riparian zone. The excess material along the edge of the stream channel has disconnected the

stream from the floodplain. Floodplain restoration projects are designed to remove excess soil from the floodplain so that the stream is reconnected to an active floodplain. Active floodplains are important to not only reduce the volume and velocity of floodwaters but also to filter nutrients and pollutants from floodwaters and to provide habitat for a diverse riparian community. The restored streambanks and floodplain area can be planted with native wildflowers, grasses, shrubs, and trees to help stabilize the riparian zone and promote the use of the area by a diversity of native wildlife. Floodplain restoration projects can range from establishing a small bankfull bench to help disperse flows to large-scale excavation projects that uncover the historic valley floor.

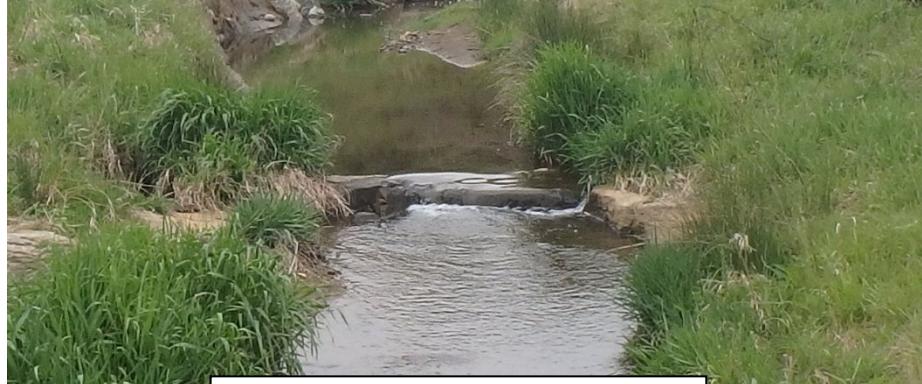
Rock Cross Vane

stream habitat. Where needed, boulders can be placed either randomly for fish habitat and to disperse flows or aligned to roll the stream flow away from the bank and into the center of the channel. In-stream structures are typically designed to manage low to moderate flow conditions and help shape and maintain a natural stream configuration. During high flow events, the structures are designed to stay in place beneath the floodwaters. These structures are often included in comprehensive stream restoration designs.

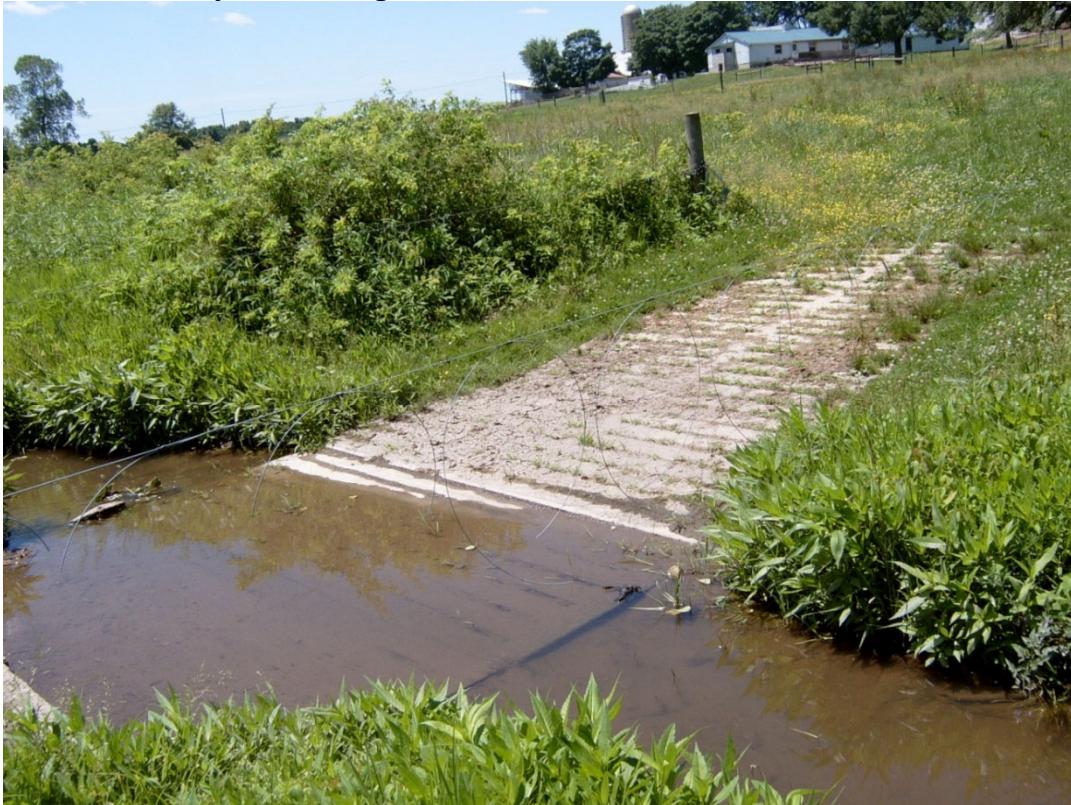
Stabilized Livestock Stream Crossing

Where livestock have unrestricted access to streams, they typically find a few favorite crossing areas and use those sites repeatedly. The resulting crossing locations begin to erode and become slippery and unstable. In these locations, livestock are at risk of injury, and the stream is subjected to high levels of sedimentation.

In combination with any streambank fencing project where quality pastureland exists on both sides of the stream, stabilized crossing areas are a necessity. Installation of the crossings typically requires a general permit registration to be sent to the Pennsylvania Department of Environmental Protection (PA DEP) and the conservation district. In Pennsylvania, the most common installation technique is to place concrete hog slats across the bottom of the stream and maintain slopes on the approaches that are no greater than 4:1. The crossings may easily be equipped with gates to create paddocks that aid in rotational grazing. Routine maintenance of the crossing locations should include inspection after high water events to ensure that the fencing with dropper wires utilized to guide livestock through the crossing remains serviceable. Funding is often available for this agricultural best management practice.

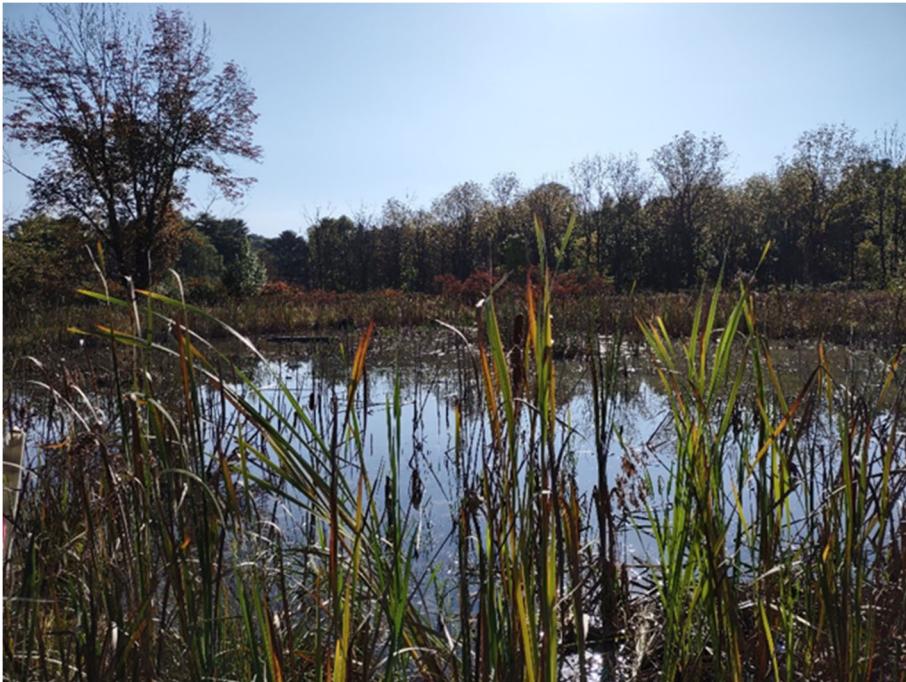
Constructed Wetlands

Throughout the Pocopson Creek and Browning Barn Tributary Watersheds, many areas lack connections to wetlands. The creation of constructed wetlands in the watershed will have multiple positive impacts on the watershed. Foremost, constructed wetlands can serve to remove contaminants and pollutants caused by human activity from the water supply through the same processes as naturally occurring wetlands. These processes help

to remove and break down contaminants. Constructed wetlands not only offer the benefit of water quality improvements through a natural and holistic process but also provide a variety of niche habitats for local plants and wildlife. Wetlands are considered to be one of the most productive ecosystems on Earth and provide habitat for birds, mammals, amphibians, and reptiles, as well as diverse plants and

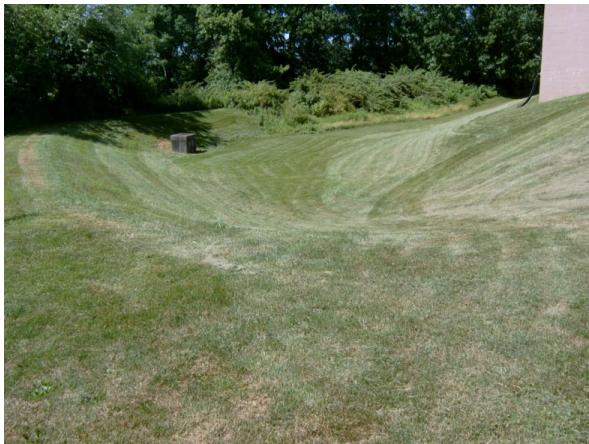
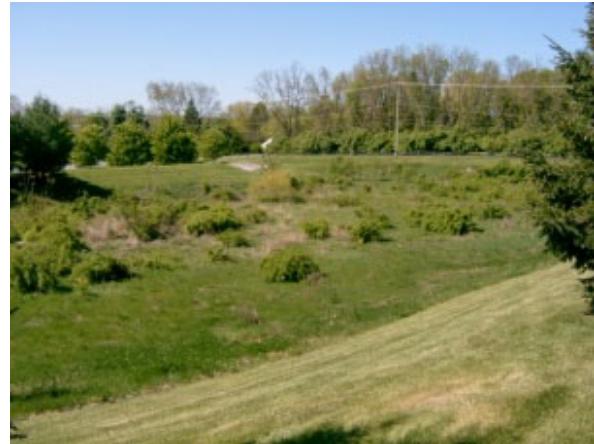
To decrease the impacts of stormwater on the watershed, effective best management practices should be installed with new construction. Where existing stormwater structures exist, they should be evaluated for effectiveness and retrofitted where necessary.

Common stormwater retrofits focus on improving the function of existing structures so that they more closely reflect the natural hydrological cycle. Within existing stormwater basins, native species may be planted or allowed to become established. Minimizing mowing and labor in this way provides for additional wildlife habitat, reduces nutrient discharges to the stream, and allows for the vegetation to return more of the stormwater to the atmosphere through evapotranspiration. Other strategies for stormwater retrofits include installing cisterns to allow for water reuse and infiltration trenches to increase the return of stormwater to the groundwater.

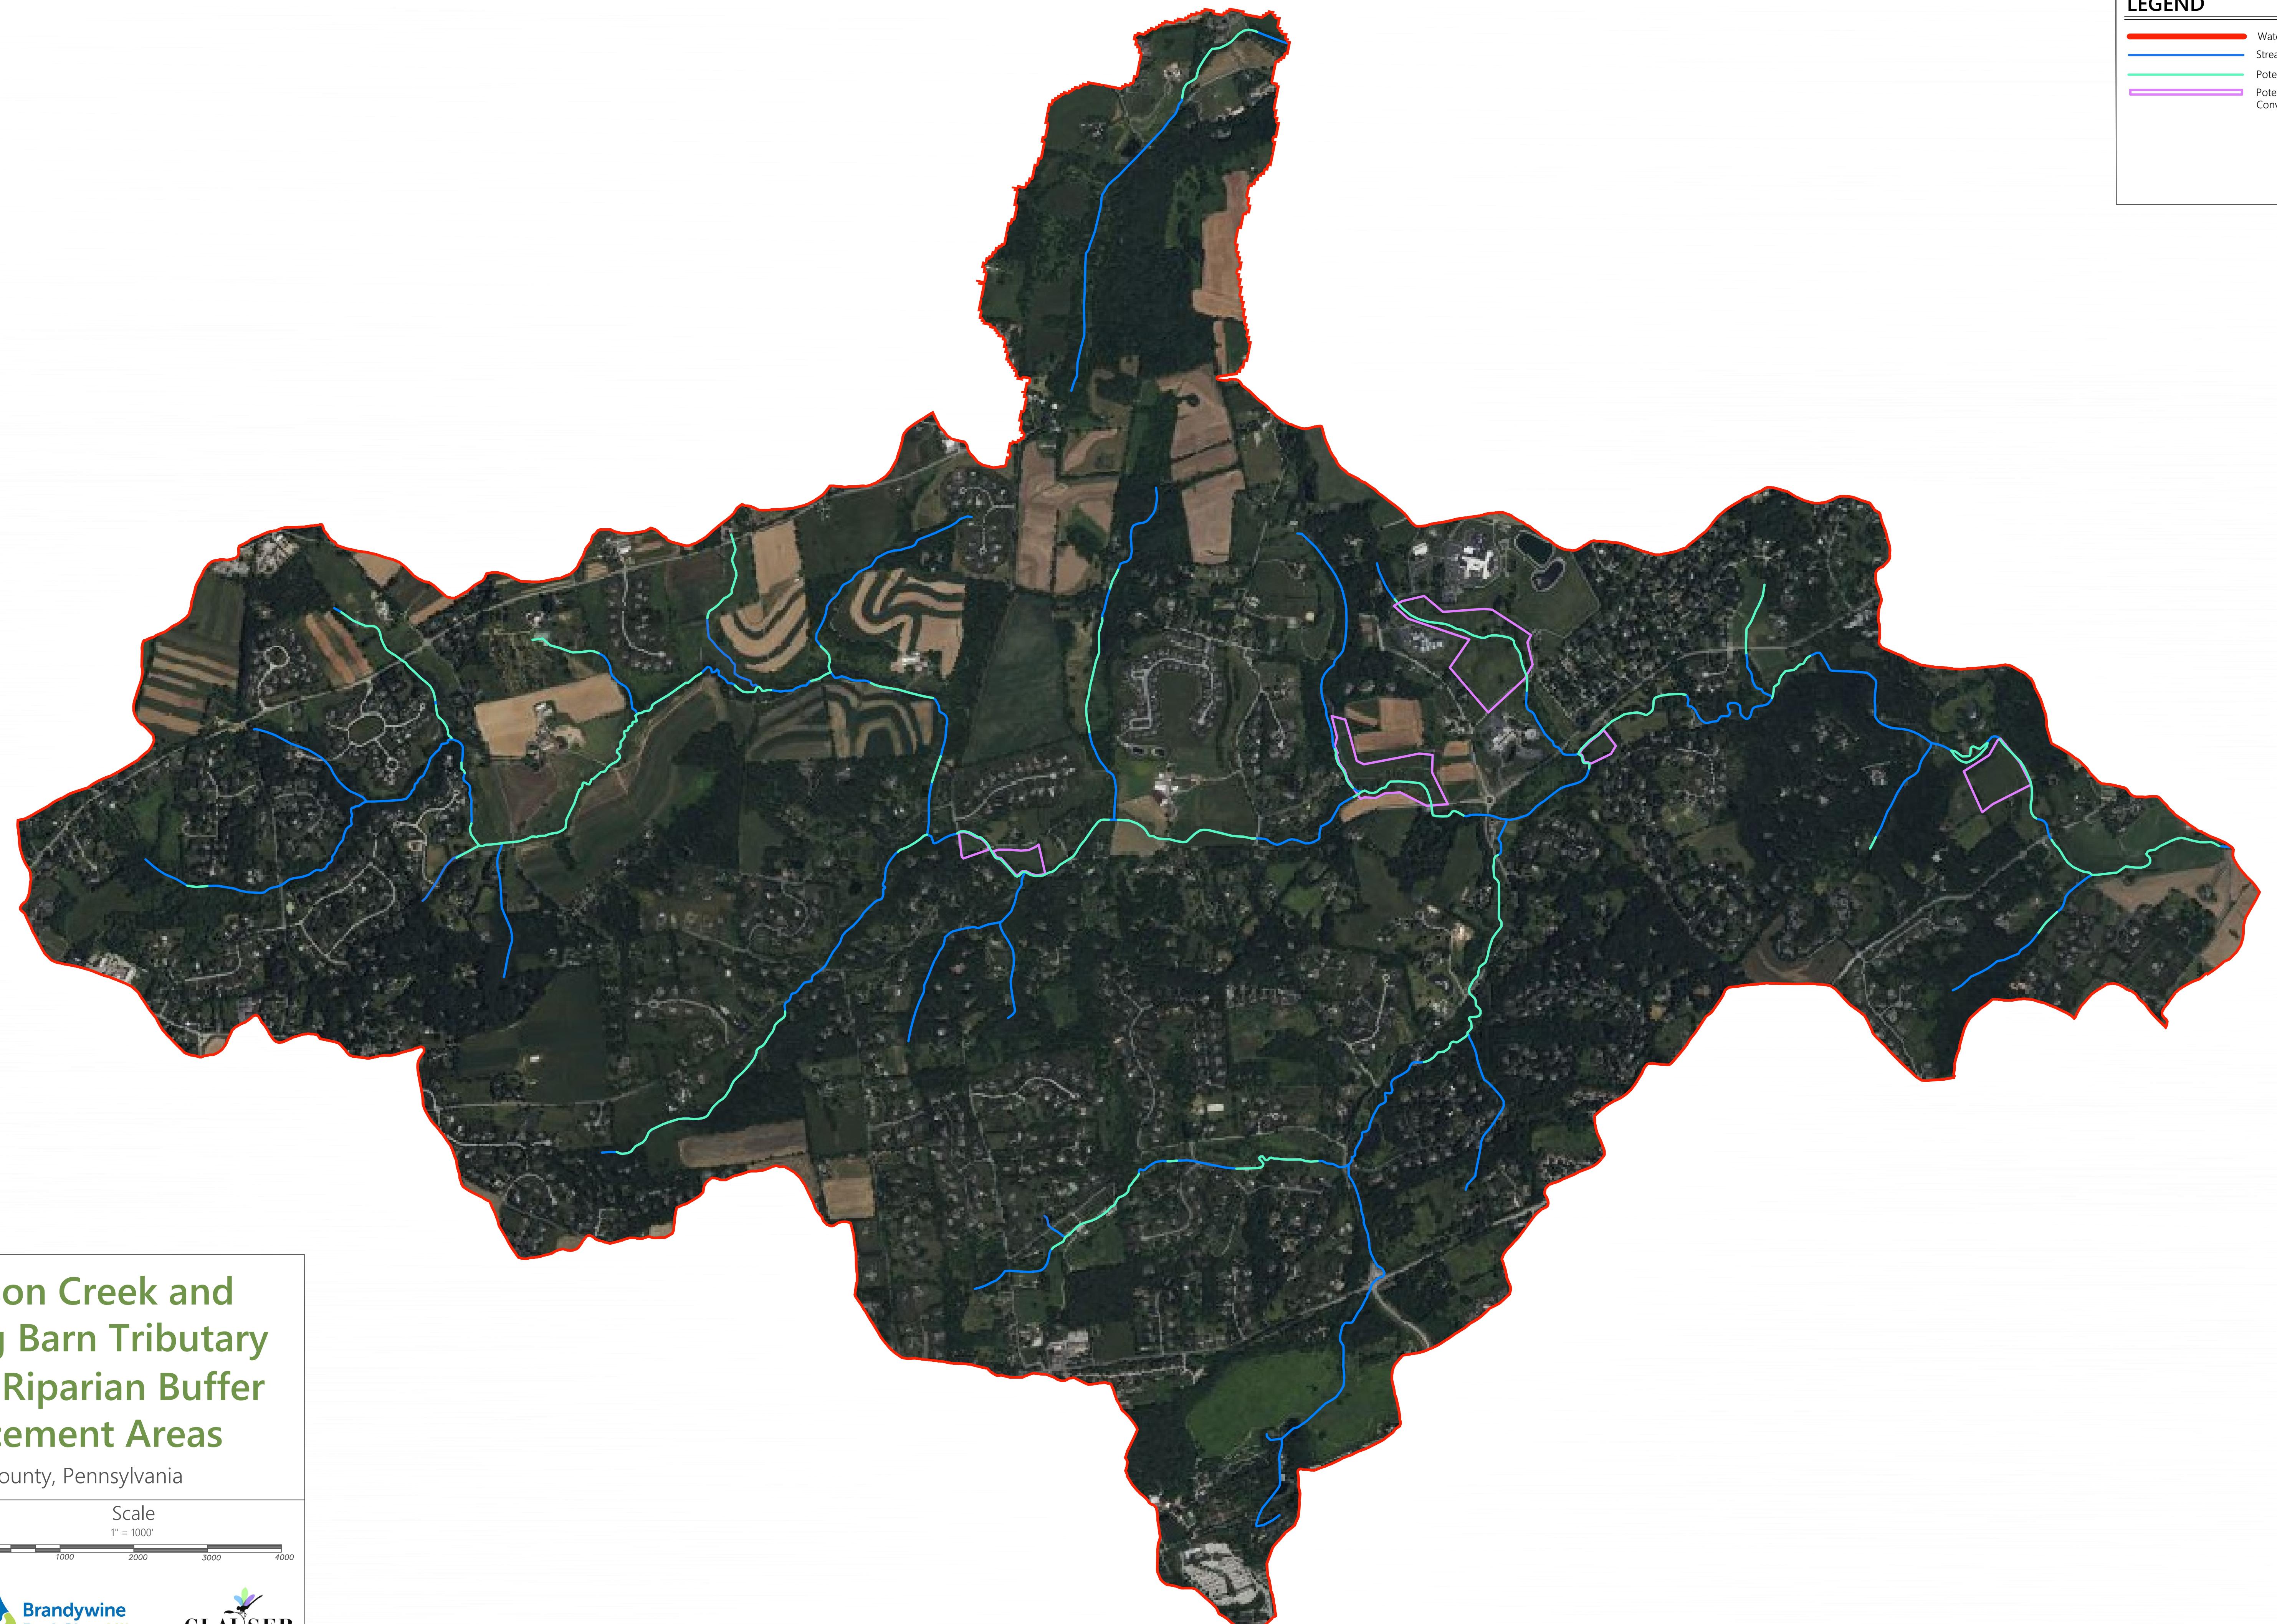
**Pocopson Creek and
Browning Barn Tributary
Potential Riparian Buffer
Enhancement Areas**

- Watershed Study Area Boundary
- Stream
- Potential Riparian Buffer Areas
- Potential Lawn to Meadow Conversion Area

Field observations taken as part of this project determined that adequate, healthy riparian buffers are missing along over 8.1 miles of stream within the study area. In many of these cases, the riparian buffers are mown as lawn to the top of the bank or within 35 feet of the stream. Many of the riparian zones that do have vegetative cover are dominated by invasive plants including multiflora rose (*Rosa multiflora*), poison hemlock (*Conium maculatum*), Japanese hops (*Humulus japonicus*), Japanese stilt grass (*Microstegium vimineum*), reed canary grass (*Phalaris arundinacea*), common reed (*Phragmites australis*), and tree of heaven (*Ailanthus altissima*). Some buffer areas contain dead and dying ash (*Fraxinus* sp.) trees, which have been parasitized by the emerald ash borer (*Agrilus planipennis*). In multiple places throughout the watershed, tree and shrub plantings have been completed within the riparian zone. Overall, these plantings are doing quite well, which is attributable to consistent maintenance during buffer establishment. A comprehensive riparian buffer planting and lawn-to-meadow conversion plan is recommended for the areas lacking sufficient riparian buffers in the Pocopson Creek and Browning Barn Tributary Watersheds (Appendix F). Significant grant funding will be necessary, including funding for bi-annual buffer maintenance for the first four to five years to protect trees from invasive plant pressure and deer and meadow vole predation.

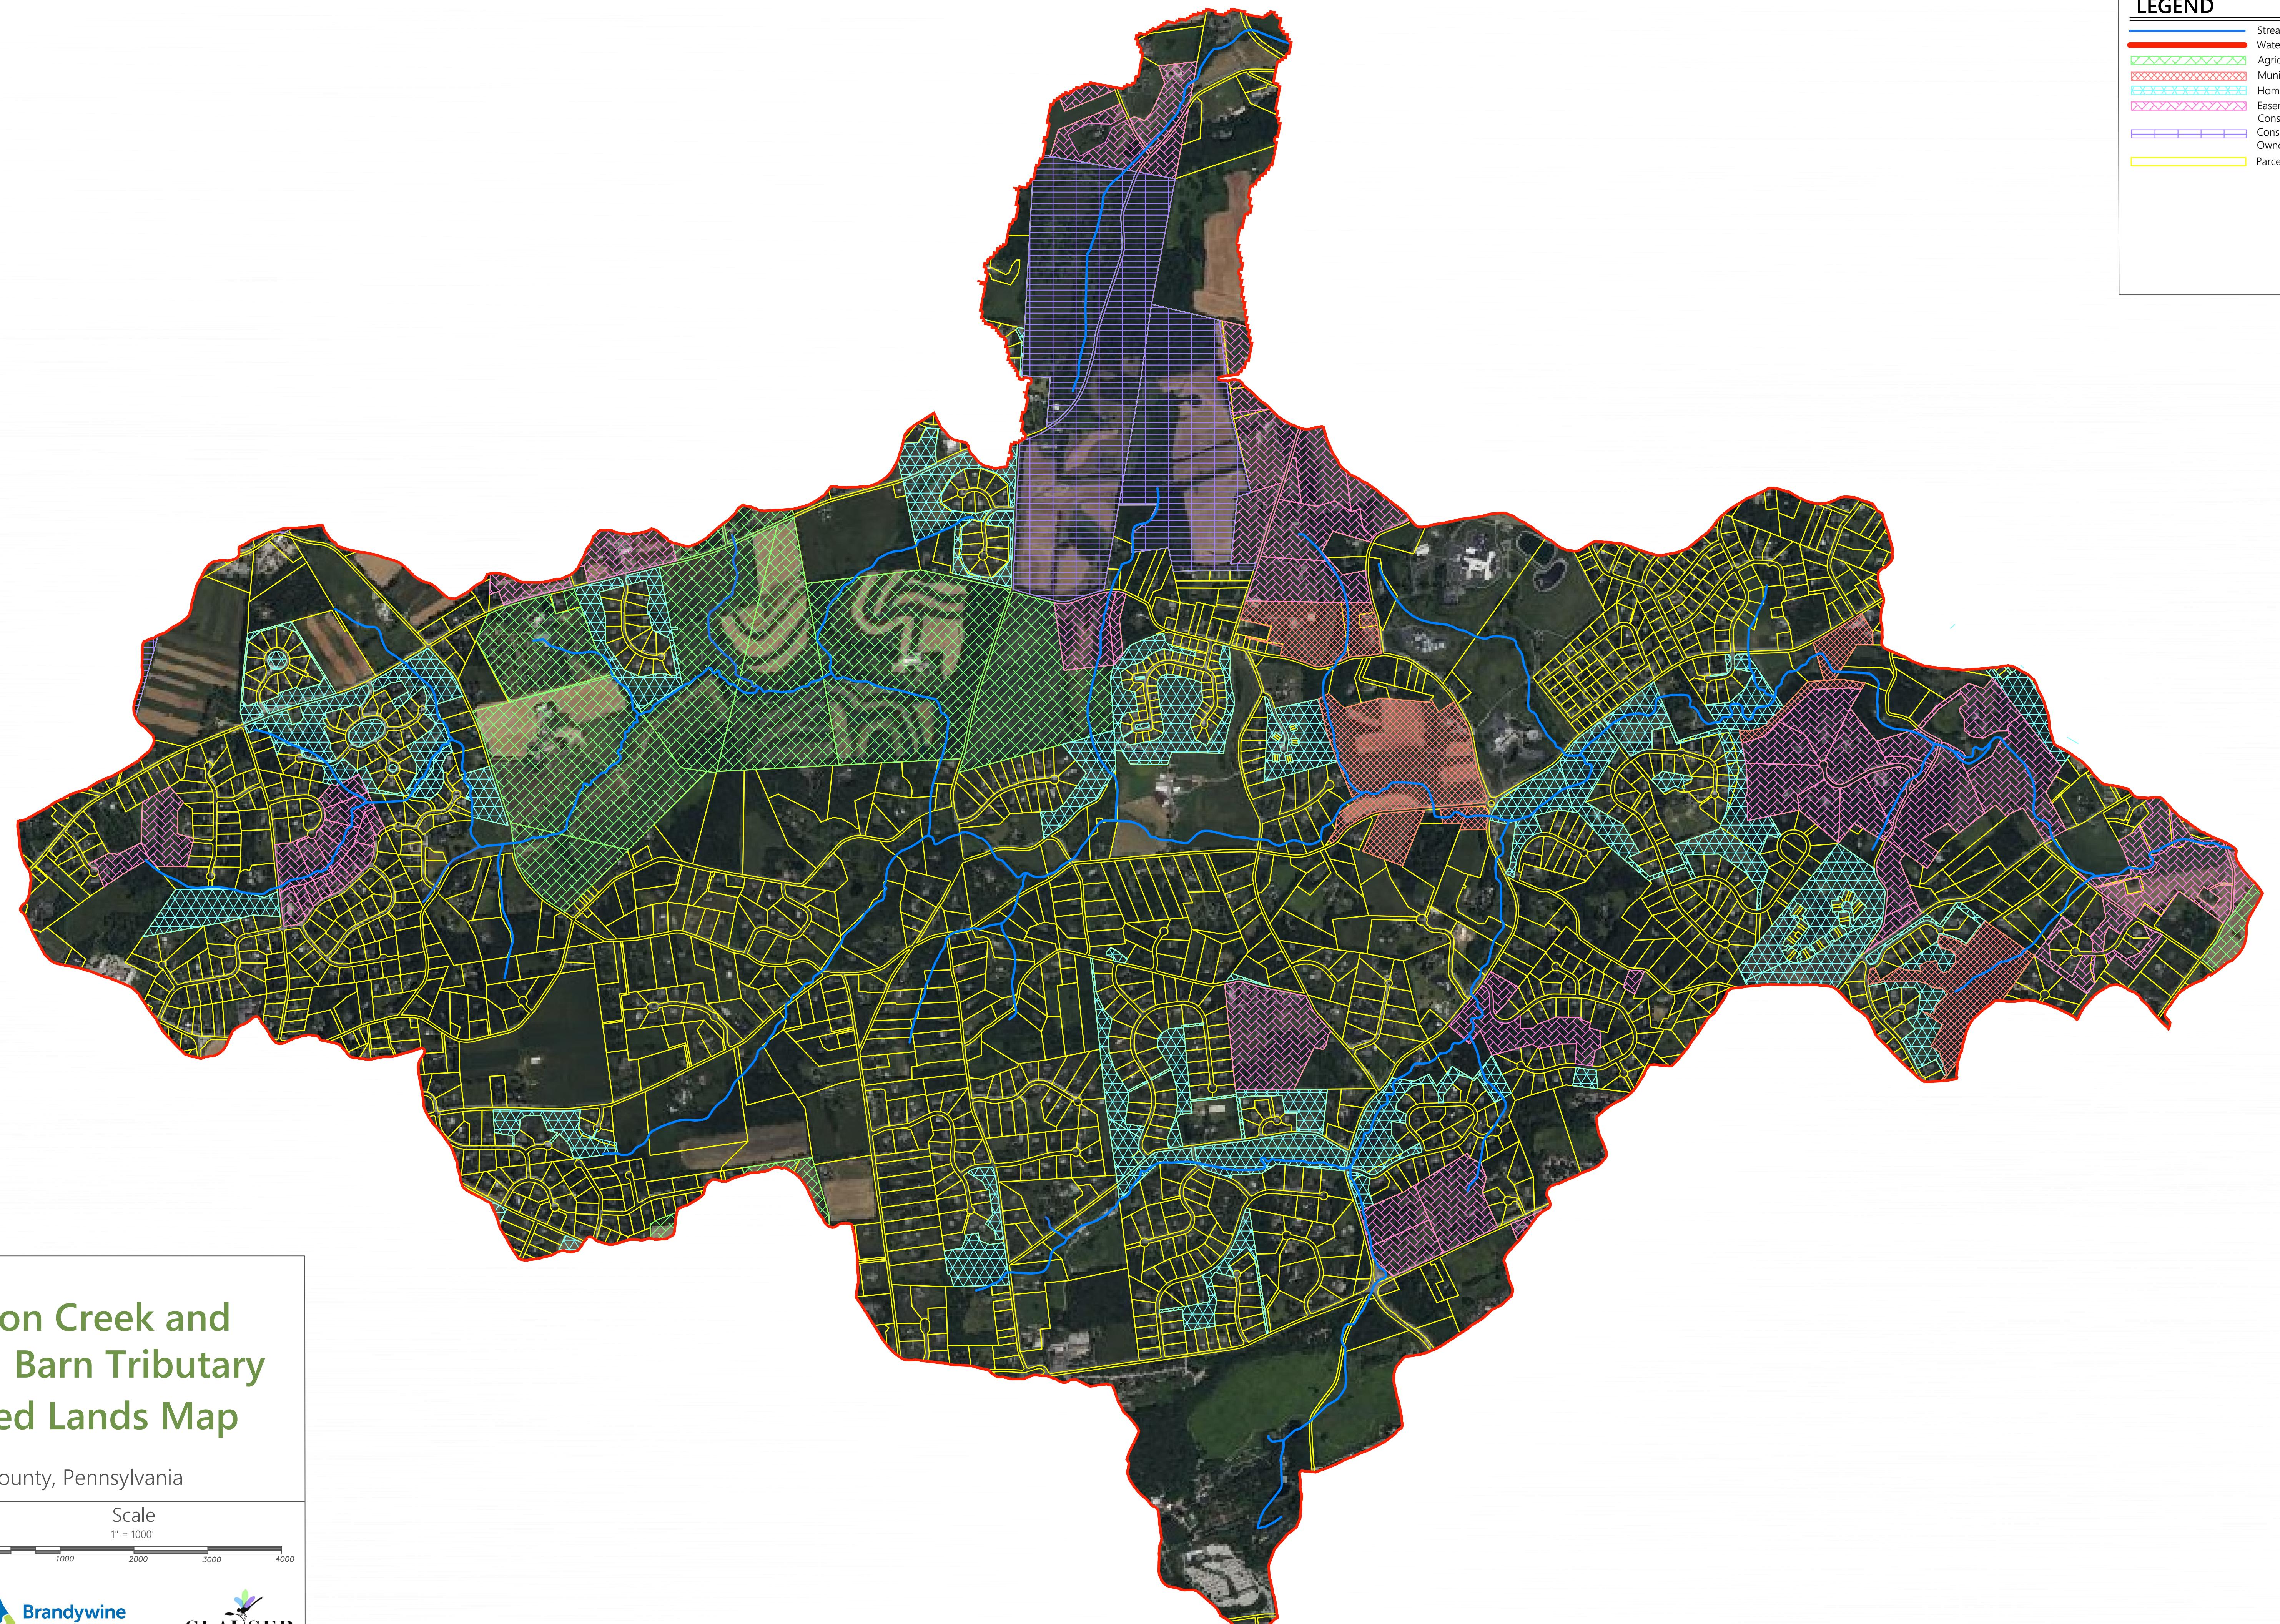
Stream	Watershed Study Area Boundary
—	Agricultural Easement
—	Municipal Owned
—	Homeowners Association
—	Easement Held by Conservation Organization
—	Conservation Organization Owned
—	Parcel Boundary
