**Restoration Plan
for
Plum Run Watershed
Chester County, Pennsylvania
February 2008**

RETTEW Associates, Inc.
Natural Sciences Group
950 East Main Street, Suite 220
Schuylkill Haven, PA 17972
(570) 385-2270
(570) 385-2217 fax
RETTEW Project No. 07-07568-002

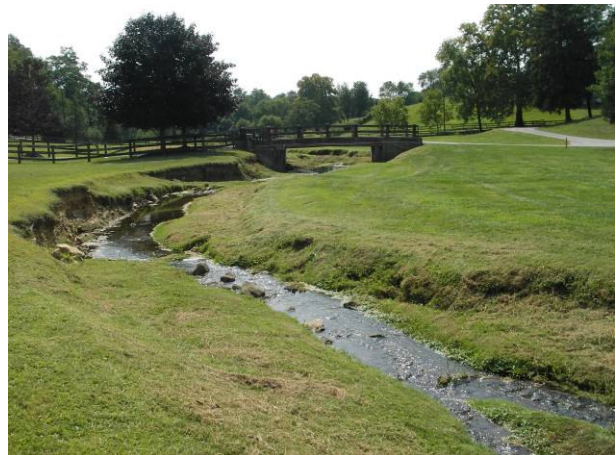
Impacted Stream Segment #17:

This impacted stream section begins at the Birmingham Rd. bridge and extends downstream for approximately 500 feet. Downstream of the bridge is the Strodes Mill structure. Strodes Mill is considered historically significant and its preservation is an asset to the community. This structure has experienced flooding issues in the past. The streambanks in this area are vegetated and approximately 3-4' high. The impacted area includes a straight section of stream that is likely not the historic location of the stream channel. Downstream of the straight reach, some riffle, run, pool and glide habitat types are present, but the stream bottom is sediment laden.
