**Restoration Plan for
Shamona Creek and East Branch Brandywine Creek
Chester County, Pennsylvania
May 2010**

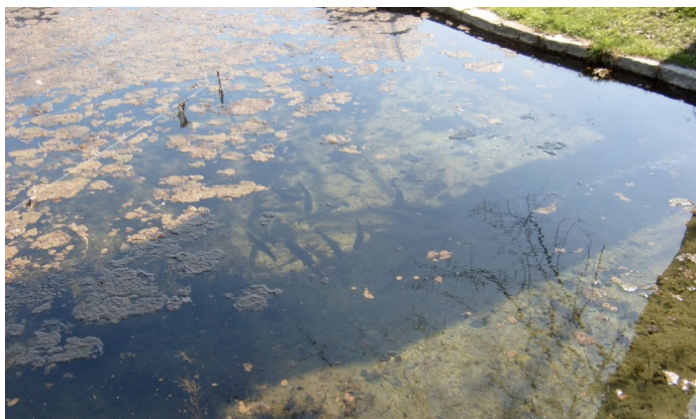
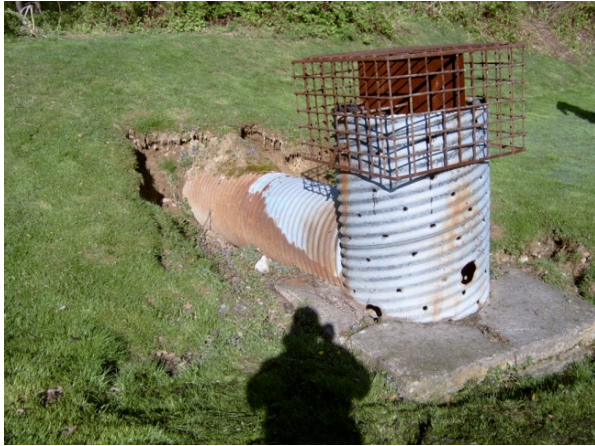
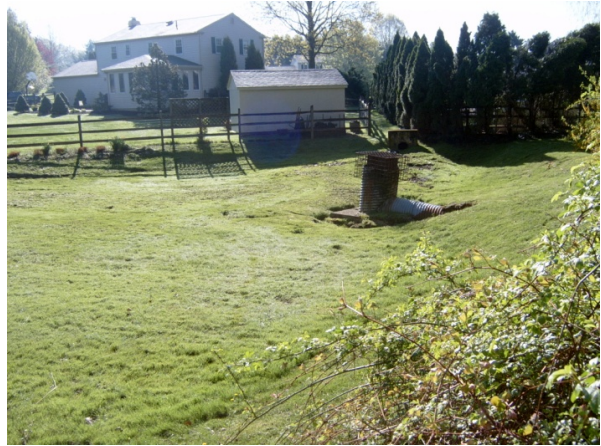
Impacted Stream Segment #22-27:

Kerr Park is a center for outdoor recreation within the Downingtown community. Several fish habitat enhancement structures have been installed within the park and are functioning well to provide habitat for both fish and macroinvertebrates within the stream. Within the park boundaries, a large section of the eastern streambank of the East Branch Brandywine Creek is mowed to within five feet of the stream. Within this area, trees to shade the stream are lacking and little buffer exists for waters leaving the mowed lawn areas.

One of the greatest assets within the park is a cooperative trout nursery. Waters flowing through the nursery discharge through a pipe that flows under a mowed lawn area and then discharges directly to the East Branch Brandywine Creek. The nursery contains a concentration of fish that are fed and managed intensively. Recently, such nurseries have been identified as potential sources of nutrient inputs to the stream system.

Several opportunities to enhance water quality and the riparian zone exist within the area that would build on the important in-stream habitat work that has already been completed. In order to provide additional shading and aid in maintaining cool water within the stream and corresponding high dissolved oxygen conditions that benefit aquatic life, a forested riparian buffer could be implemented. The buffer area should extend along the East Branch as well as an unnamed tributary that flows through the park. To enhance the trout nursery area, a portion of the mowed lawn area above the discharge could be converted into a wetland treatment cell that would aid in uptake of nutrient discharges from the outfall.

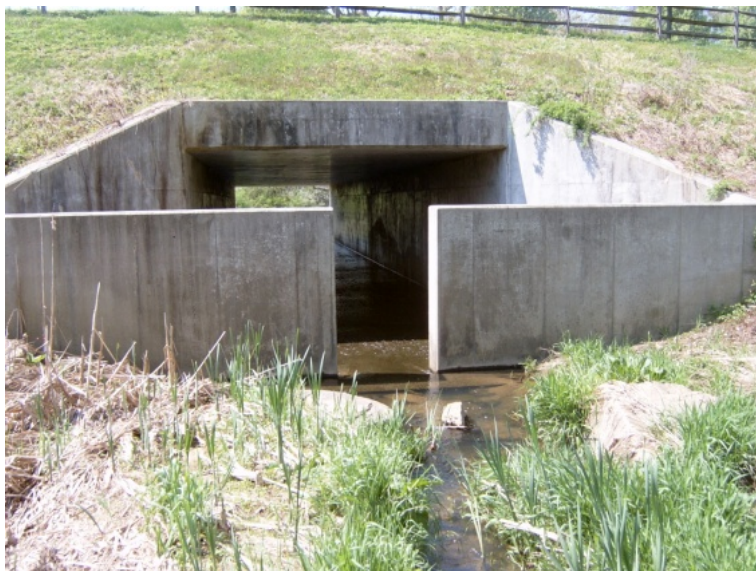
This stream segment includes severely eroded streambanks that are approximately 1-4 feet high along both the mainstem of Shamona Creek and an unnamed tributary that drains into Shamona Creek within this stream segment. The sediment that has been deposited within the floodplain was likely deposited during flooding events in which the Wharton Dam located at the downstream end of this segment was functioning to back up water and allow the sediment to settle out. The function of this flood control dam to properly regulate flows to Shamona Creek is an essential component to maintaining the downstream flow conditions.

Conservation work in this area should include an investigation of the function of the Wharton Dam by a qualified engineer to determine if it is functioning as designed and if that design is optimum under current watershed conditions. If any alterations are required to improve the function of the dam, the dam should be retrofitted. In order to minimize sedimentation and corresponding nutrient inputs to the downstream areas, the areas where sediment has been deposited should be maintained to restore the original floodplain elevations within those areas. After restoring the original floodplain elevations, the streambanks should be stabilized and riparian buffers should be restored to shade the stream. The engineering evaluation of this structure is ongoing under a 2010 Growing award to Township.
