**Restoration Plan
for
Valley Run Watershed
Chester County, Pennsylvania
December 2008**

Prepared by:
RETTEW Associates, Inc.
Natural Sciences Group
950 East Main Street, Suite 220
Schuylkill Haven, PA 17972
(570) 385-2270
(570) 385-2217 fax
RETTEW Project No. 07-07568-004

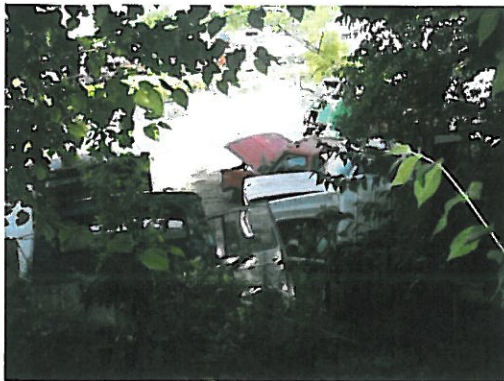
Impacted Stream Segment #6:

Confluence of Valley Run and a small tributary (which drains stormwater from a salvage yard). The small pond in this area likely serves as a sediment basin.

The stormwater basins in this area could be restructured for the purpose of improving water quality. Surrounding lawn areas could be planted with trees. Potential retrofits include adding infiltration capabilities and native plantings within the basins.

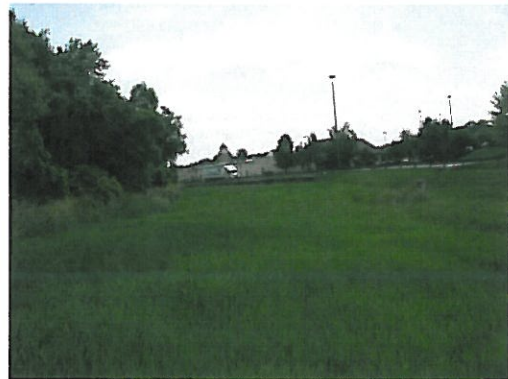
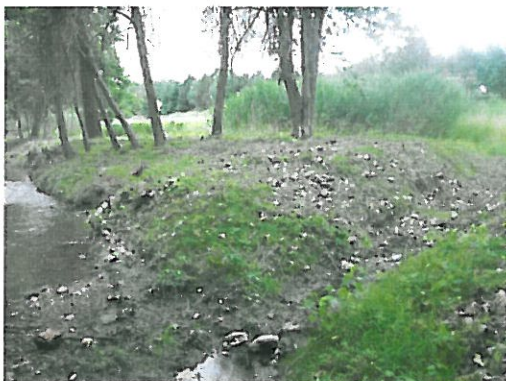
Impacted Stream Segment #18:

A large stormwater basin is situated north of G.O. Carlson Boulevard in this area. The outfall passes thru a small emergent wetland swale before entering Valley Run

The basin would be a prime target for stormwater management retrofits that target volume reduction by utilizing naturalization and infiltration techniques. Additionally, riparian buffer enhancements with native shrubs should be considered for this area.
