Lower West Branch Red Clay Creek Watershed Restoration Plan

New Garden Township, Kennett Square Borough, and Kennett Township Chester County, Red Clay Watershed, Pennsylvania

August 4, 2023

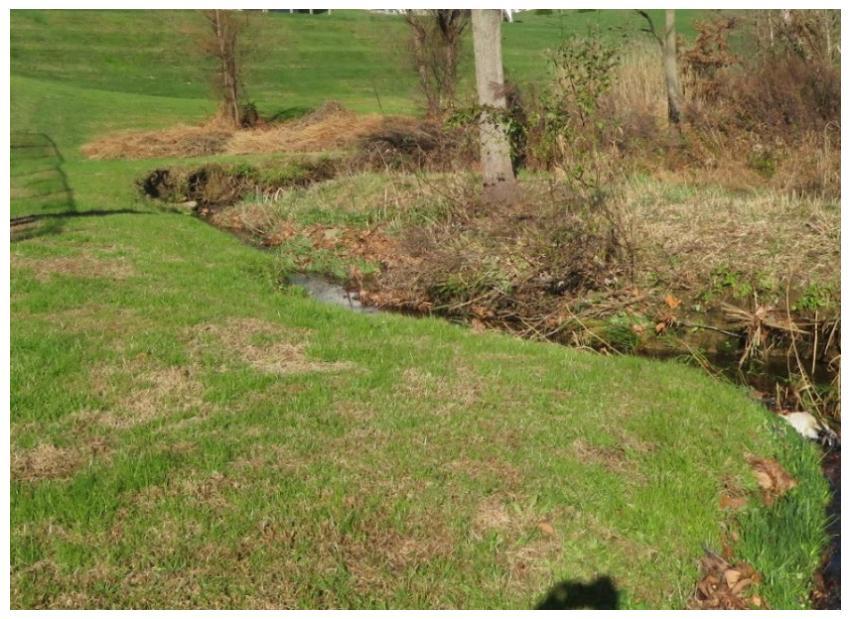
Throughout the watershed, there are significant stretches of stream that lack healthy riparian buffers (Appendix F). Riparian buffers play a large role in water quality by creating natural filtration for water runoff into the streams, stabilizing streambanks, absorbing floodwaters, and providing vital habitat for wildlife. Within the Lower West Branch Red Clay Creek Watershed, streamside forests historically provided leaf litter that served as the foundation of the food chain for the bulk of the aquatic community. As forests were cleared and replaced with fields, pastures, mowed lawns, and impervious areas, water quality and the aquatic community suffered. Throughout the watershed, invasive plant species including multiflora rose (*Rosa multiflora*), poison hemlock (*Conium maculatum*), Japanese hops (*Humulus japonicus*), Japanese stilt grass (*Microstegium vimineum*), Japanese knotweed (*Reynoutria japonica*), reed canary grass

Throughout the watershed, approximately 6.78 stream

miles are identified as potential locations for riparian buffer enhancement projects. Within those areas, mowing and grazing should be stopped or at least limited to minimize impacts to the stream community. The application of fertilizers and pesticides should be limited to only what is essential to decrease potential water quality impacts. Landowners within the identified areas should be encouraged and assisted in the planting of native trees and shrubs. Invasive species should be managed. While the wider the riparian buffer the better for the environment, the first thirty-five feet from the edge of the stream is typically considered the most crucial for maintaining water quality.
