# Lower West Branch Red Clay Creek Watershed Restoration Plan

New Garden Township, Kennett Square Borough, and Kennett Township  
Chester County, Red Clay Watershed, Pennsylvania

August 4, 2023

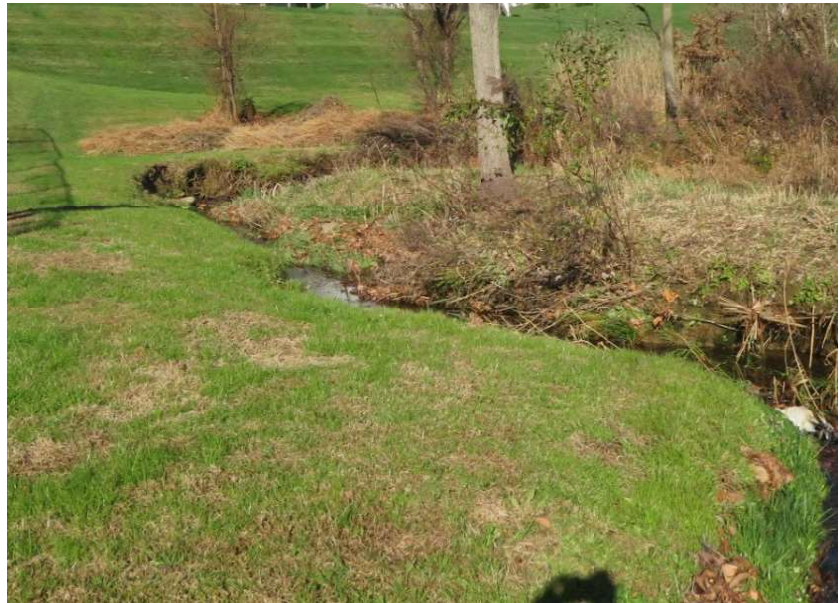
#### Riparian Buffer Enhancements Throughout Watershed:

Throughout the watershed, there are significant stretches of stream that lack healthy riparian buffers (Appendix F). Riparian buffers play a large role in water quality by creating natural filtration for water runoff into the streams, stabilizing streambanks, absorbing floodwaters, and providing vital habitat for wildlife. Within the Lower West Branch Red Clay Creek Watershed, streamside forests historically provided leaf litter that served as the foundation of the food chain for the bulk of the aquatic community. As forests were cleared and replaced with fields, pastures, mowed lawns, and impervious areas, water quality and the aquatic community suffered. Throughout the watershed, invasive plant species including multiflora rose (*Rosa multiflora*), poison hemlock (*Conium maculatum*), Japanese hops (*Humulus japonicus*), Japanese stilt grass (*Microstegium vimineum*), Japanese knotweed (*Reynoutria japonica*), reed canary grass (*Phalaris arundinacea*), common reed (*Phragmites australis*) and tree of heaven (*Ailanthus altissima*) have become established within the riparian zone and have provided substantial competition for the native plant species that are necessary for the diverse wildlife that rely on the watershed.

Throughout the watershed, approximately 6.78 stream miles are identified as potential locations for riparian buffer enhancement projects. Within those areas, mowing and grazing should be stopped or at least limited to minimize impacts to the stream community. The application of fertilizers and pesticides should be limited to only what is essential to decrease potential water quality impacts. Landowners within the identified areas should be encouraged and assisted in the planting of native trees and shrubs. Invasive species should be managed. While the wider the riparian buffer the better for the environment, the first thirty-five feet from the edge of the stream is typically considered the most crucial for maintaining water quality.

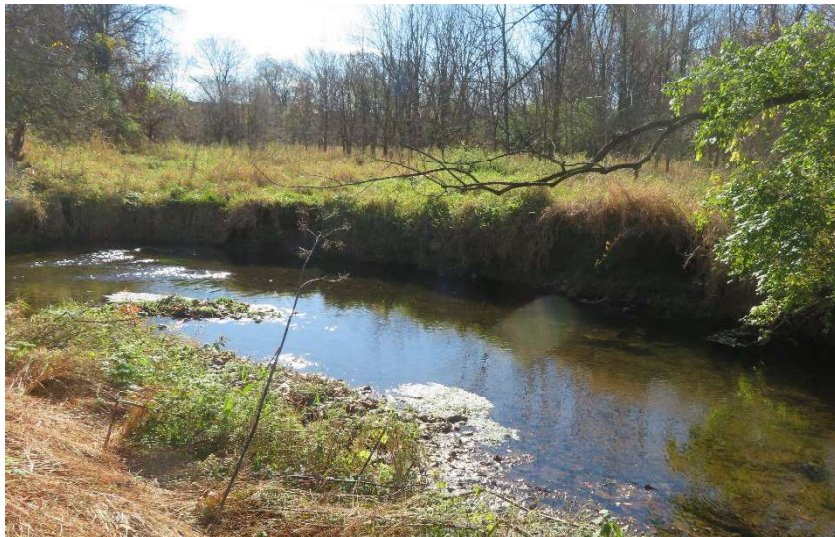
Throughout this stream section, the 3 to 4 feet high streambanks are actively eroding. The stream channel is disconnected from the floodplain by sediment that settled in this lower gradient area during the backwater flooding conditions created when Bucktoe Creek enters The Lower West Branch Red Clay Creek during flooding conditions.

Work within this stream section should focus on the creation of an active floodplain, stabilization of streambanks by grading them to a stable slope, installing natural stream

design structures to create fish habitat and protect the streambanks, creating floodplain wetlands, planting native species, and controlling invasives. Completing the design, permitting, and construction of this project in conjunction with the restoration of Impacted Stream Segment #15-16 would minimize costs for both projects.
