**Restoration Plan  
for  
Plum Run Watershed  
Chester County, Pennsylvania  
February 2008**

RETTEW Associates, Inc.  
Natural Sciences Group  
950 East Main Street, Suite 220  
Schuylkill Haven, PA 17972  
(570) 385-2270  
(570) 385-2217 fax  
RETTEW Project No. 07-07568-002

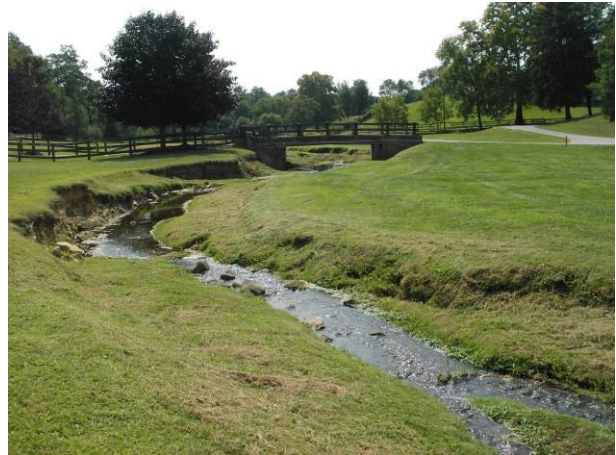
Restore the natural stream geometry and restore the floodplain by removing legacy sediment. Temporary stabilization of the streambank should only occur with stream channel geometry restoration as the channel is likely to continue lateral erosion unless the stream's hydrology is considered in the restoration effort. After restoration of the channel, a riparian buffer enhancement project would be appropriate to increase the likelihood of a positive outcome for the project and work to naturally reinforce the streambanks. While this project covers a large area and is potentially the most expensive in the restoration plan, it will also likely have the greatest positive effect as sediment from this area likely impacts the stream all the way to the confluence with the Brandywine. Also important are the minimal number of wetlands that are located on the streambanks which should aid in permitting of the project and not obstruct access to the site. The lack of forest in a large section of this reach should be looked at as an opportunity to begin the project without having to clear and grub or be as concerned with removing invasive rootstock.

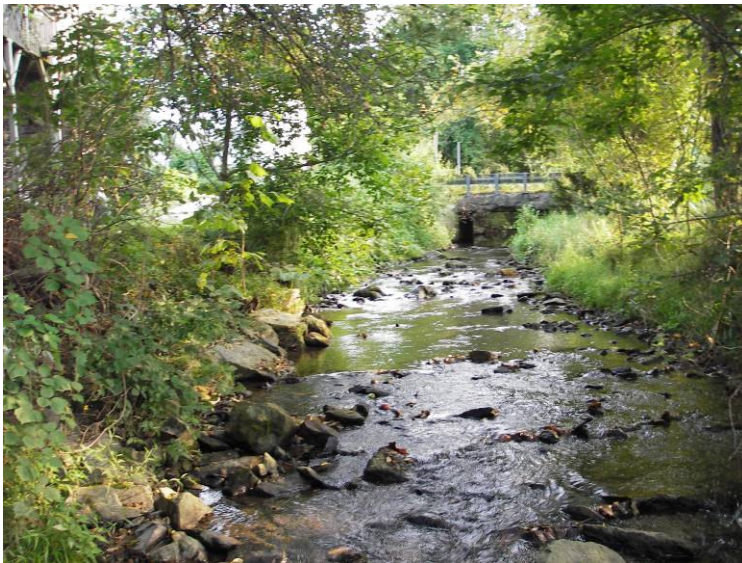
### **Impacted Stream Segment #17:**

This impacted stream section begins at the Birmingham Rd. bridge and extends downstream for approximately 500 feet. Downstream of the bridge is the Strodes Mill structure. Strodes Mill is considered historically significant and its preservation is an asset to the community. This structure has experienced flooding issues in the past. The streambanks in this area are vegetated and approximately 3-4' high. The impacted area includes a straight section of stream that is likely not the historic location of the stream channel. Downstream of the straight reach, some riffle, run, pool and glide habitat types are present, but the stream bottom is sediment laden.

While a large floodplain restoration project that restores the stream to its pre-European settlement location would be ideal, the constraint of an existing PennDOT bridge should not be underestimated. A suitable alternative approach would minimize project costs, but still minimize

flooding risk to the structure and promote biodiversity. An option of installing traditional in-stream deflectors to encourage the channel to move away from the structure during bankfull and lower flows events should be coupled with floodplain restoration on the east side of the stream. The improved floodplain on the east side of the stream would ideally allow flows higher than bankfull to spread out away from the structure. As the east side of the stream is currently in riparian buffer and agriculture, expanding the floodplain in that area may be
