**Restoration Plan
for
Trib. 414 Watershed
Chester County, Pennsylvania
August 2008**

RETTEW Associates, Inc.
Natural Sciences Group
950 East Main Street, Suite 220
Schuylkill Haven, PA 17972
(570) 385-2270
(570) 385-2217 fax
RETTEW Project No. 07-07957-002

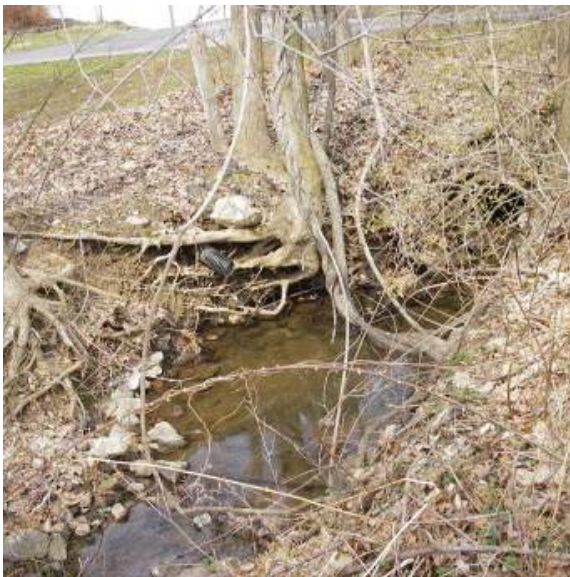
The stormwater from the extensive impervious areas upstream of this location are likely the cause of much of the downslope degradation. While the stream is not incised and indicative of an impacted stream from a habitat standpoint, the shallow bedrock is likely playing a role in stabilizing this area. While points 39 and 73 indicate the areas of the watershed where stormwater management retrofits become most necessary, this high priority project is a watershed wide initiative. The field investigation map indicates where good sites for initial stormwater best management practice retrofit projects are located (Appendix A).

Urban stormwater management retrofits that consider volume, rate, and water quality should be included with any work that drains into Trib. 414. While landowner education targeting homeowners will be helpful, an outreach program that targets the commercial areas of the watershed may have the greatest potential for success. Consideration should be given to development of a recognition program

where businesses that install stormwater retrofits receive a “Friends of the Red Clay Watershed” sign to help identify them as a watershed steward to their patrons and employees. Educational programs in this community should focus on reducing the discharge of stormwater to Trib. 414. Stormwater retrofits including extended detention ponds, wet ponds, constructed wetlands, bioretention areas, filtering practices, infiltration practices (including drywells, infiltration trenches, permeable pavers, etc.), vegetated swales, green roofs, stormwater planters, rain gardens, rain barrels and stormwater cisterns should be encouraged (Shueler *et al* 2007).
